TABLE OF CONTENTS

BOWKER CREEK ASSESSMENT SUMMARY

REACH 1A
Reach # 1A – Creek mouth into Oak Bay to upstream (west) end of 1776 Beach Drive) (140m) 2733, 2717, and 2713 Somass Drive; 1725, 1762, and 1776 Beach Drive (privately owned)
Channel Description Channel banks are primarily concrete, mortared rock and concrete sandbags (Photos 1-6,8-10,12-15). The channel bottom is a mix of bedrock, heavily silted substrate of sand, gravel, cobble, and boulders, and extensive concrete and asphalt armouring (Photos 3,8,9,12,13,16). Thick algal mats and root mats from golden willow are present. Vertical armoured banks 1-2m tall, channel width 3.0m – 5.5m, wetted width 0.4m-3.5m (summer). The creek is channelized and straightened with a gradient range from 1.5-4% with a narrow strip of riparian vegetation (Photos 17 & 18). There is a 22m long pool downstream of the culvert which is suitable as a holding location for juvenile fish prior to entering the marine environment, and also for adults entering the stream to hold while awaiting higher flows and while maturing. Tidal influence occurs downstream of Beach Drive. Concrete box culvert at Beach Drive (3.0m wide x 2.2m tall x 15m long). Small a

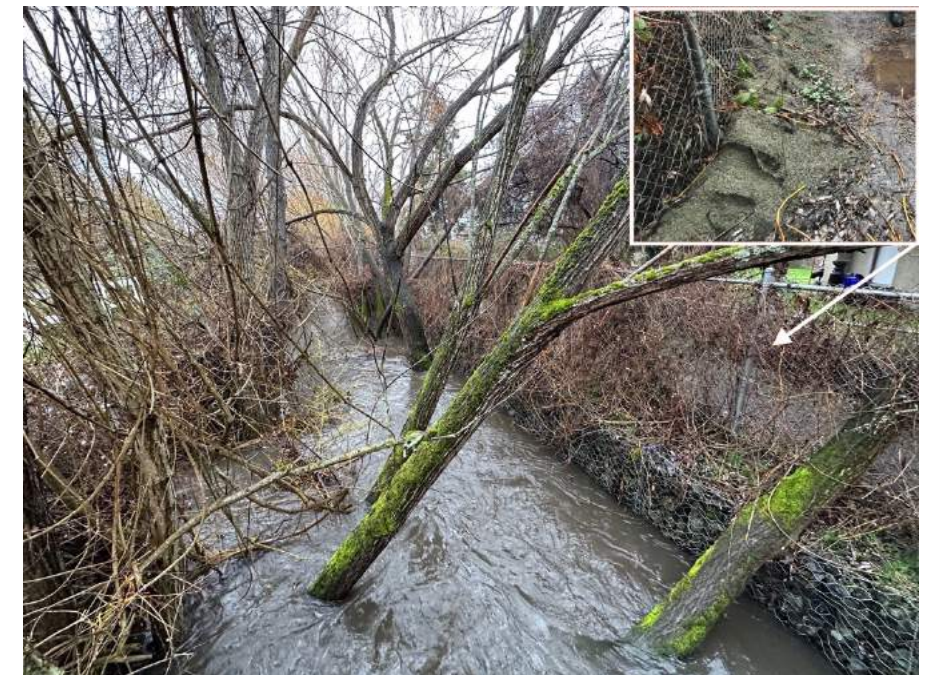
Photo 7A-24. View downstream from Haultain Street bridge of instream golden willows and gabions. An old berm of disintegrated sandbags lines the property fence immediately adjacent to the footpath above the west bank, indicating previous flood events.

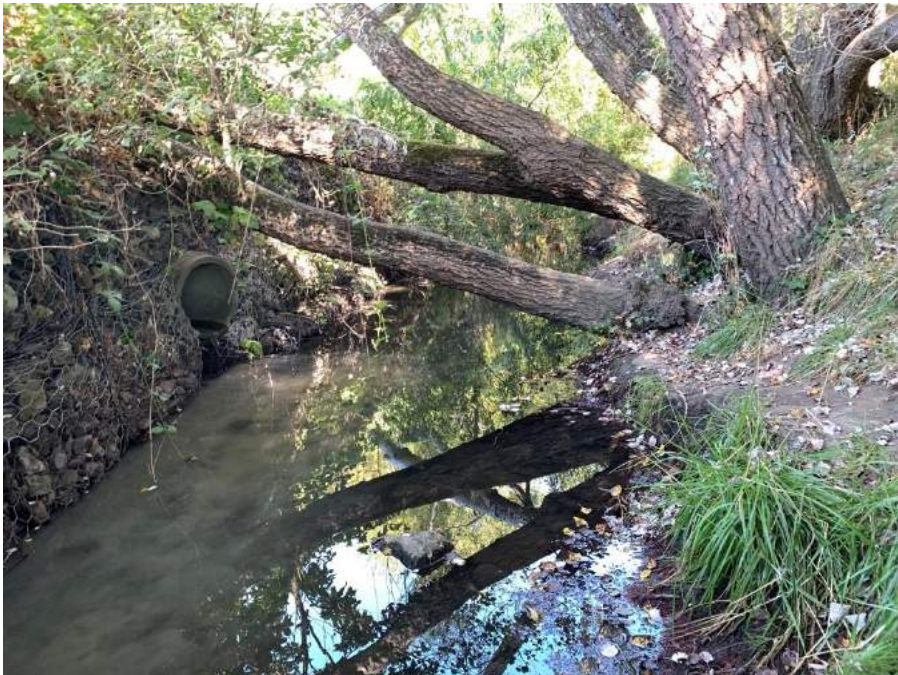
Photo 7B-2. Gabions on the west bank, large white poplar tree (invasive) on the bank, and sedimentation from stormdrain very likely from the nearby open pit construction site (view upstream).

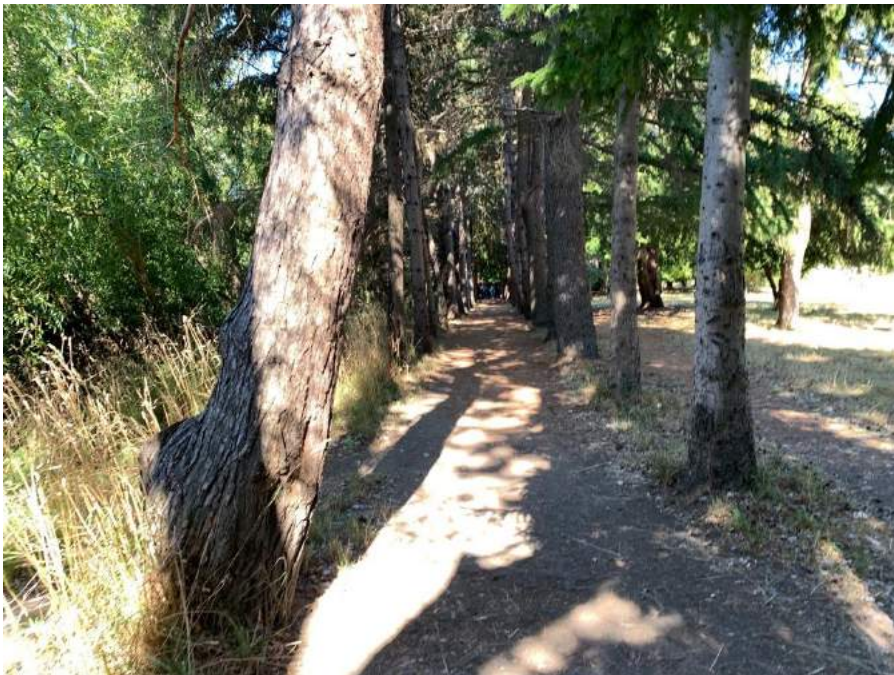
Photo 7B-4. Path with double row of non-native conifers at top of east bank (view upstream).

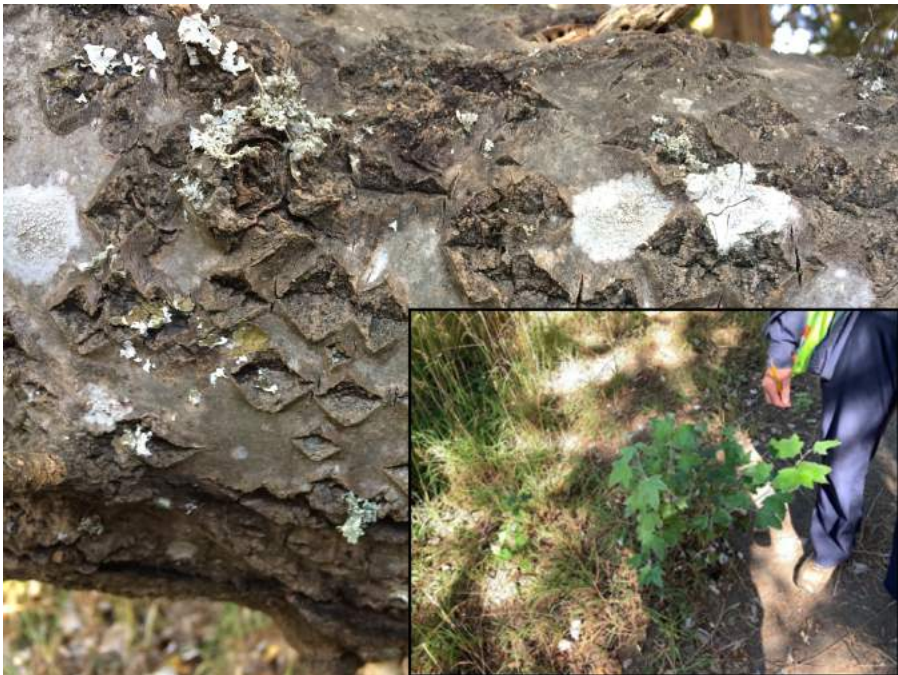
Photo 7B-5. Invasive white poplar spreading along the bank and into the field.

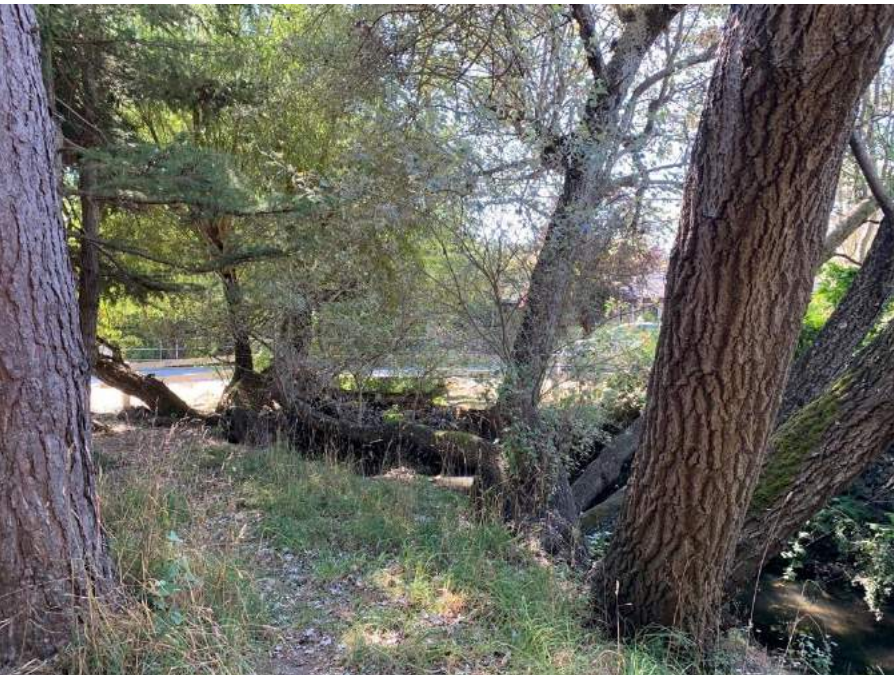
Photo 7B-6. Large white poplar (invasive) on the bank, adjacent to golden willow (invasive) (view downstream to Haultain St).

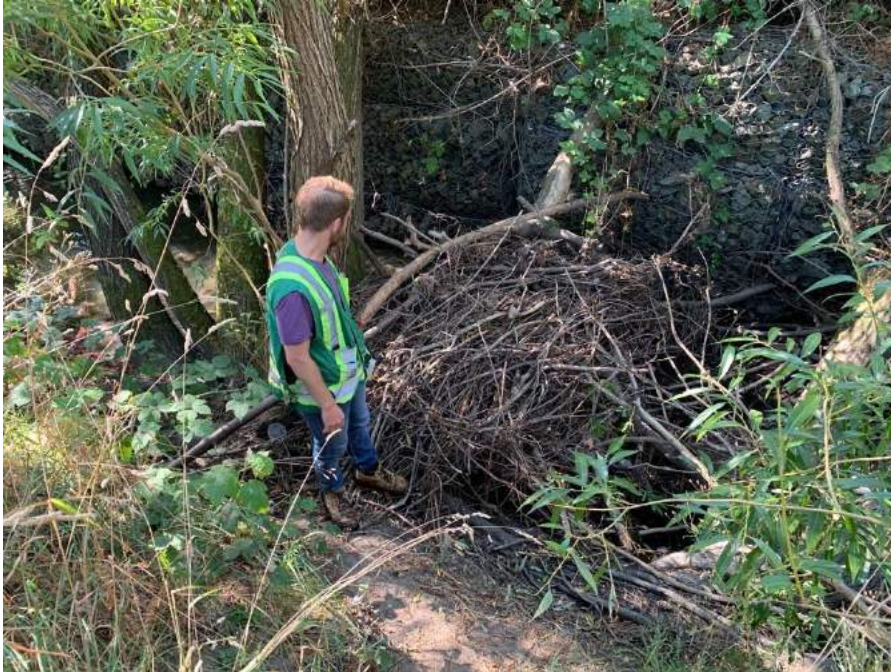
Photo 7B-7. Invasive golden willow, bare soil on banks, and debris jam in the channel (see Photos 7B-21 & 22 for high flows here).

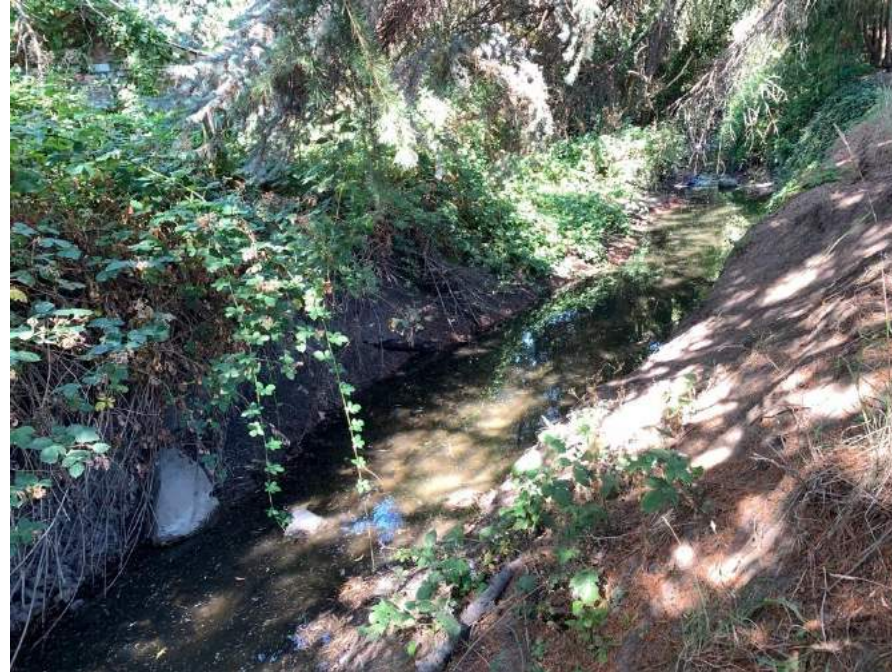
Photo 7B-8. Himalayan blackberry (west bank) and steep bare soil bank on east side (view upstream).

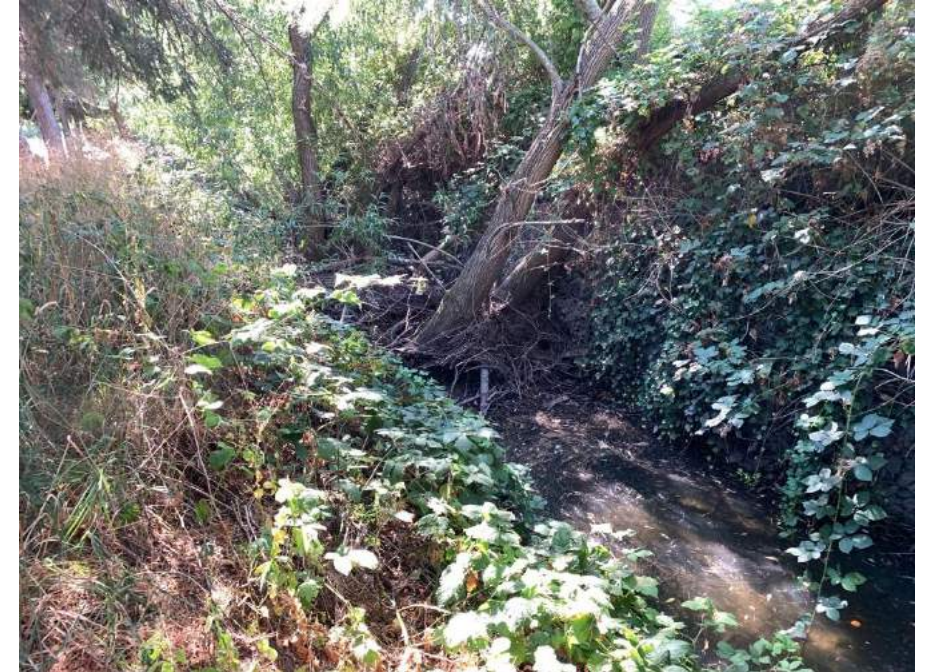
Photo 7B-9. Steep bank with Himalayan blackberry, English ivy, agricultural grasses and golden willow in the background (view downstream).

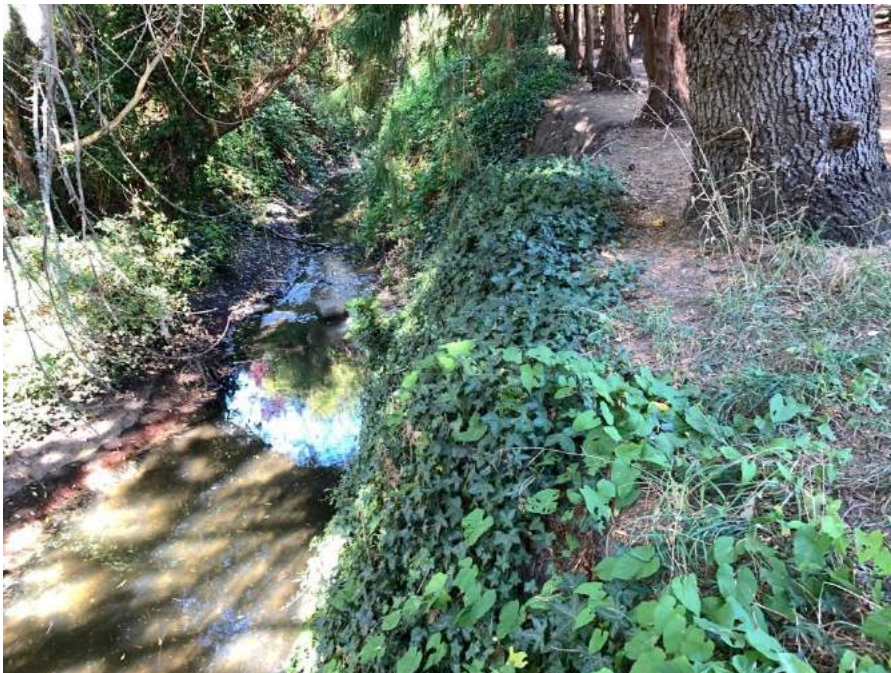
Photo 7B-10. Almost vertical bank with English ivy and morning glory (view upstream).

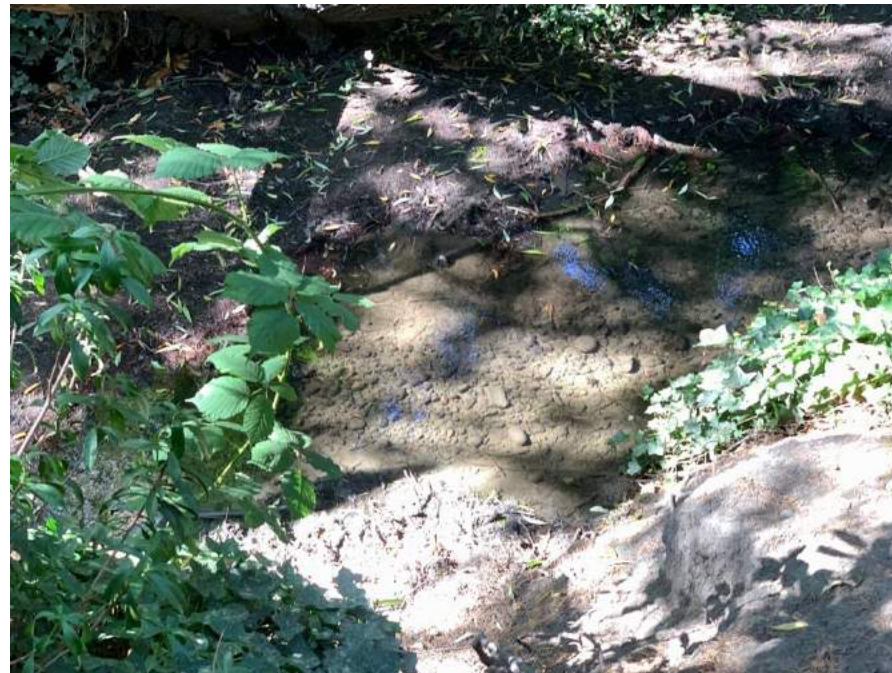
Photo 7B-11. Bare, steep bank, with invasive species, and cobble/gravel substrate.

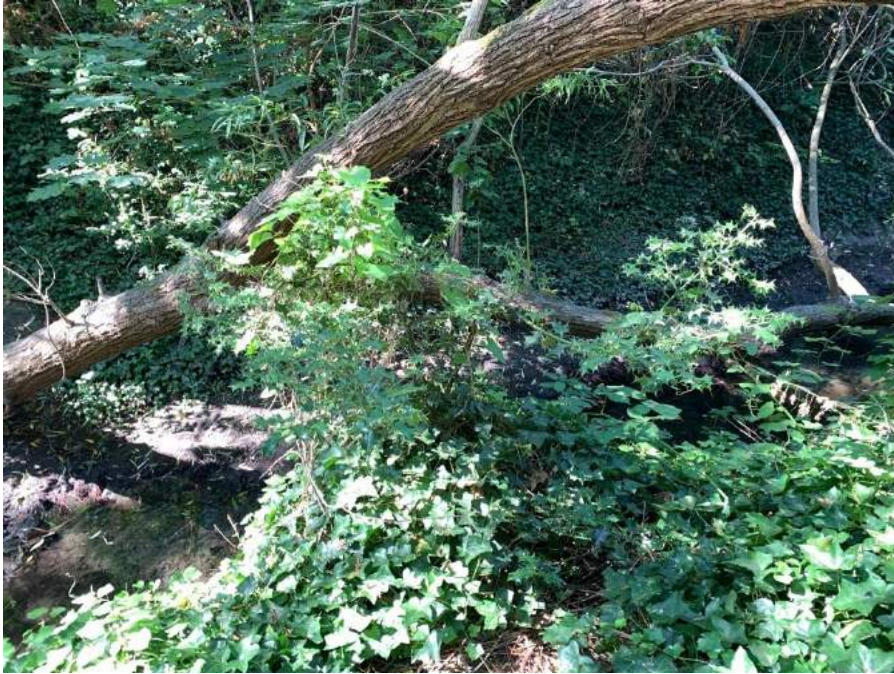
Photo 7B-13. Golden willow, English ivy, English holly (all invasive).

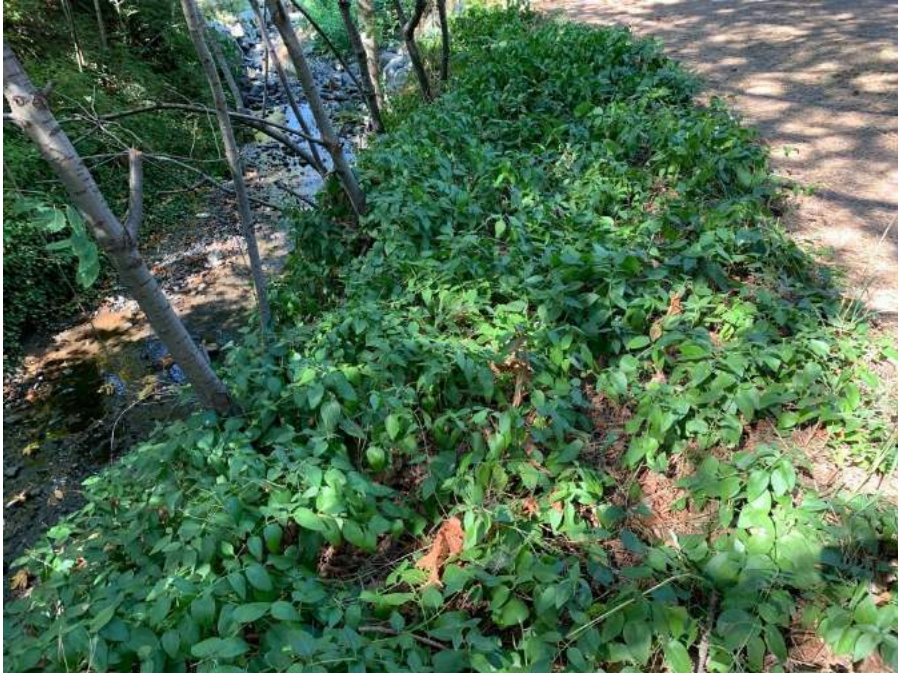
Photo 7B-14. Invasive periwinkle on the steep slope (view upstream).

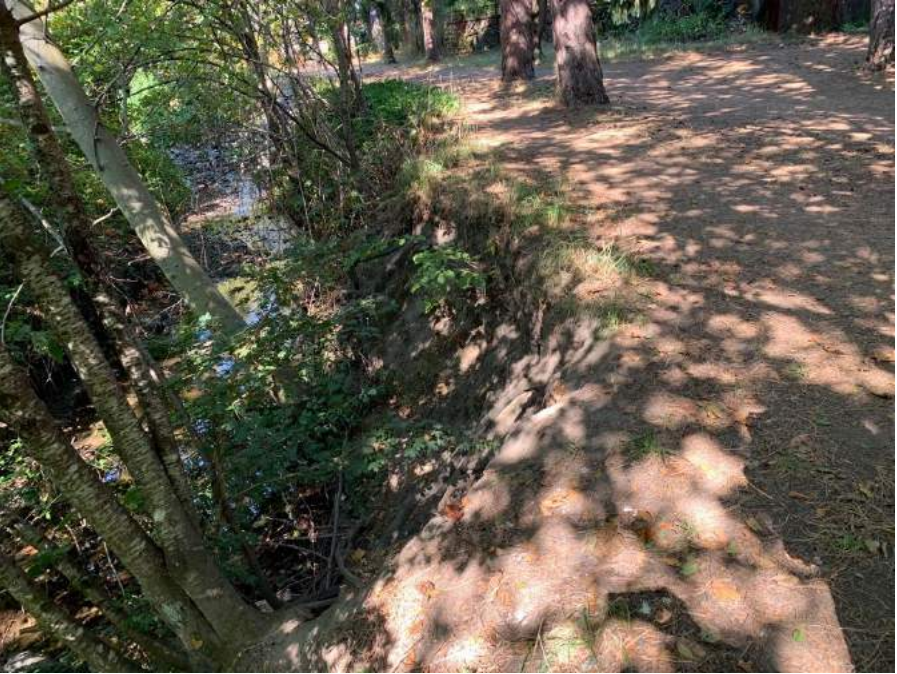
Photo 7B-15. Eroding bare bank (east side of channel) (view upstream).

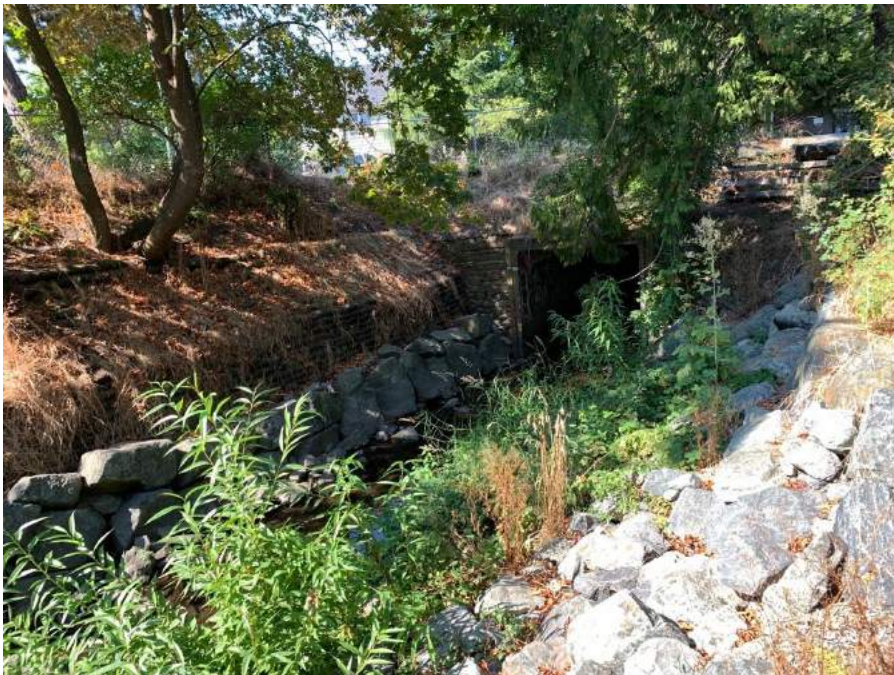
Photo 7B-16. Riprap and MSE bags (with grass) as recent erosion protection (west bank) immediately downstream of Richmond Road, and golden willow (view upstream).

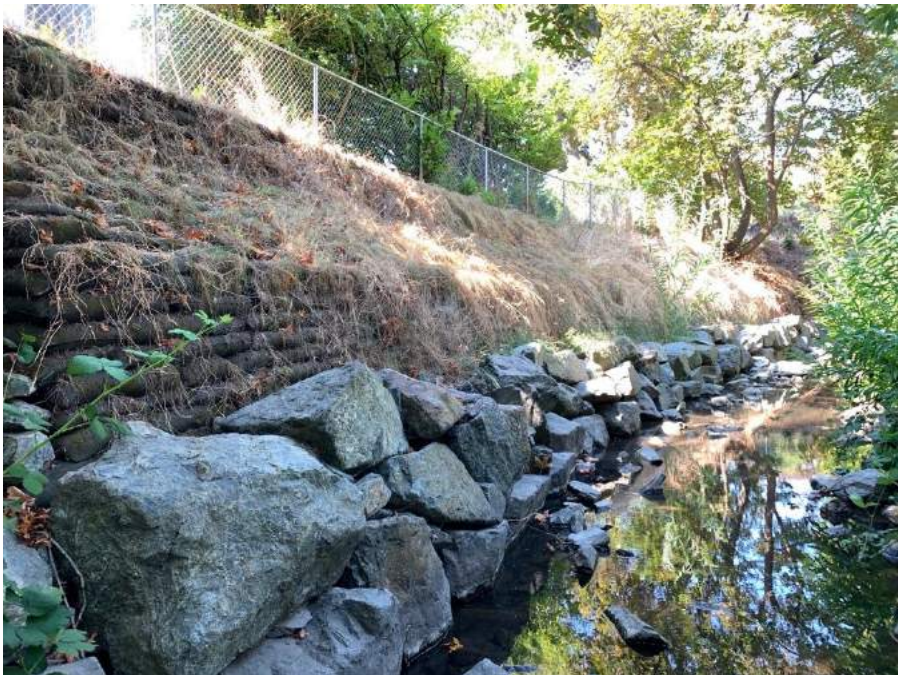
Photo 7B-17. Riprap and MSE bags (with grass) erosion protection (west bank) (view upstream).

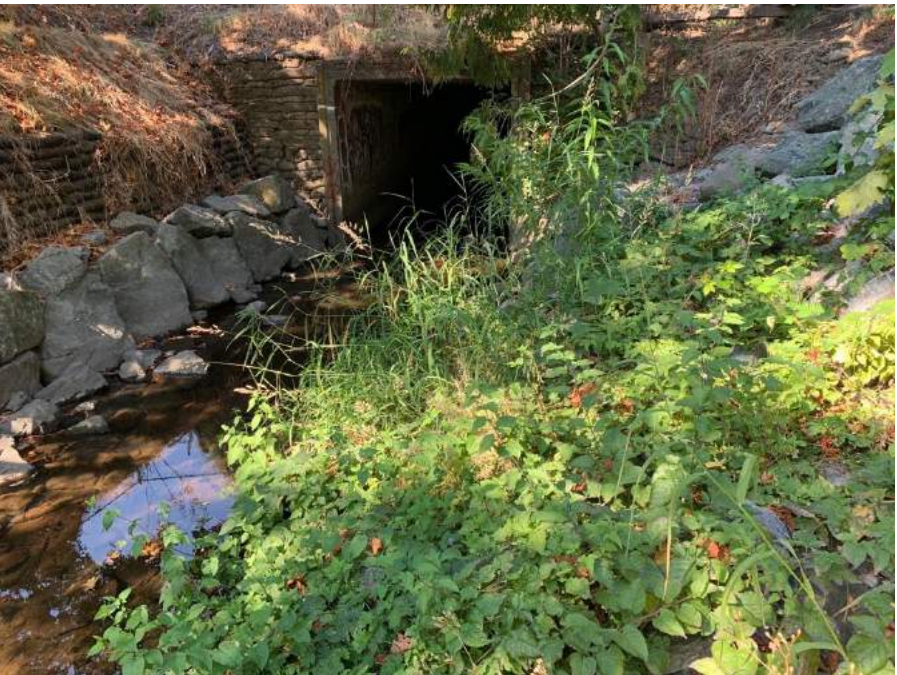
Photo 7B-18. Invasive European black nightshade and European bittersweet on erosion protection at upstream end of the reach, culvert under Richmond Road in the background (view upstream).

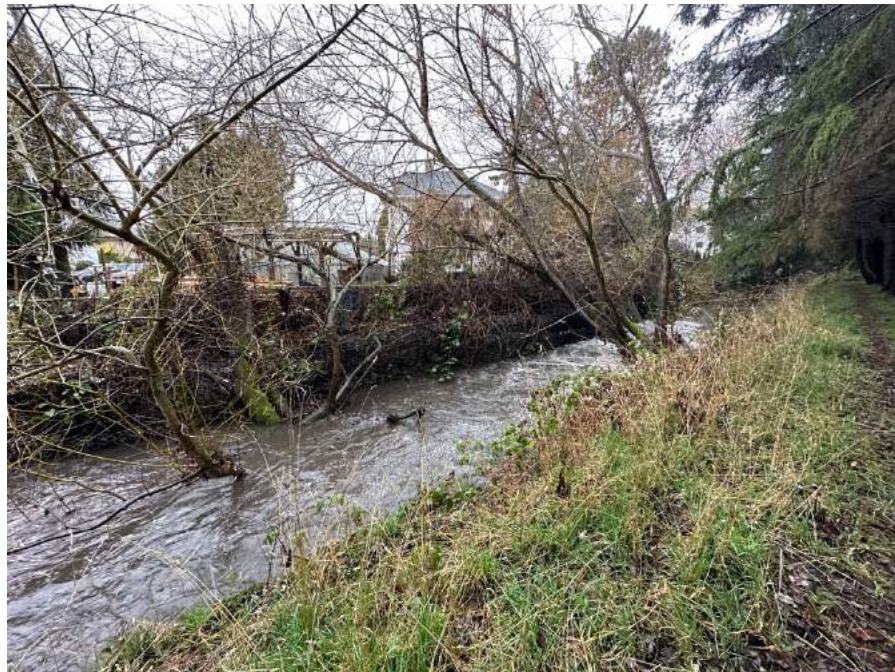
Photo 7B-21. Lower end of reach looking upstream at debris jam pictured in Photo 7B-7 (~30m upstream of Haultain Street).

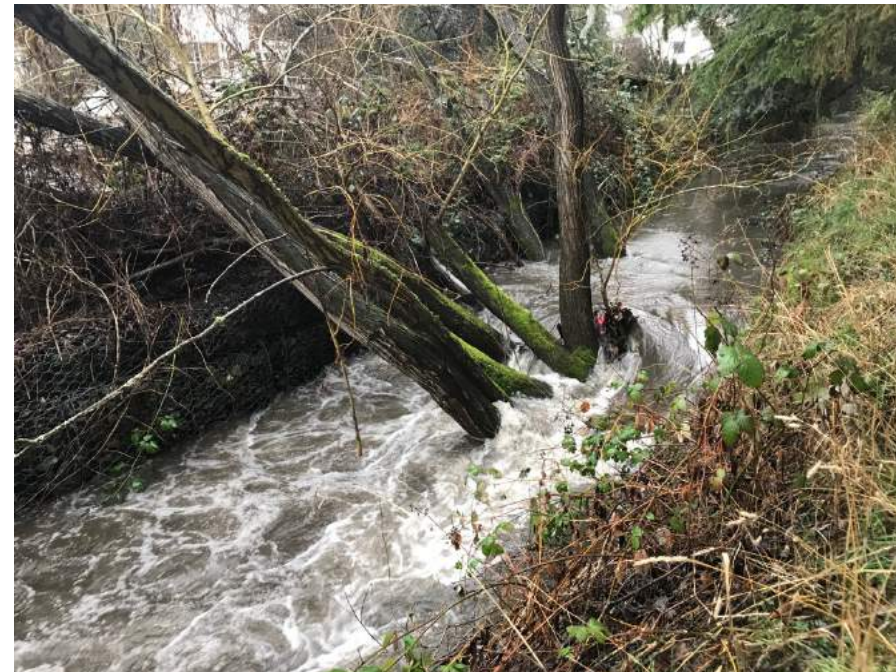
Photo 7B-22. Lower end of reach looking upstream at debris jam pictured in Photo 7B-7 with a vertical drop in height of approximately 0.5-0.75 m (~30m upstream of Haultain Street).

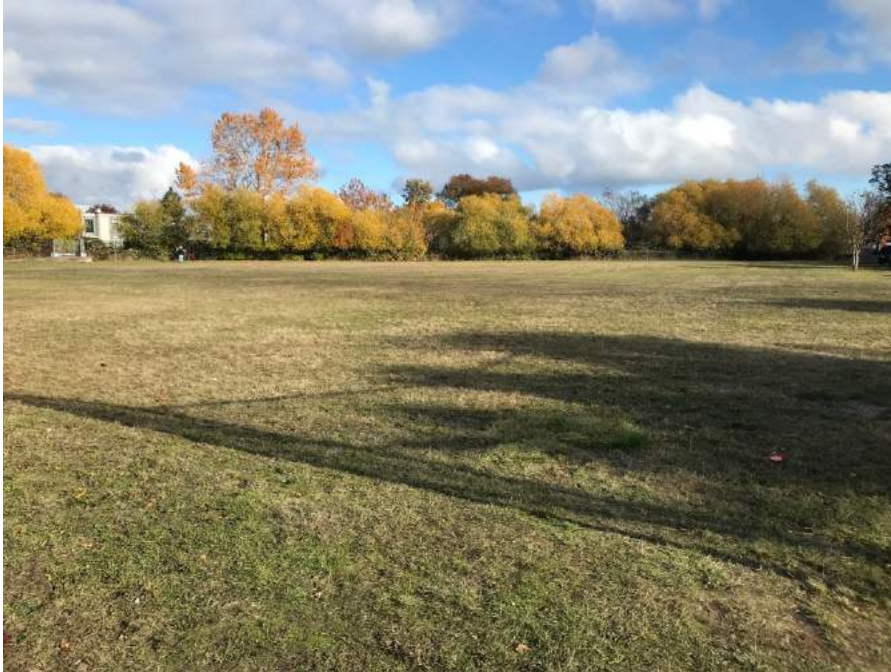
Photo 9-1. Richmond School property on west side of the creek: Extensive mowed field up to the narrow and fenced riparian strip at the top of bank (view east toward creek).

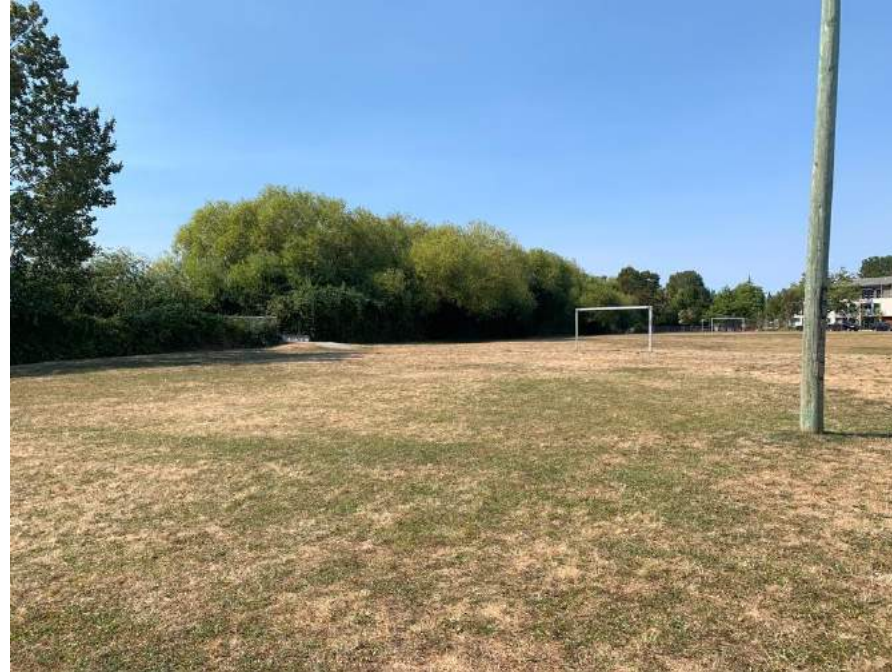
Photo 9-2. Richmond School property on east side of the creek: Extensive mowed field up to the narrow and fenced riparian strip at the top of bank (view northwest/upstream). School buildings are on right.

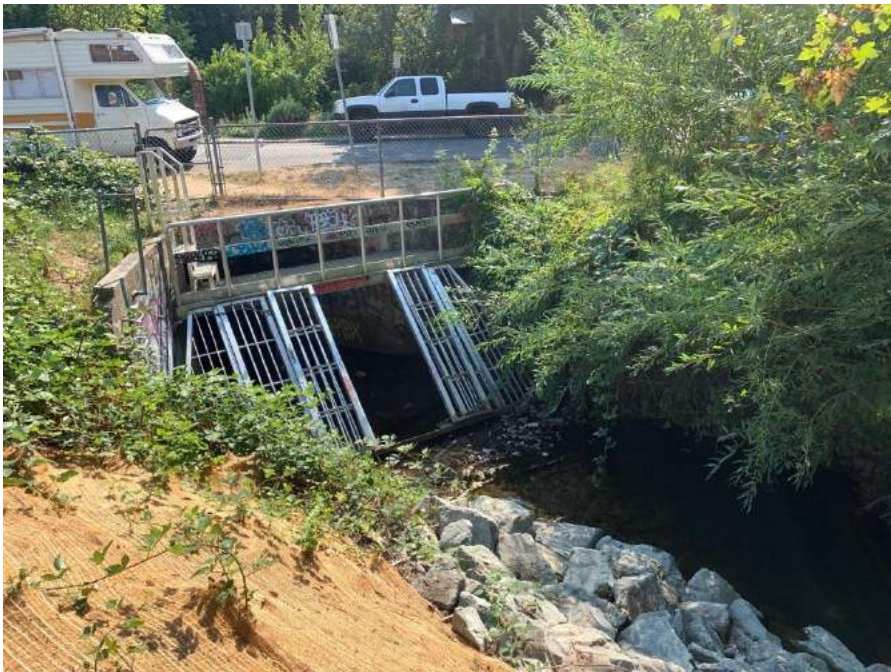
Photo 9-4. Newton Street culvert and recent riprap erosion protection along the east bank with Spirit Park (culverted Reach 8) in the background (view downstream/south).

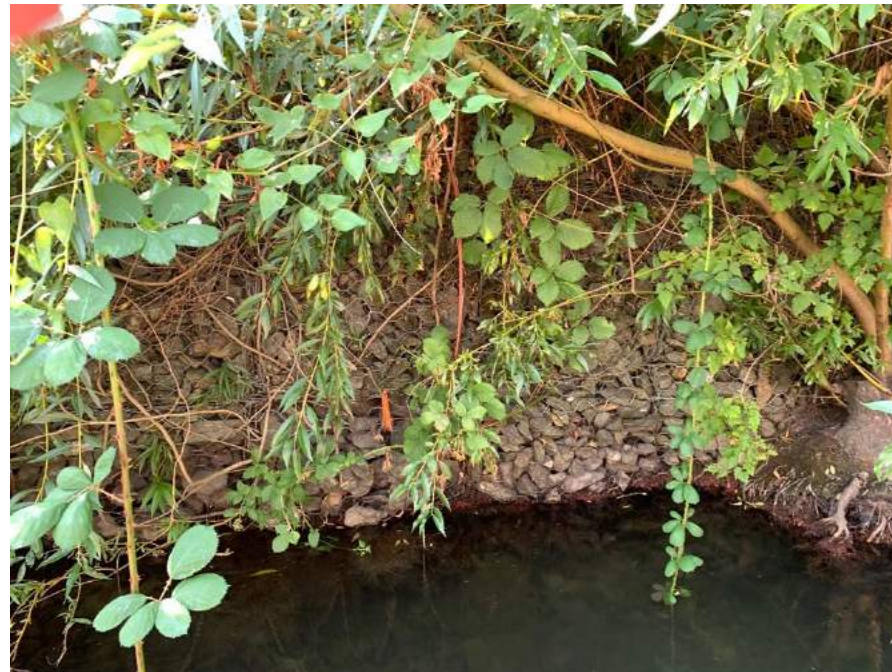
Photo 9-5. Older gabions on the west bank, near the Newton Street culvert.

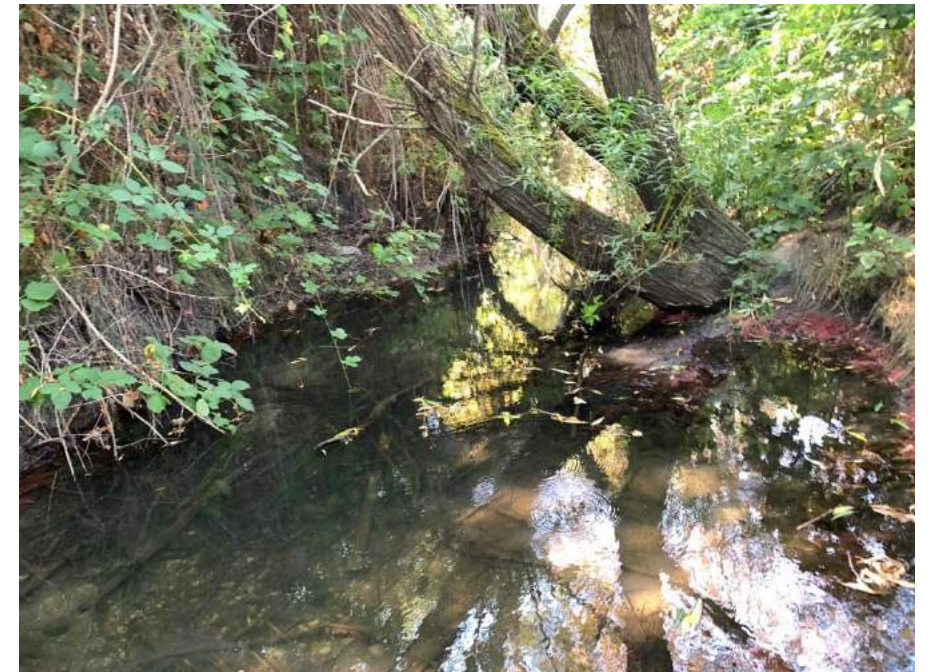
Photo 9-6. Golden willow and root mats forming pool areas in the channel. Invasive species on the bank (Himalayan blackberry, English ivy) (view upstream).

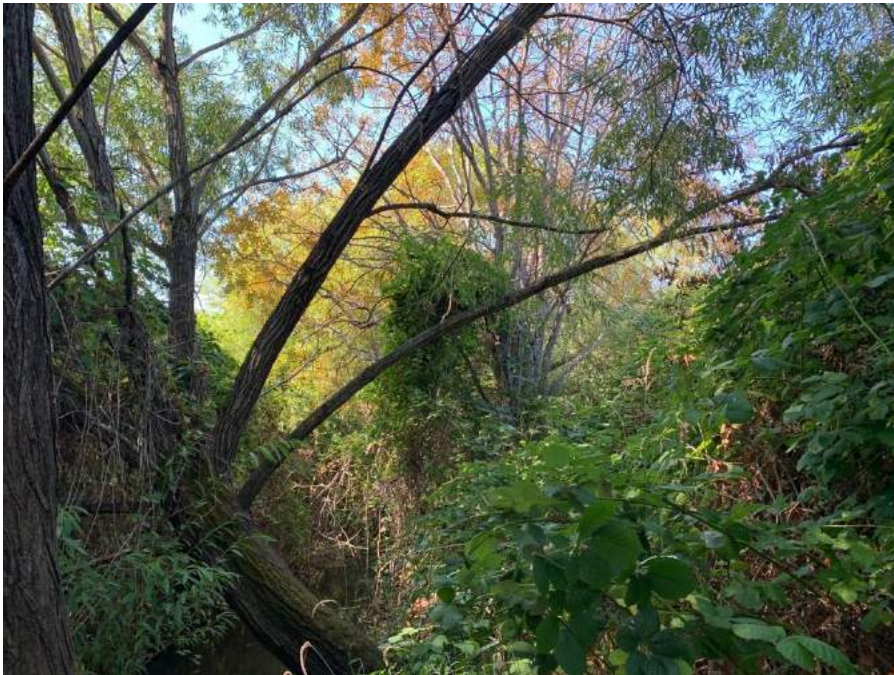
Photo 9-7. Invasive golden willow Himalayan blackberry, English ivy, morning glory, European bittersweet.

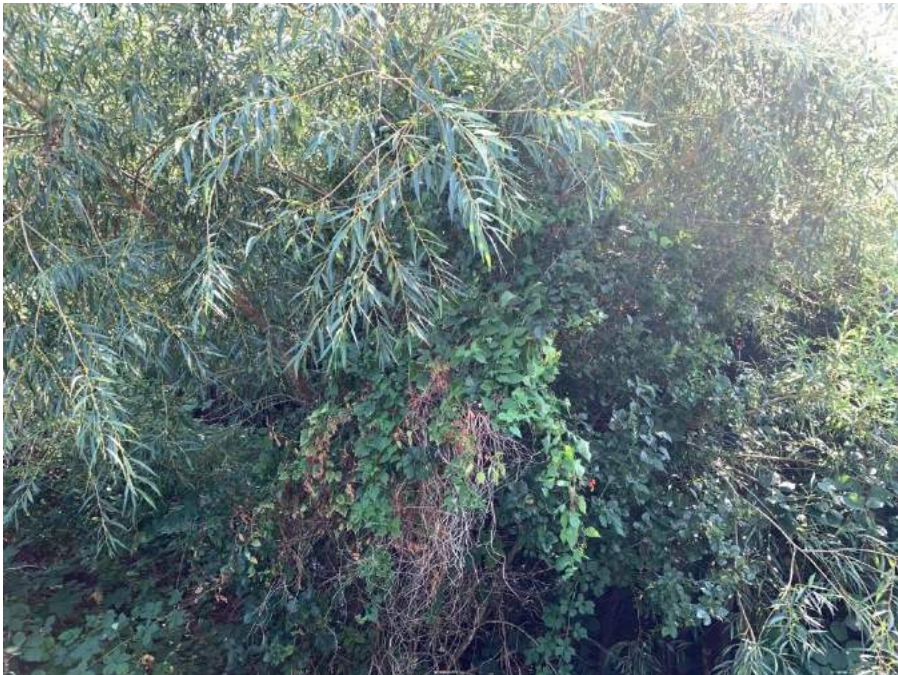
Photo 9-8. Invasive golden willow covered in morning glory.

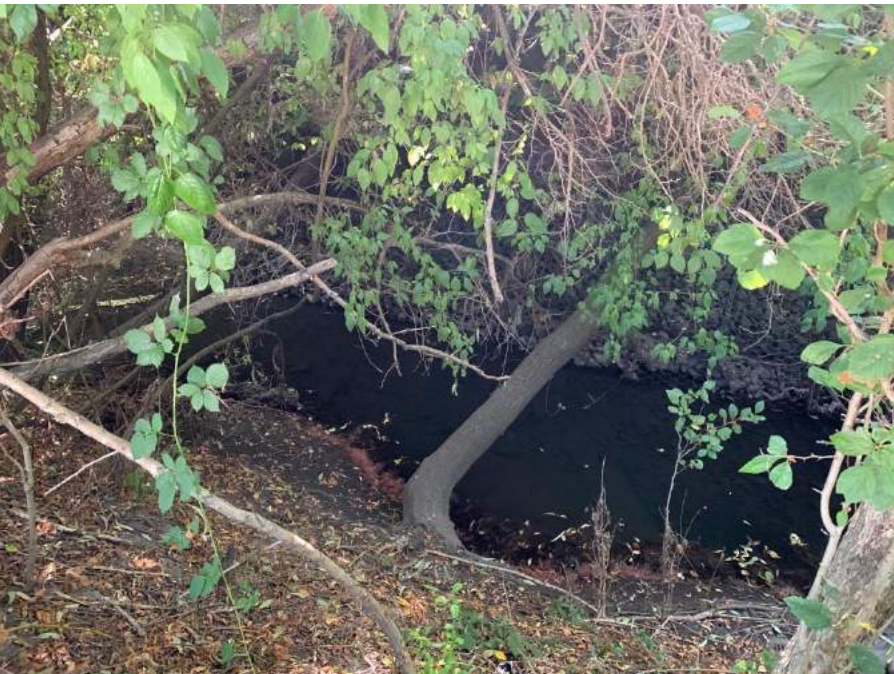
Photo 9-12. Older gabions on the west bank, near the apartment complex (upper end of reach)

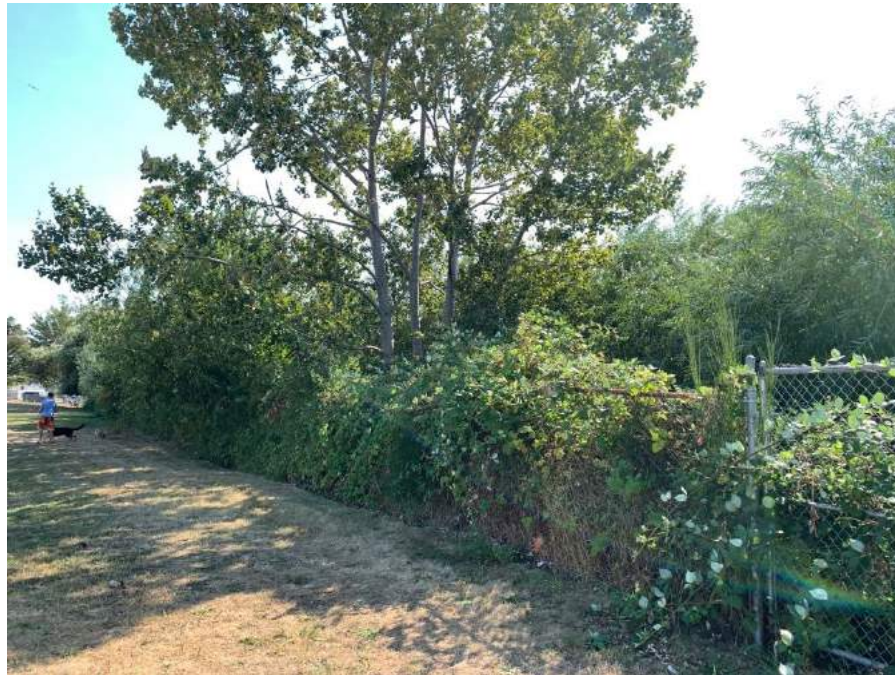
Photo 9-13. Black cottonwood, with invasive golden willow and Himalayan blackberry, and mowed lawn to top of bank (view downstream along east bank).

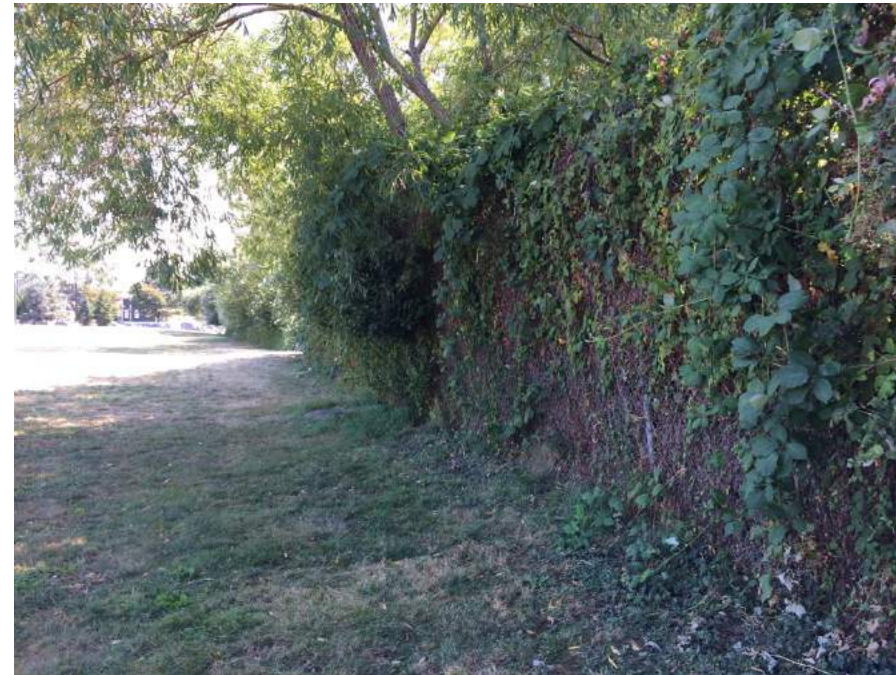
Photo 9-14. The east side of the creek is fenced immediately adjacent to the top of bank, with some fences up to 8 ft tall and embedded with invasive species (view downstream along east bank).

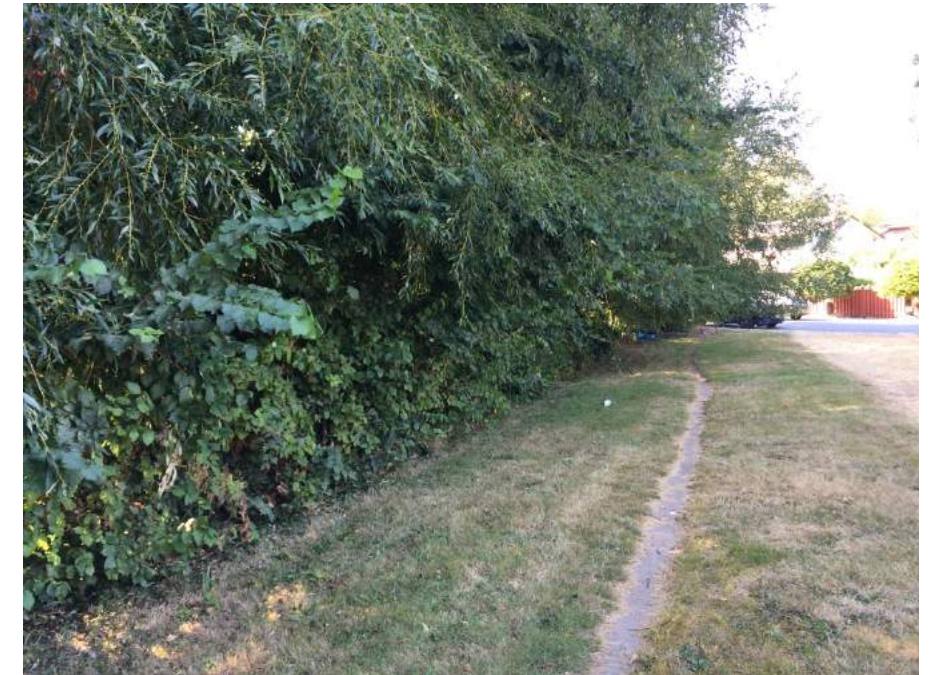
Photo 9-15. An informal foot path and mowed lawn extend to the top of bank along the upper reach to Pearl Street. Along this section there is an older dis-used footbridge that was blocked off and has since been removed (see Photo 9-20) (view upstream along east bank).

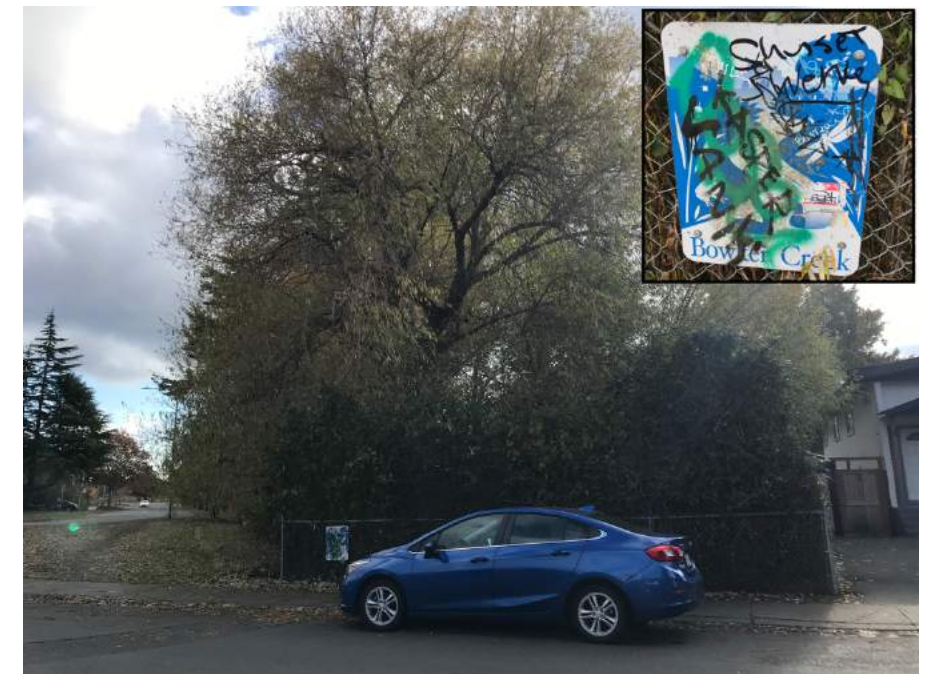
Photo 9-18. Riparian vegetation is dense, but limited in width by fences. Multiple opportunities for public education exist along this high foot-traffic area: Bowker Creek signage is simple and has become defaced (view downstream from Pearl Street).

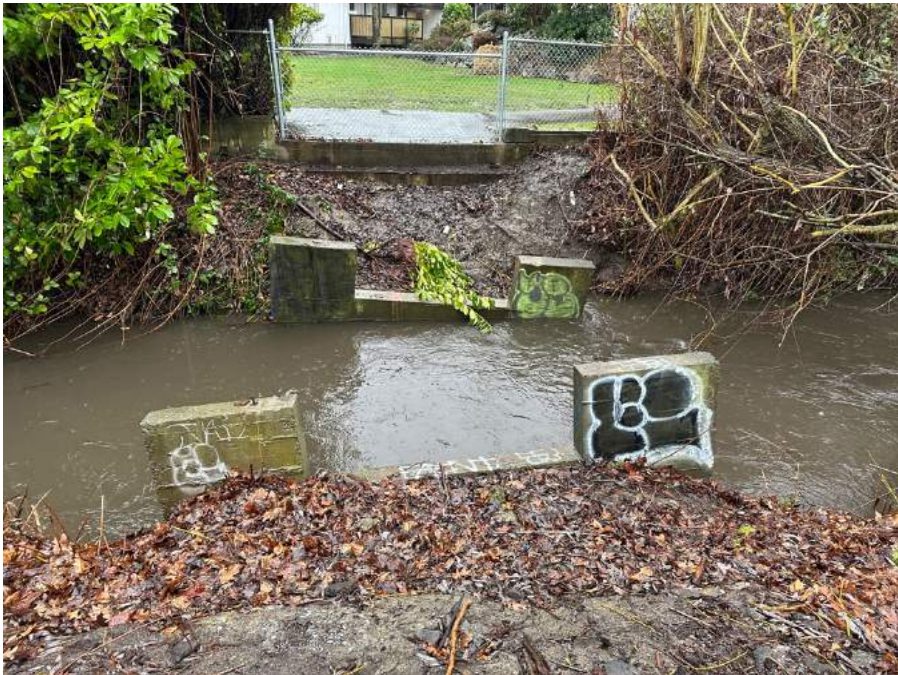
Photo 9-20. Former upstream footbridge has been removed. Footings show significant movement from erosion (view west).
