TABLE OF CONTENTS

BOWKER CREEK ASSESSMENT SUMMARY

REACH 1A
Reach # 1A – Creek mouth into Oak Bay to upstream (west) end of 1776 Beach Drive) (140m) 2733, 2717, and 2713 Somass Drive; 1725, 1762, and 1776 Beach Drive (privately owned)
Channel Description Channel banks are primarily concrete, mortared rock and concrete sandbags (Photos 1-6,8-10,12-15). The channel bottom is a mix of bedrock, heavily silted substrate of sand, gravel, cobble, and boulders, and extensive concrete and asphalt armouring (Photos 3,8,9,12,13,16). Thick algal mats and root mats from golden willow are present. Vertical armoured banks 1-2m tall, channel width 3.0m – 5.5m, wetted width 0.4m-3.5m (summer). The creek is channelized and straightened with a gradient range from 1.5-4% with a narrow strip of riparian vegetation (Photos 17 & 18). There is a 22m long pool downstream of the culvert which is suitable as a holding location for juvenile fish prior to entering the marine environment, and also for adults entering the stream to hold while awaiting higher flows and while maturing. Tidal influence occurs downstream of Beach Drive. Concrete box culvert at Beach Drive (3.0m wide x 2.2m tall x 15m long). Small a

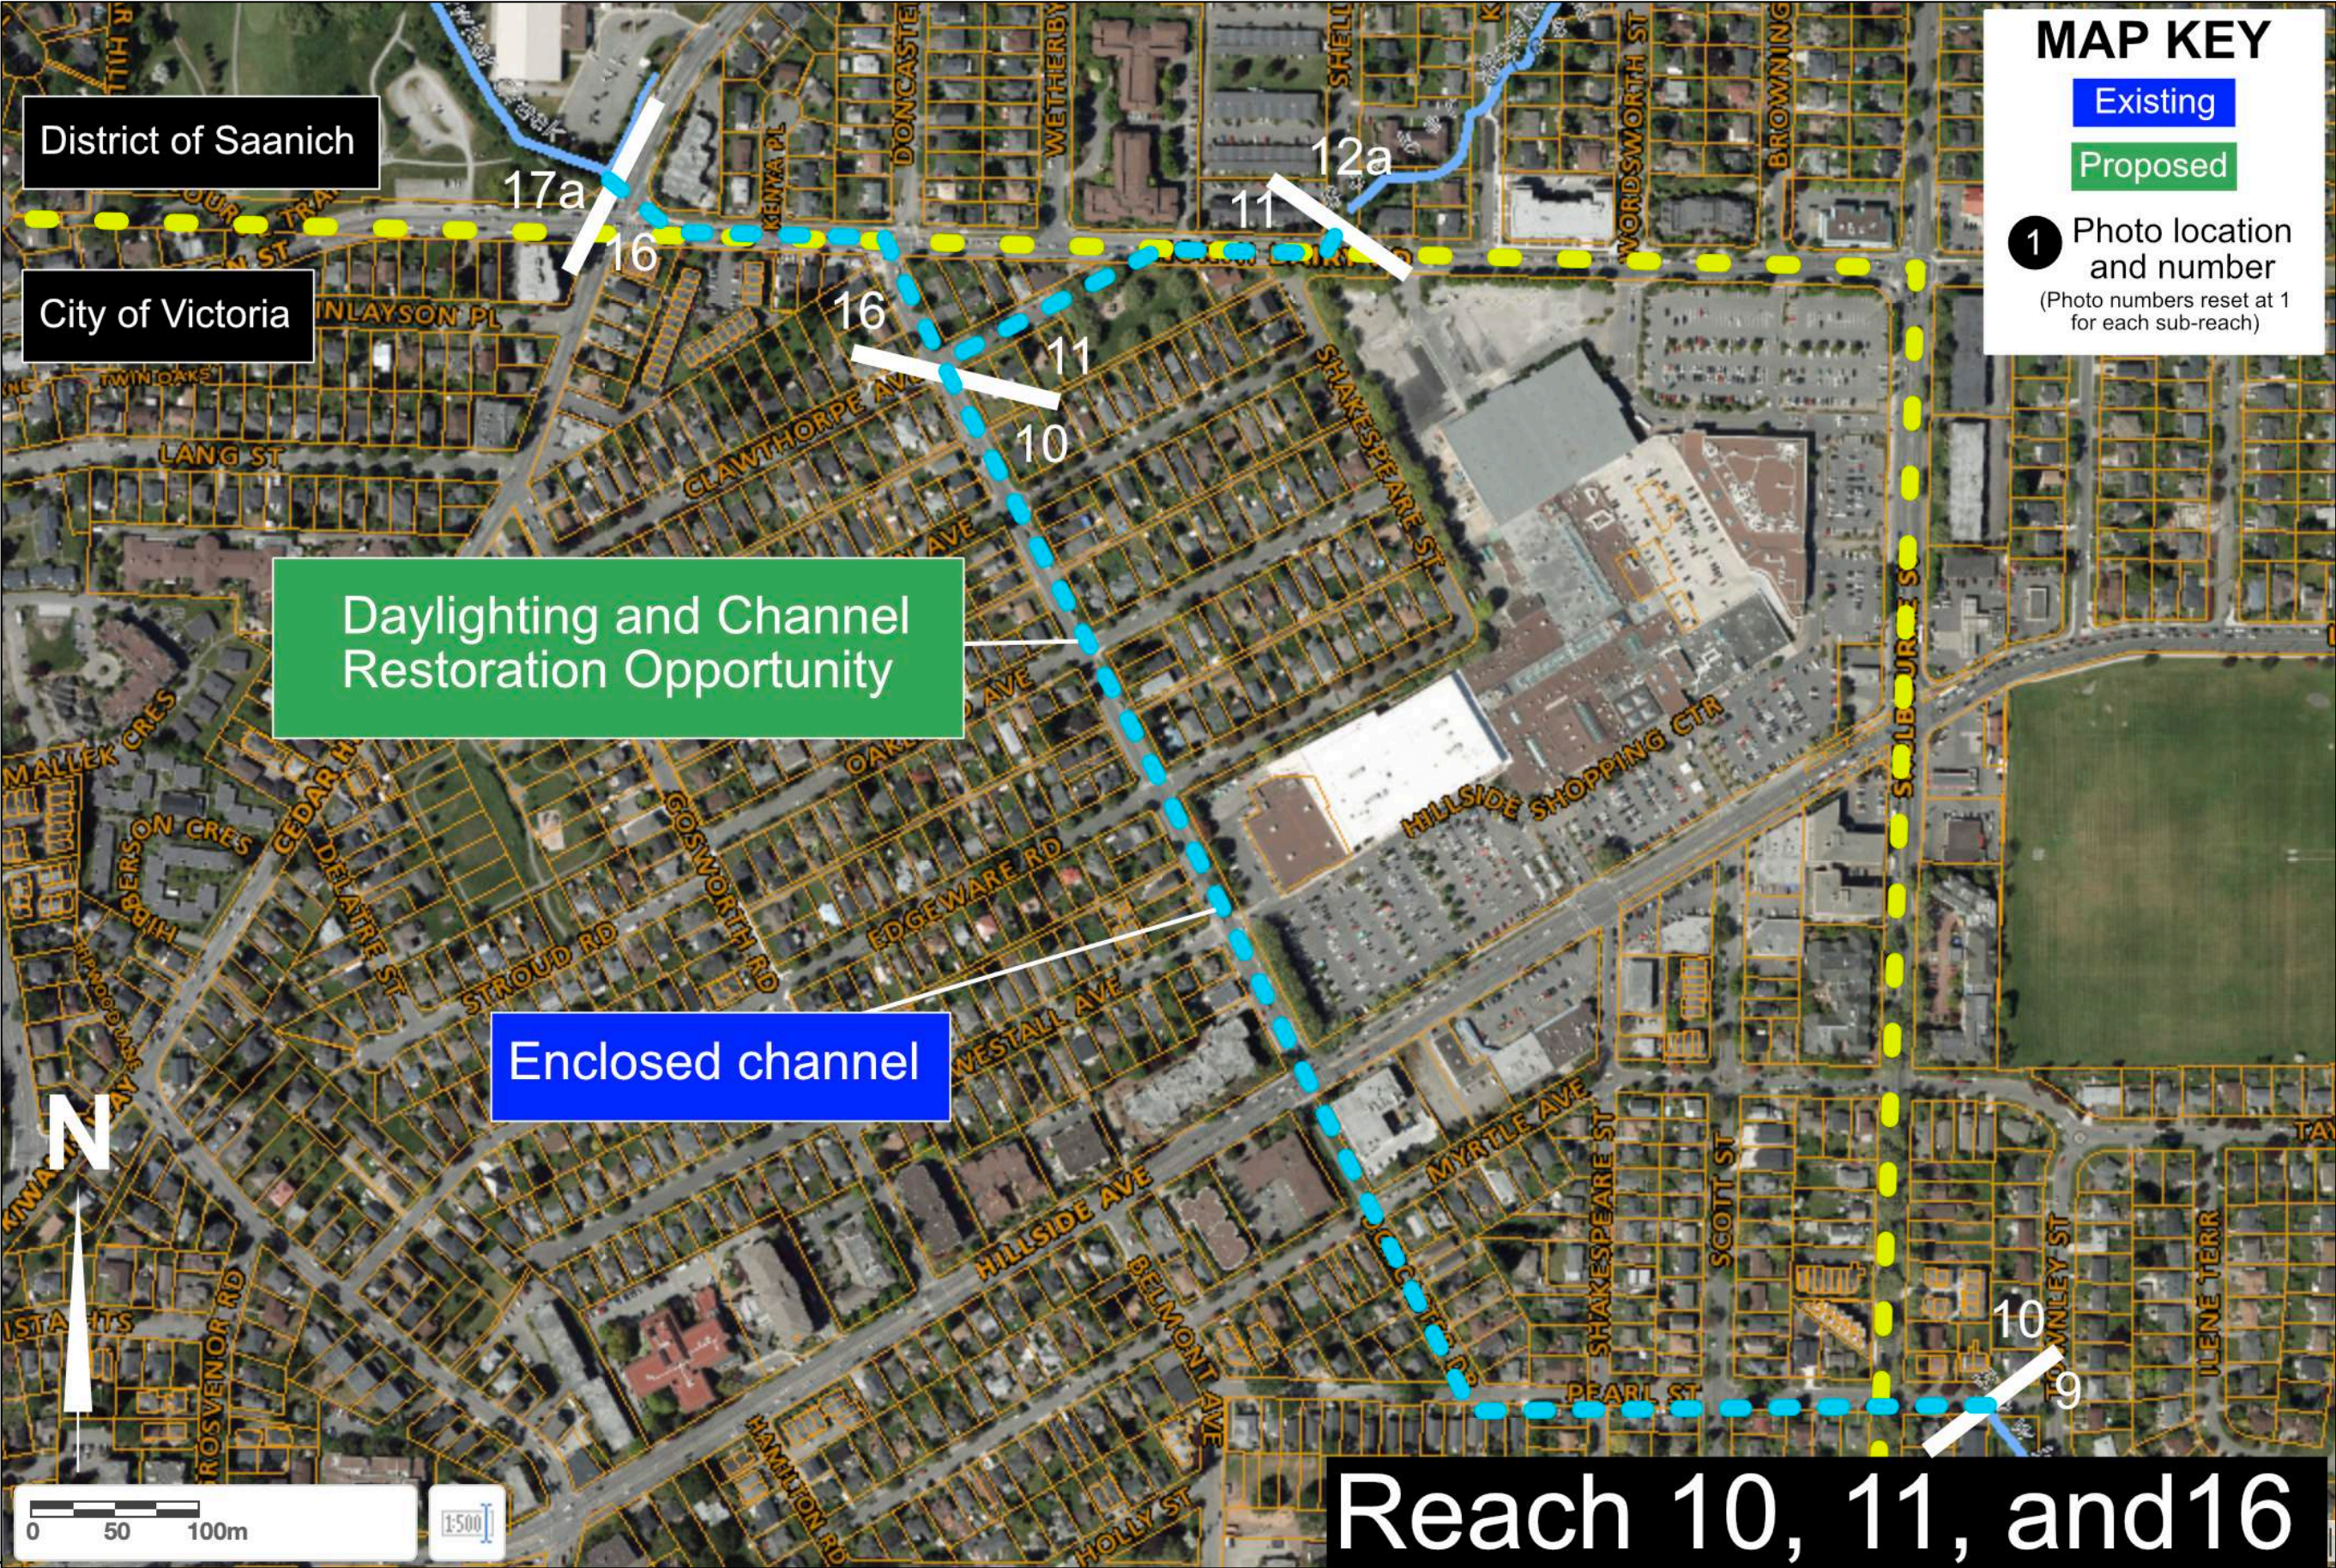
Photo 9-24. Vertical bare slopes at leaning chainlink fence and slope cracking along west bank below the school footbridge demonstrate the ongoing erosion (view west) (see Photos 9-10 & 9-23).

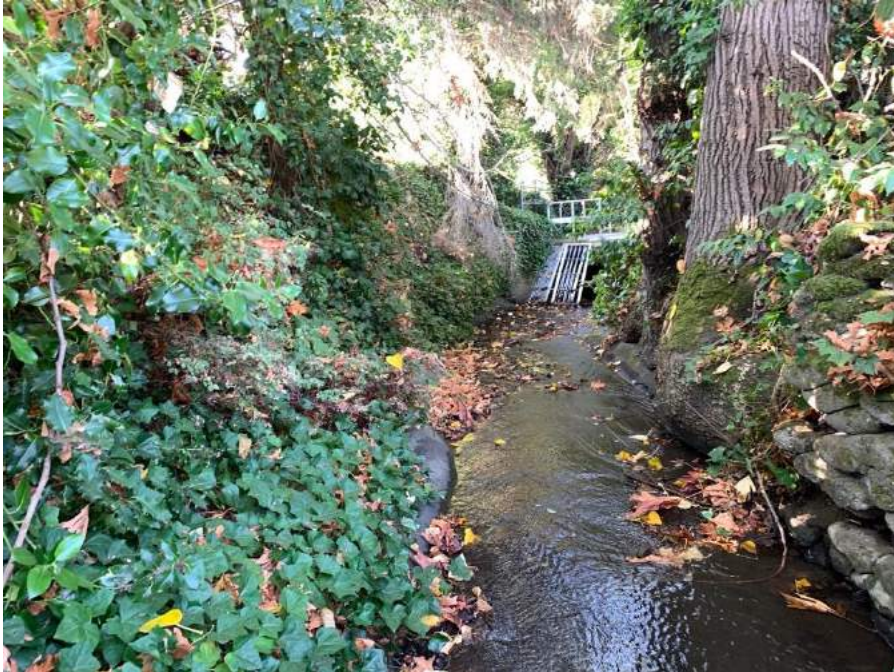
Photo 12A-1. 1564 North Dairy Road and culvert at downstream end of the reach. Concrete bottom Invasive species and erosion under the concrete sandbags.

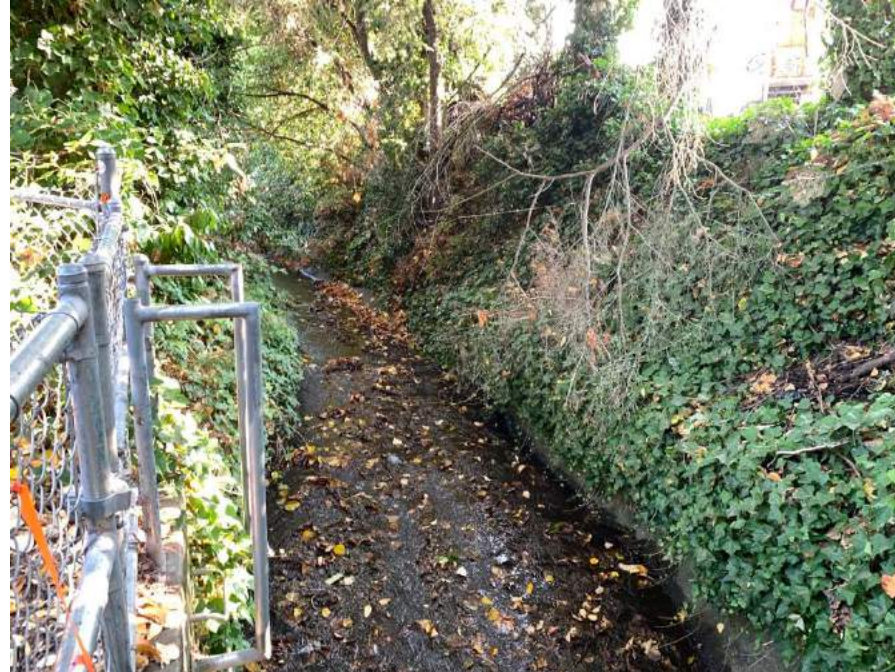
Photo 12A-2. 1564 North Dairy Road and culvert at downstream end of the reach. Invasive species and erosion under the concrete sandbags.

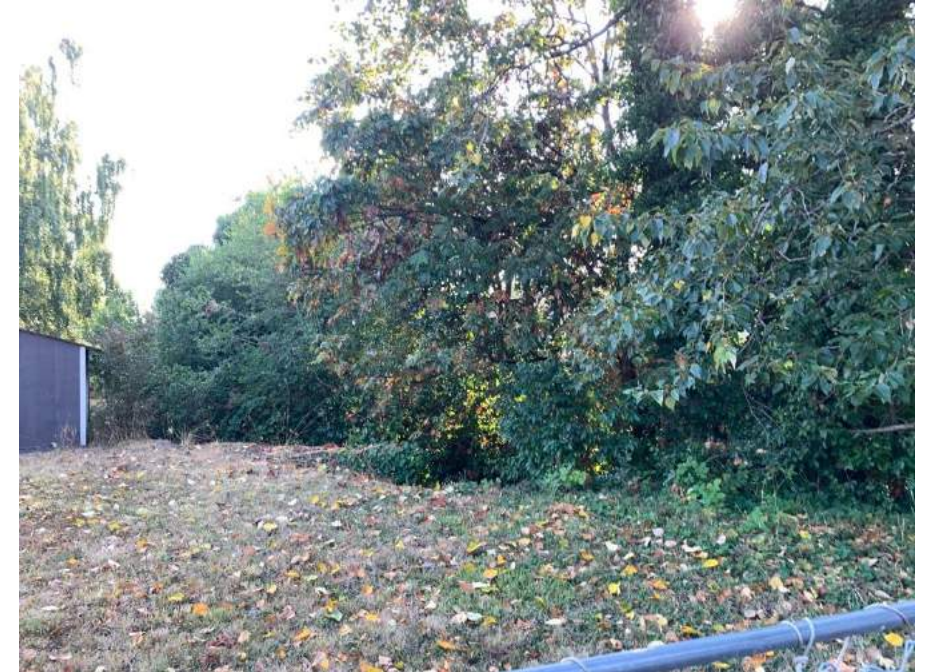
Photo 12A-3. 1564 North Dairy Road unused lawn area where riparian area could be re-sloped and native vegetation planted.

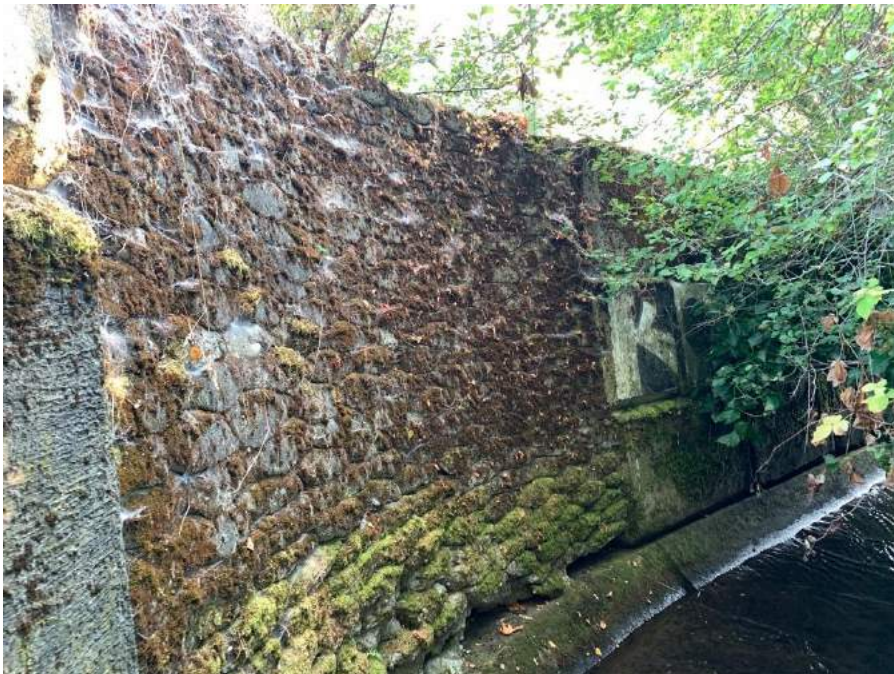
Photo 12A-4. 1564 North Dairy Road concrete sandbags.

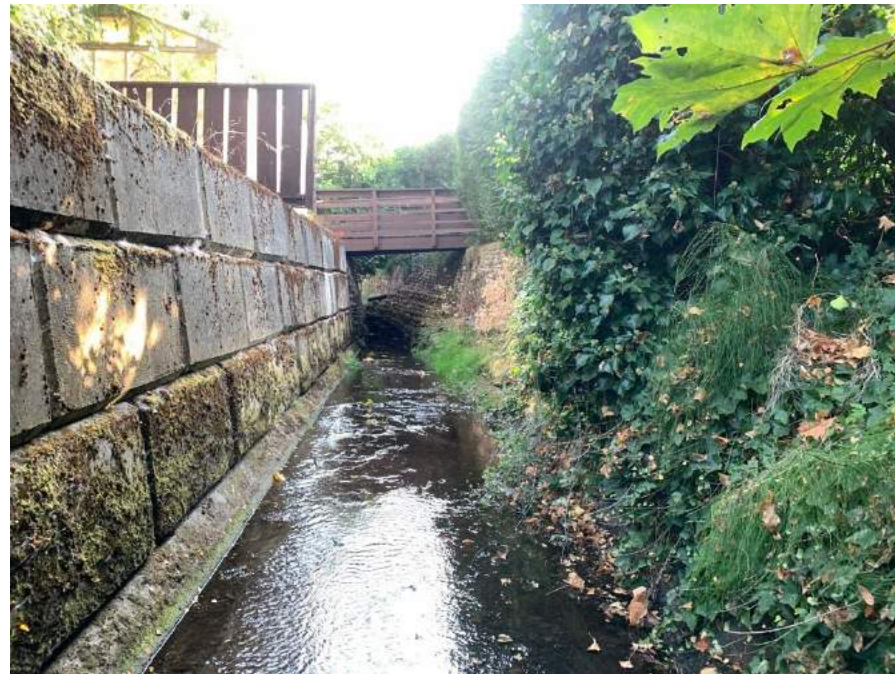
Photo 12A-5. 1564 North Dairy Road and 3211 Shelley Street lock blocks and English ivy at 1564 North Dairy Road and 3204 Keats Street.

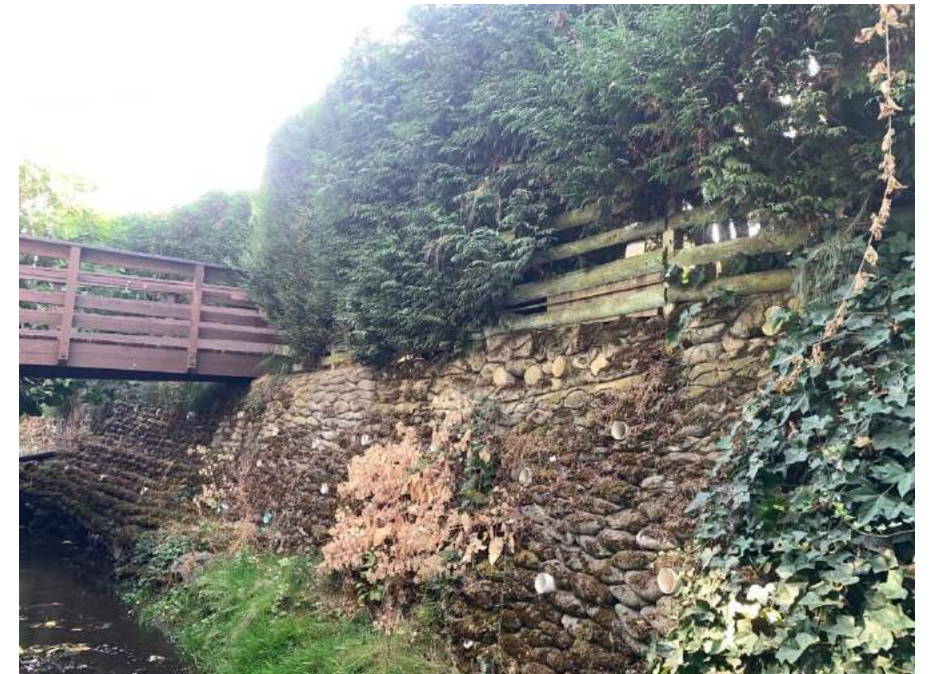
Photo 12A-6. 3204 Keats Street concrete sandbag retaining wall.

- 3204 Keats Street, remove armouring and repair erosion, re-slope banks, and plant native vegetation (Photo 6-7).
- 3211 Shelley Street and District of Saanich (Keats Street right-of-way) remove extensive Himalayan blackberry, remove gabions and armouring, re-slope banks and plant native vegetation (Photos 5, 8-10).

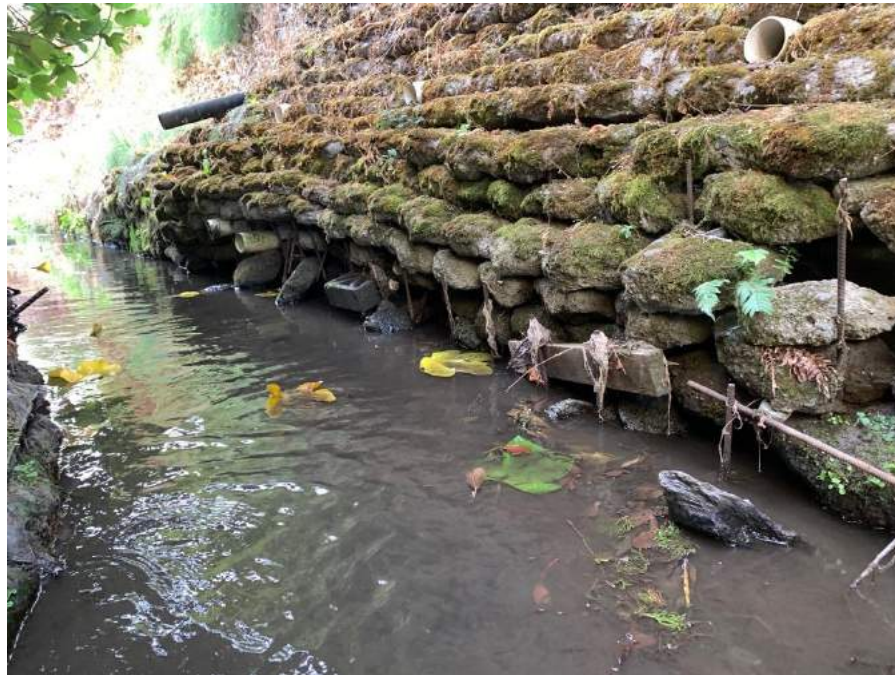
Photo 12A-7. 3204 Keats Street concrete sandbag retaining wall with erosion at the base.

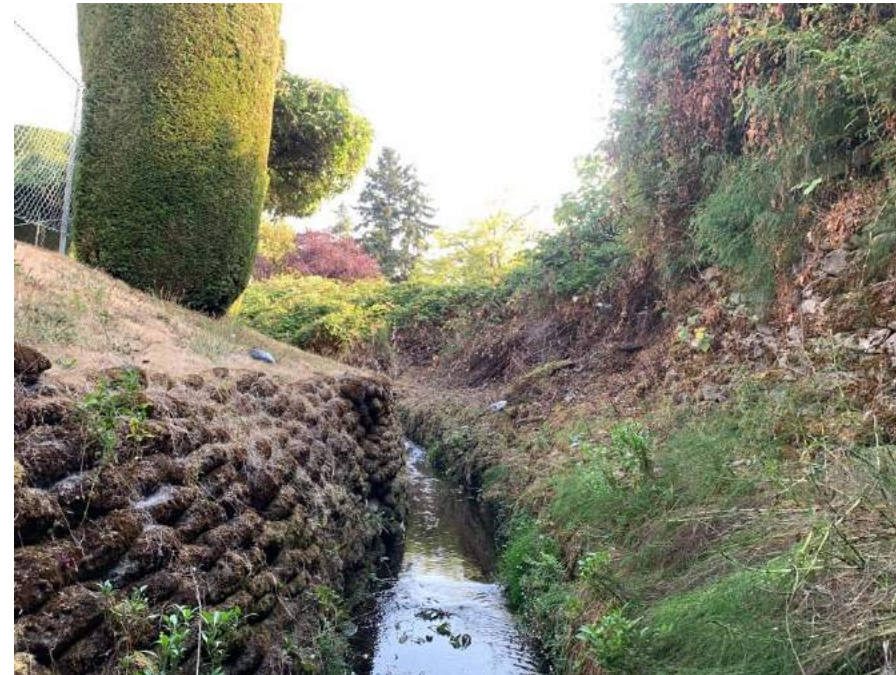
Photo 12A-8. 3204 Keats Street with narrow channel and small terrace on the south (right side); 3211 Shelley Street with lawn and concrete sandbags.

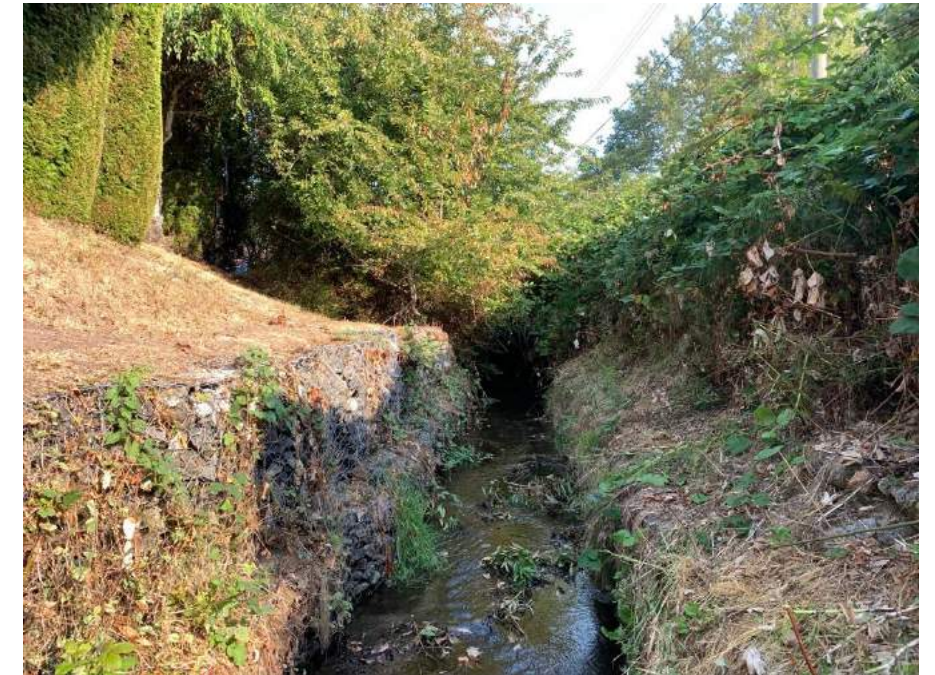
Photo 12A-9. 3211 Shelley Street with gabions, lawn and Himalayan blackberry (left), joins with Himalayan blackberry in the Keats Street right-of-way (right) (view upstream).

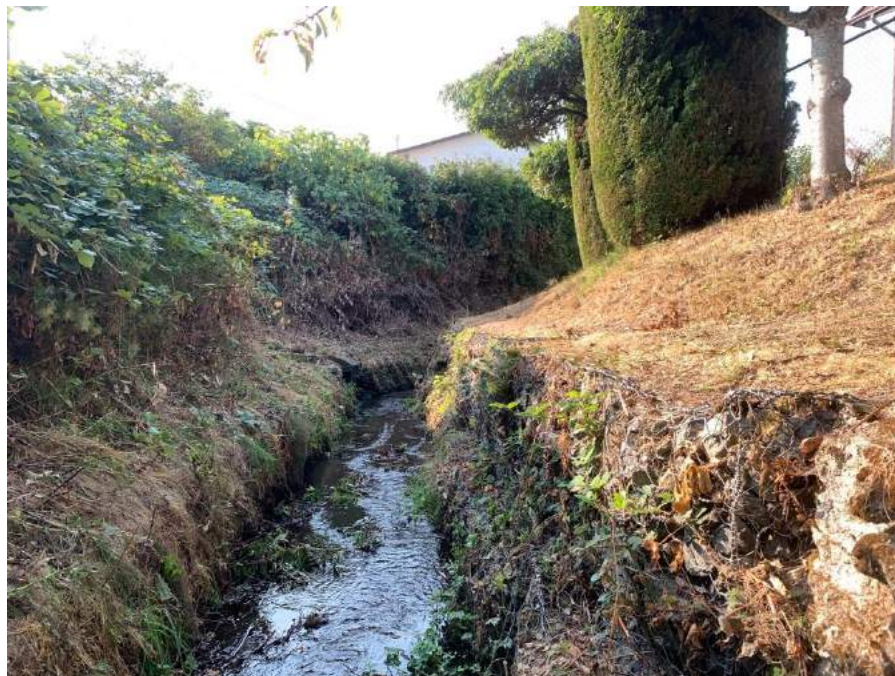
Photo 12A-10. 3211 Shelley Street with gabions, lawn and Himalayan blackberry, joins with Himalayan blackberry in the Keats Street right-of-way.

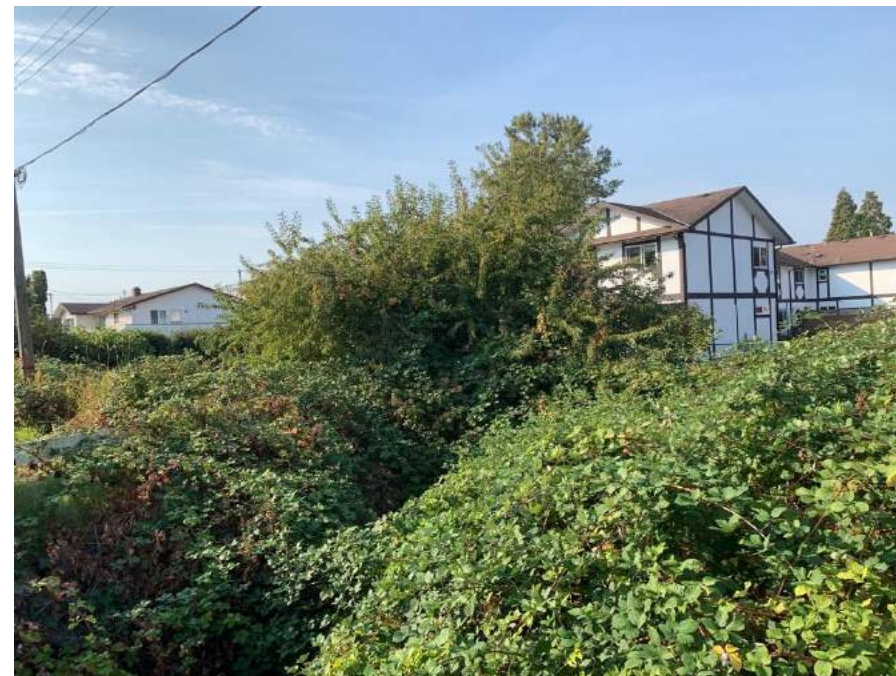
Photo 12A-11. Looking downstream from the Keats Street footbridge, Himalayan blackberry in the Keats Street right-of-way.

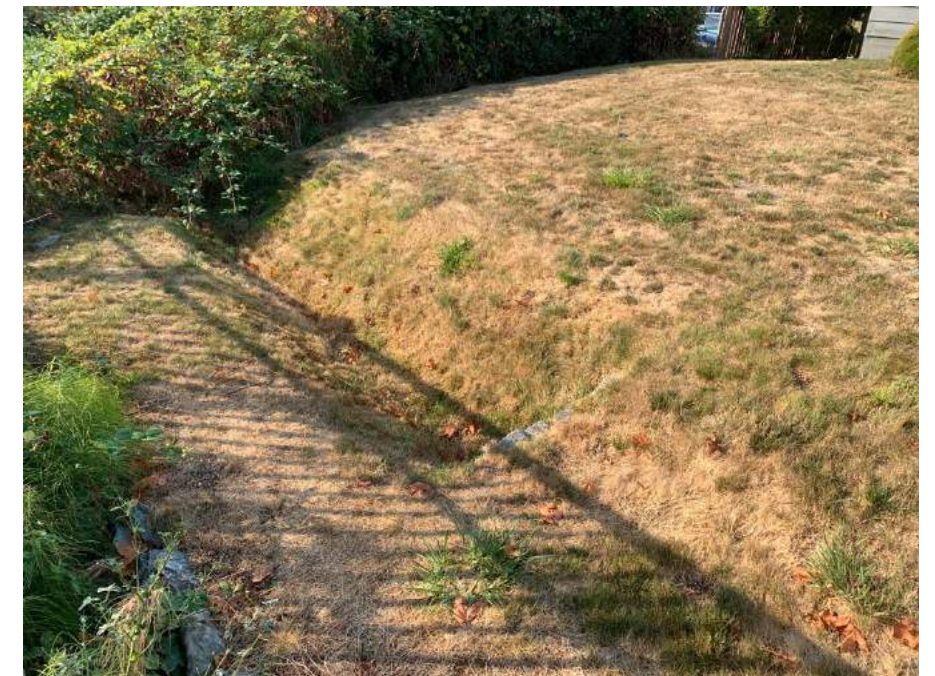
Photo 12A-12. Ditch in the Keats Street right-of-way that could be converted to a rain garden to treat road run off.

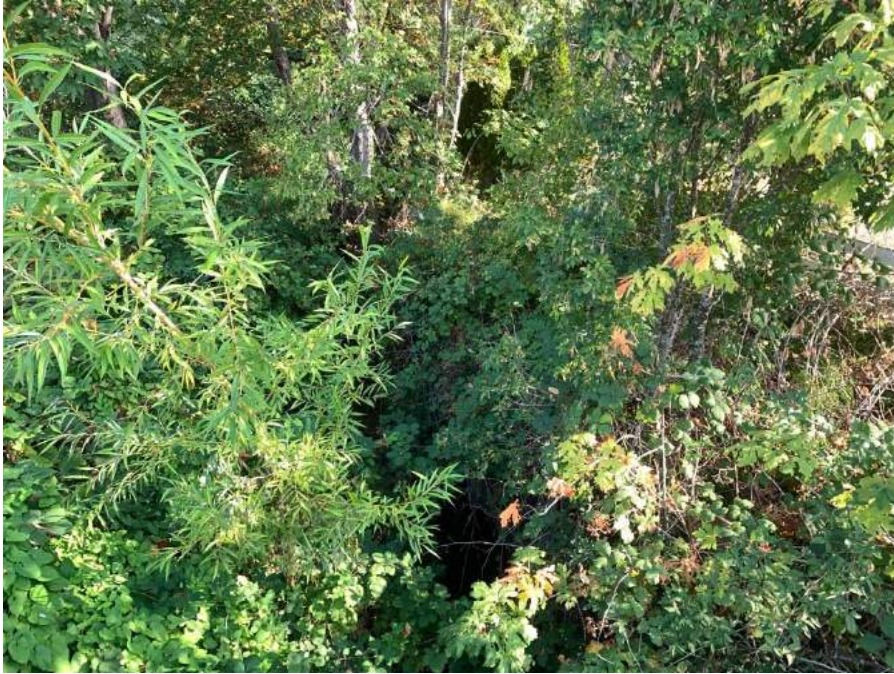
Photo 12A-13. Looking upstream from the Keats Street footbridge (3211 Keats Street and property to the north) with golden willow, Himalayan blackberry, English ivy and morning glory.

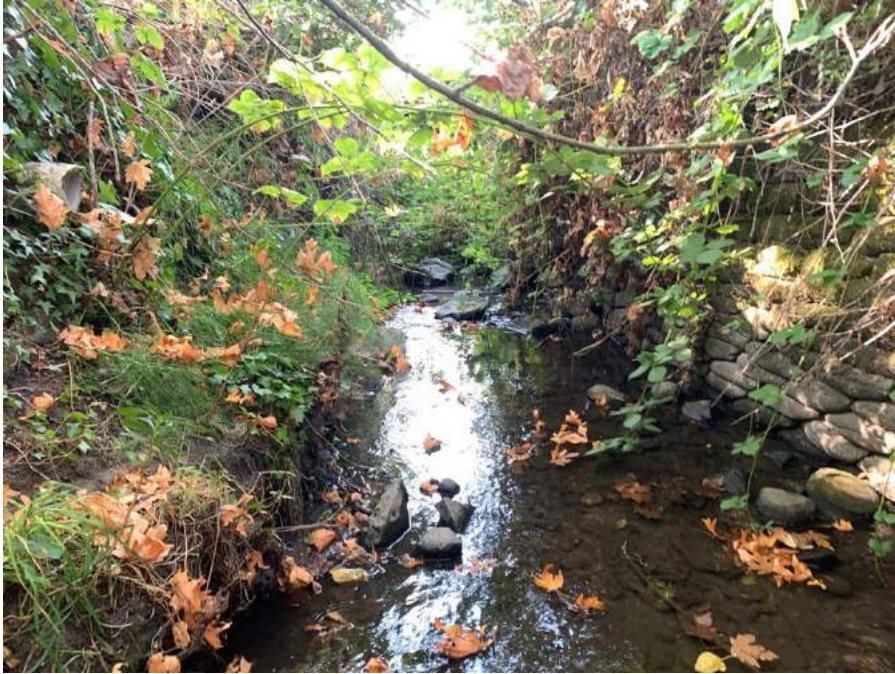
Photo 12A-14. 3211 Keats Street and property to the north (no address), with concrete sandbags and a mix of invasive and native vegetation.

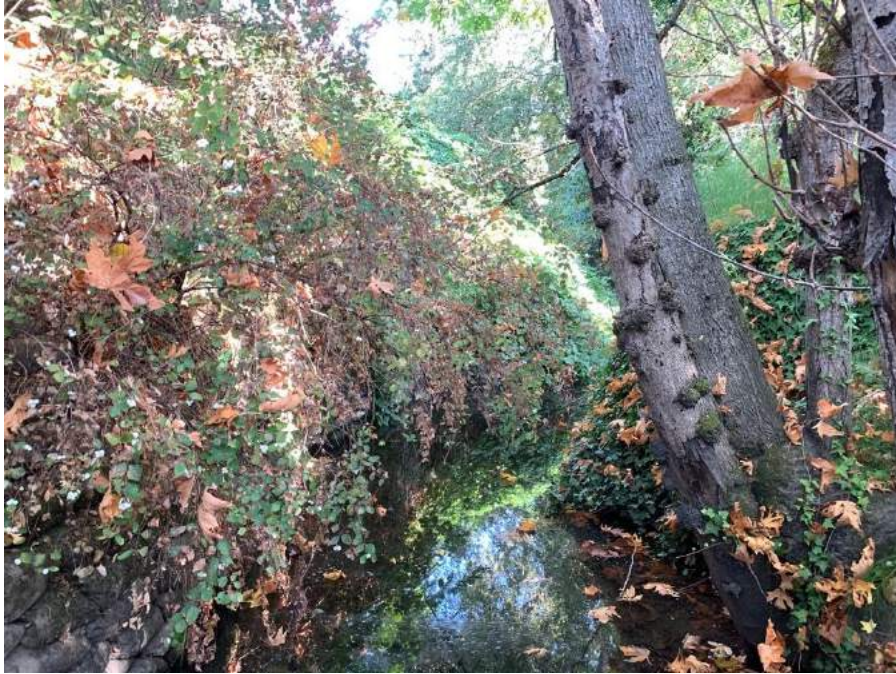
Photo 12A-15. Property to the north of 3211 Keats Street (no address), with concrete sandbags and a mix of invasive and native vegetation.

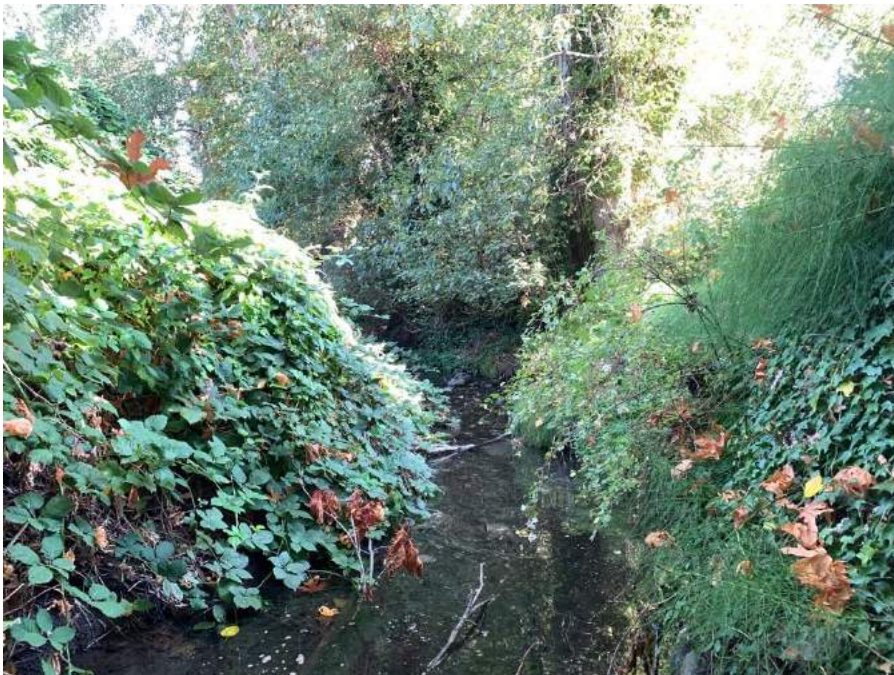
Photo 12A-16. Property to the north of 3211 Keats Street (no address), with Himalayan blackberry and English ivy.

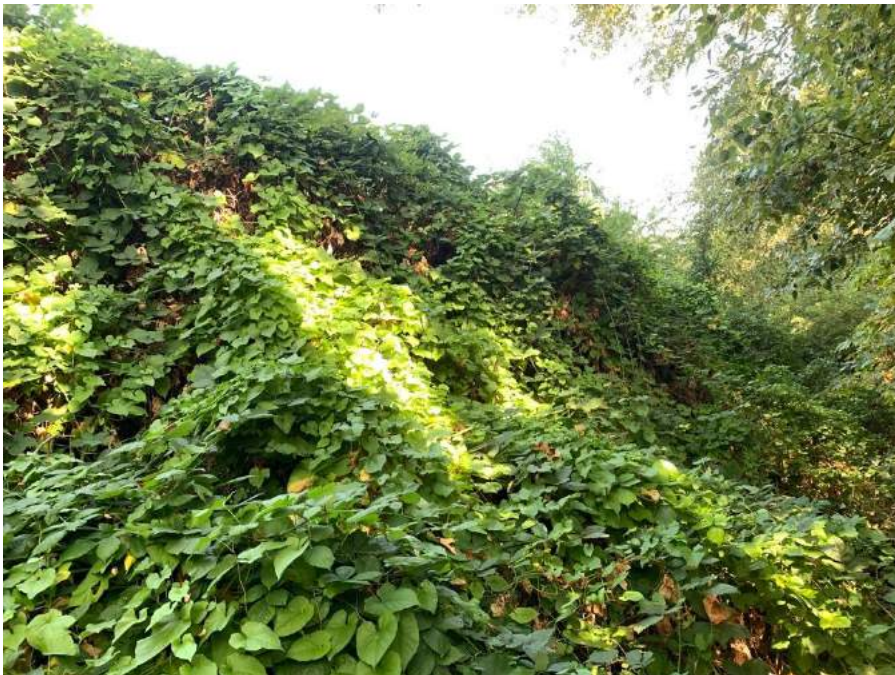
Photo 12A-17. Property to the north of 3211 Keats Street (no address), with morning glory.

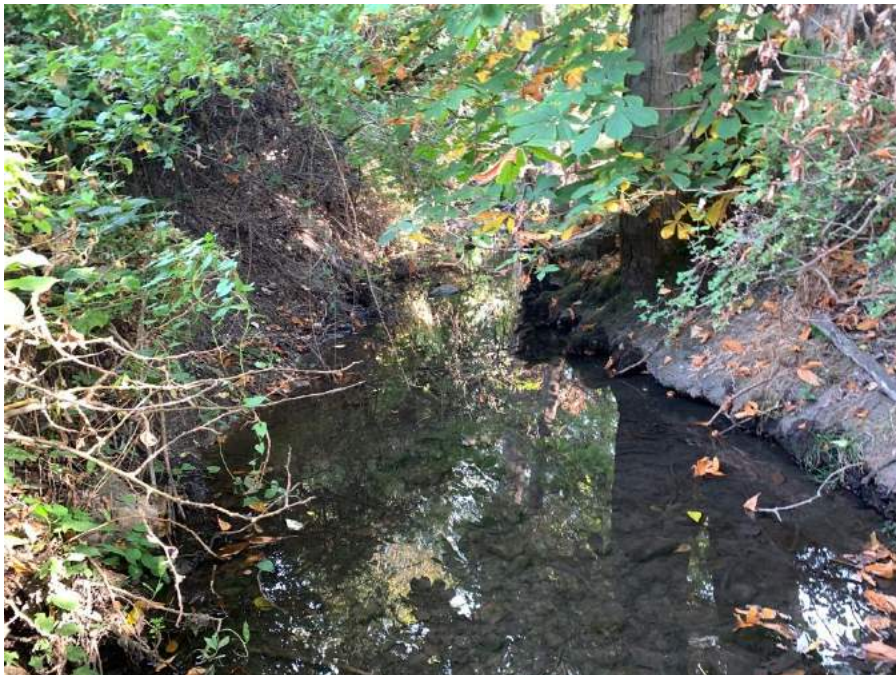
Photo 12A-18. 3225 Keats Street and 3226 Wordsworth Street with steep soil banks and mix of native and invasive vegetation.

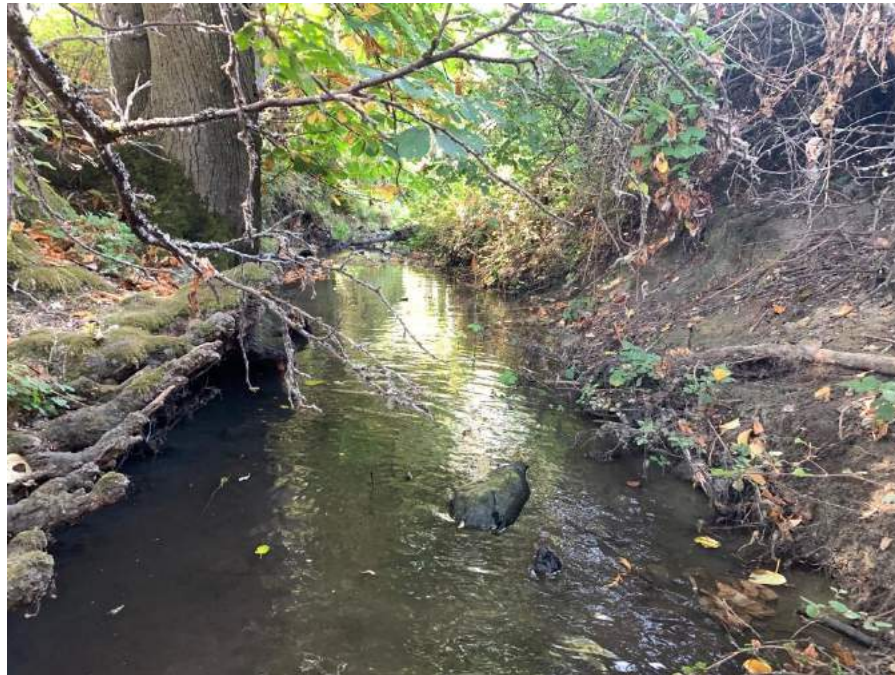
Photo 12A-19. 3225 Keats Street and 3226 Wordsworth Street with steep soil banks and mix of native and invasive vegetation.

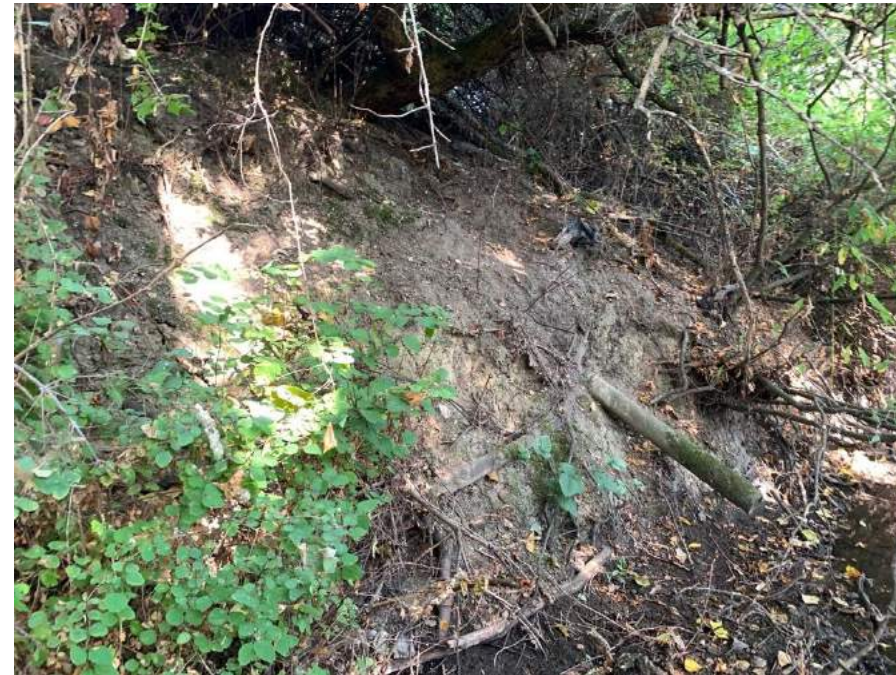
Photo 12A-20. Erosion at 3225 Keats Street across from 3226 Wordsworth Street with steep soil banks and mix of native and invasive vegetation.

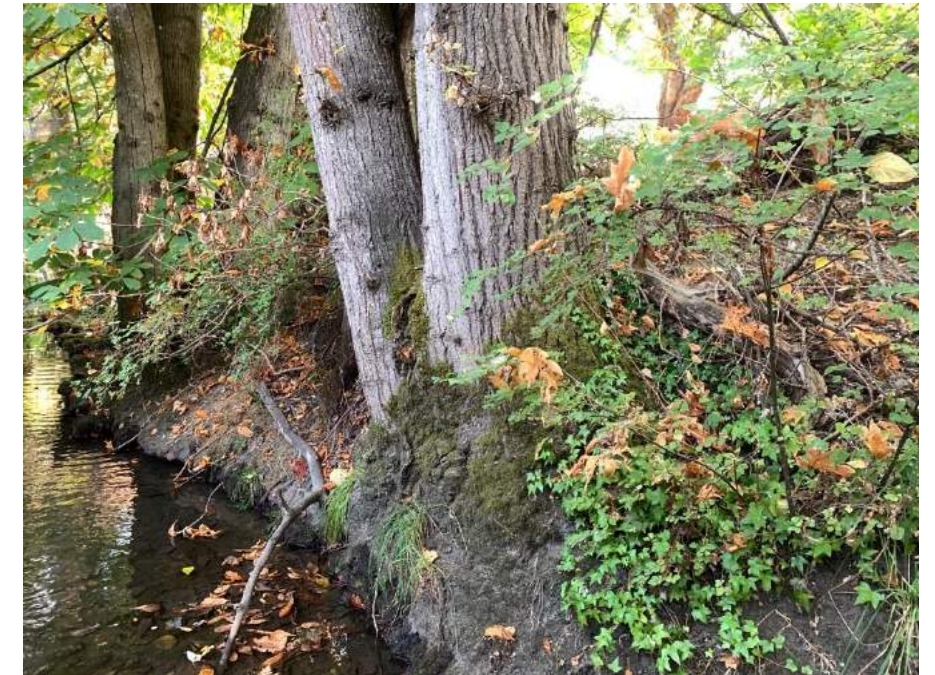
Photo 12A-21. 3225 Keats Street and 3226 Wordsworth Street with steep soil banks and mix of native and invasive vegetation.

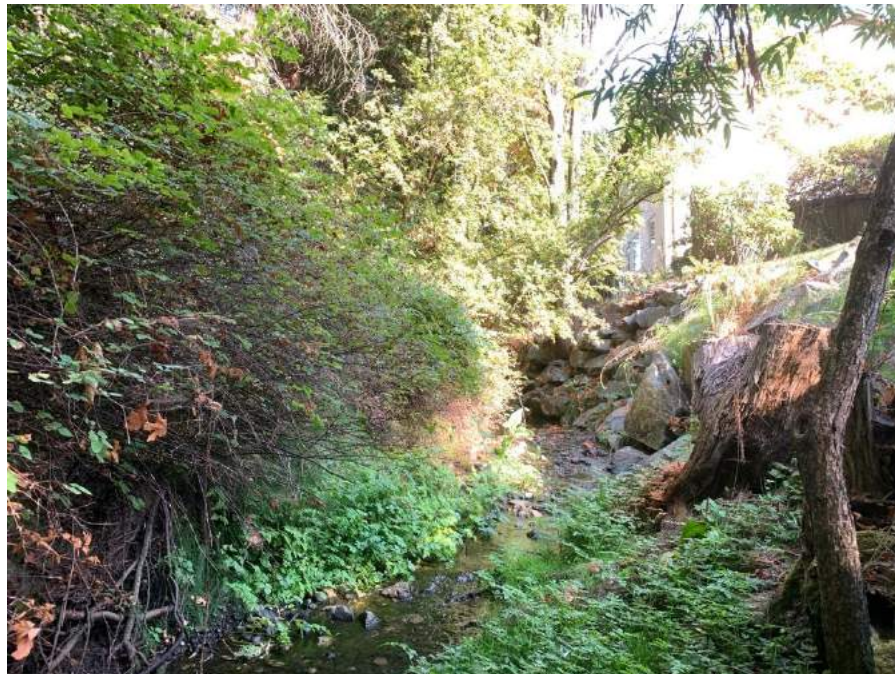
Photo 12A-22. 3225 Keats Street with overhanging mostly native shrub vegetation and 3228 Wordsworth Street with riprap banks and lawn.

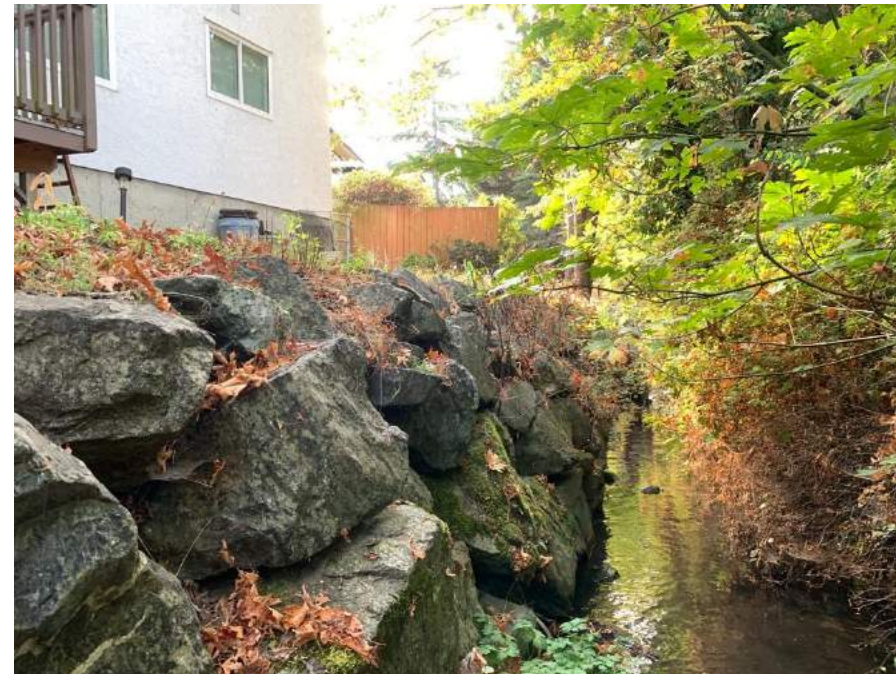
Photo 12A-23. 3235 Keats Street with overhanging mostly native shrub vegetation and 3228 Wordsworth Street with riprap banks and lawn.

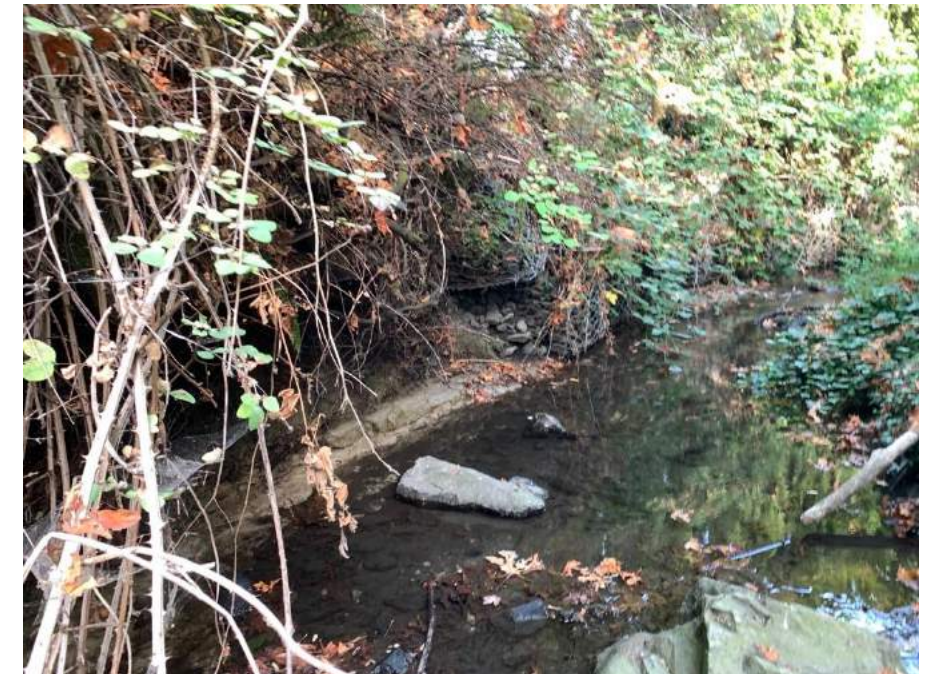
Photo 12A-24. 3245 Keats Street, 1589 McRae Avenue and 3230 Wordsworth Street with eroding bank and gabions with Himalayan blackberry and English ivy.

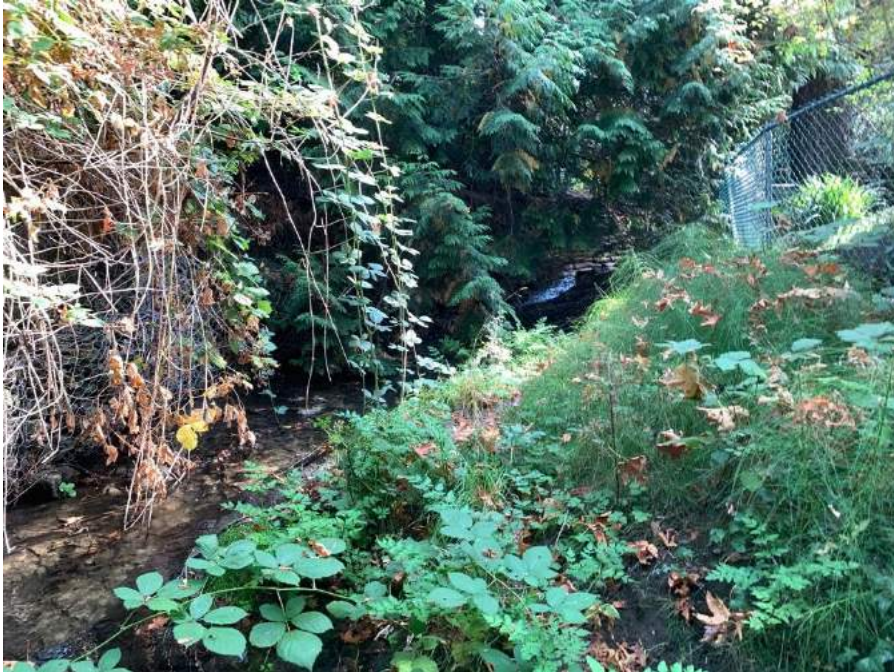
Photo 12A-25. 1589 McRae Avenue and 3230 Wordsworth Street with eroding bank and gabions with Himalayan blackberry, English ivy, horsetail, and Pacific water-parsley.

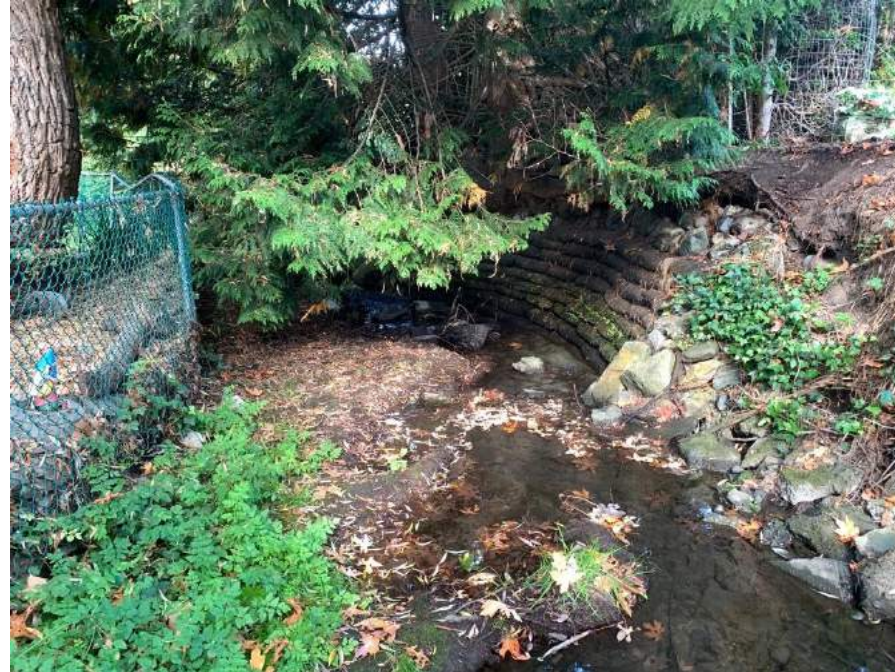
Photo 12A-26. 1599 McRae Avenue and 3230 Wordsworth Street with eroding bank and MSE geo bag wall and bare understory.

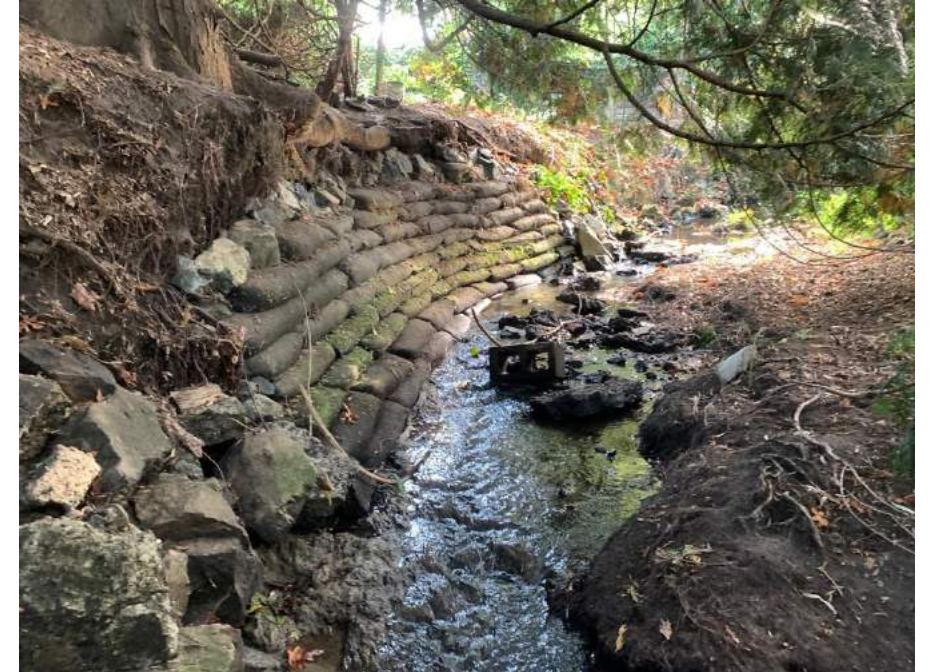
Photo 12A-27. Wordsworth Street right-of-way and 1601 McCrae Avenue, soil banks with a mx of native and invasive species.

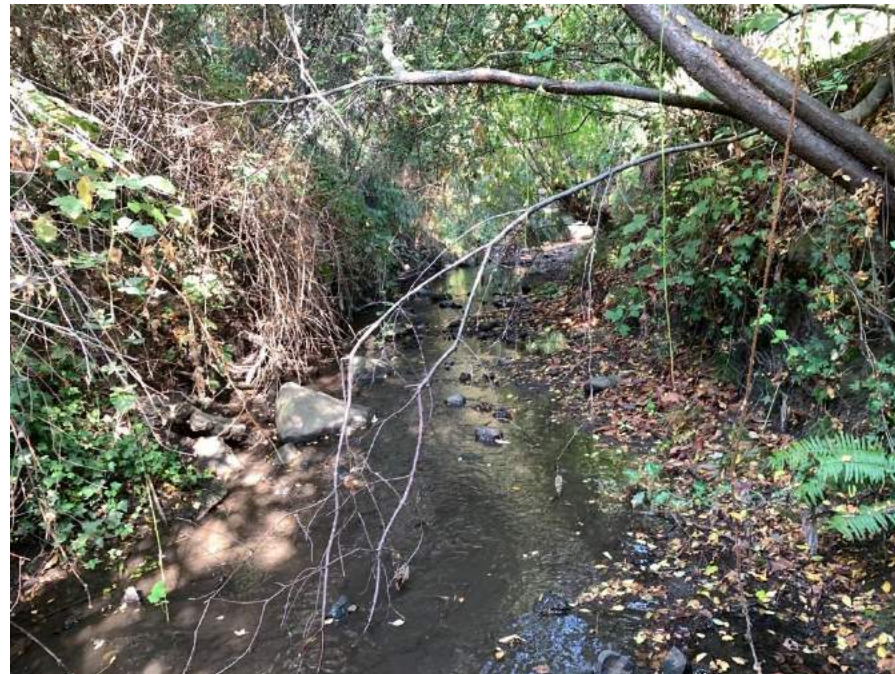
Photo 12A-29. 3230 Wordsworth Street with some floodplain on the inside corner of the channel.

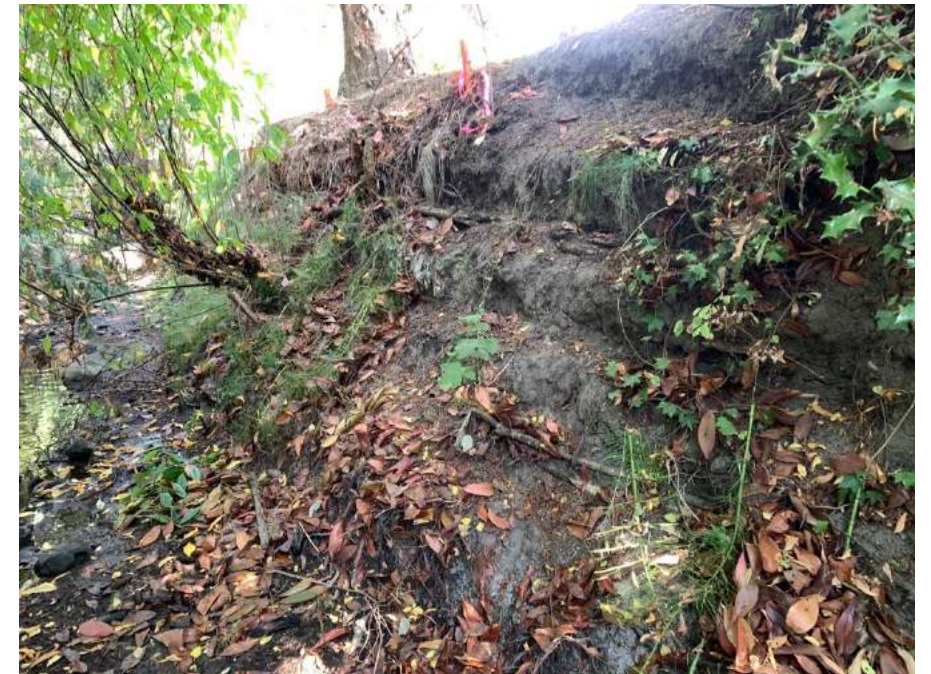
2022 – Channel and riparian area are in a similar condition as observed in 2011. Bioengineering near McCrae Avenue does not appear to have become well established (some cuttings are growing, but most have died).

Photo 12A-30. 1607 McCrae Avenue, soil banks with bioengineering willow wattles that have died.
