TABLE OF CONTENTS

BOWKER CREEK ASSESSMENT SUMMARY

REACH 1A
Reach # 1A – Creek mouth into Oak Bay to upstream (west) end of 1776 Beach Drive) (140m) 2733, 2717, and 2713 Somass Drive; 1725, 1762, and 1776 Beach Drive (privately owned)
Channel Description Channel banks are primarily concrete, mortared rock and concrete sandbags (Photos 1-6,8-10,12-15). The channel bottom is a mix of bedrock, heavily silted substrate of sand, gravel, cobble, and boulders, and extensive concrete and asphalt armouring (Photos 3,8,9,12,13,16). Thick algal mats and root mats from golden willow are present. Vertical armoured banks 1-2m tall, channel width 3.0m – 5.5m, wetted width 0.4m-3.5m (summer). The creek is channelized and straightened with a gradient range from 1.5-4% with a narrow strip of riparian vegetation (Photos 17 & 18). There is a 22m long pool downstream of the culvert which is suitable as a holding location for juvenile fish prior to entering the marine environment, and also for adults entering the stream to hold while awaiting higher flows and while maturing. Tidal influence occurs downstream of Beach Drive. Concrete box culvert at Beach Drive (3.0m wide x 2.2m tall x 15m long). Small a

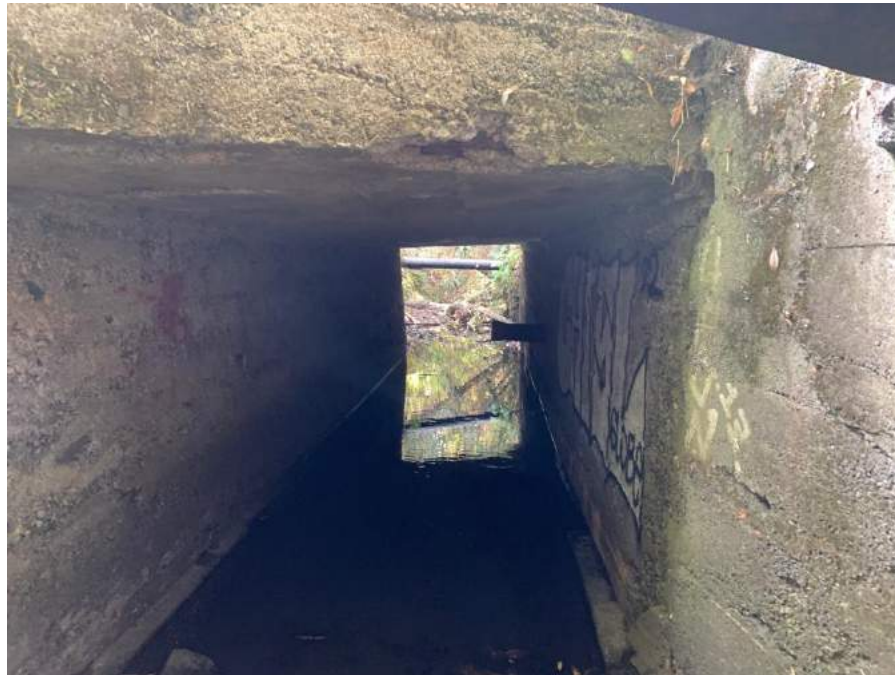
Photo 12B-1. Culvert under McRae Avenue, downstream end of Reach 12B (view downstream).

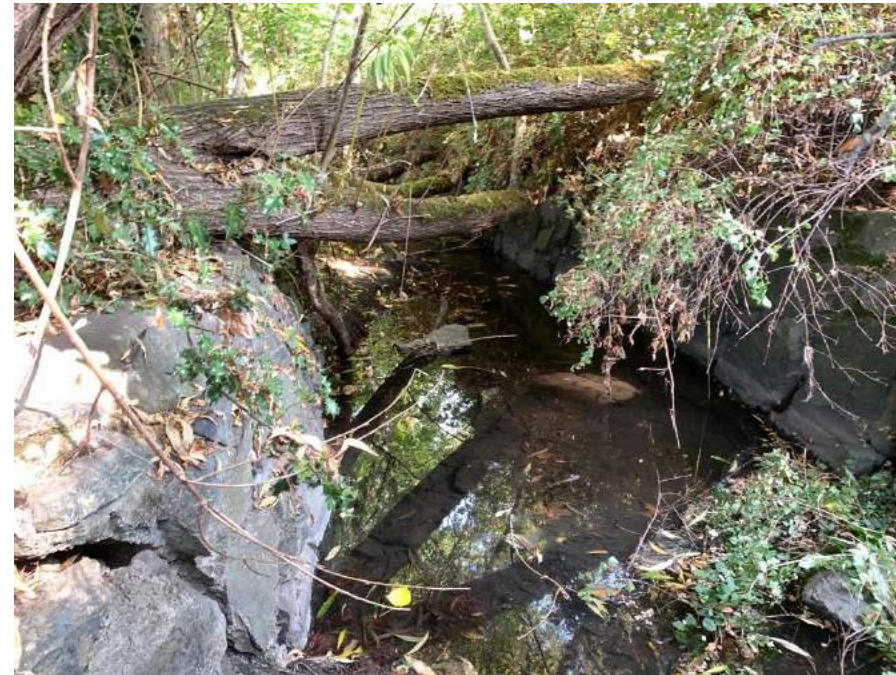
Photo 12B-2. Armouring on banks and channel bottom, downstream end.

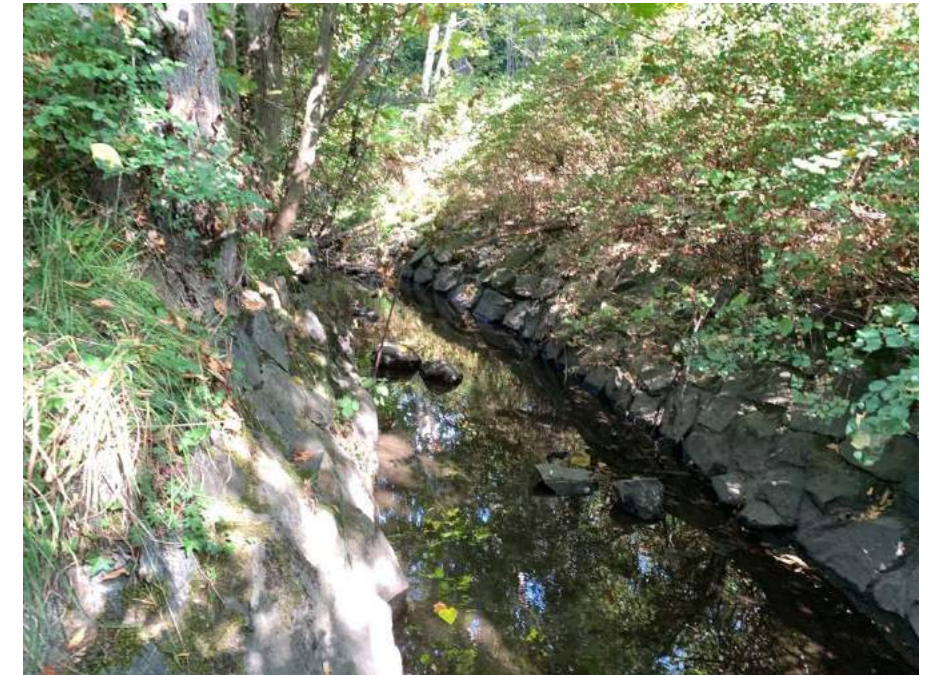
Photo 12B-3. Armouring on banks and channel bottom, downstream end.

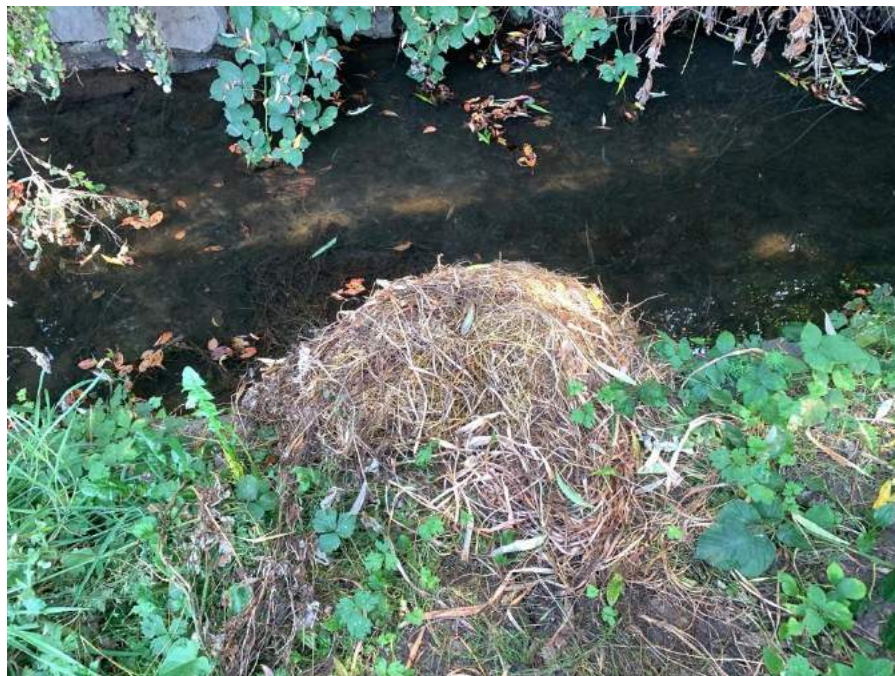
Photo 12B-4. Yard waste deposited in the creek.

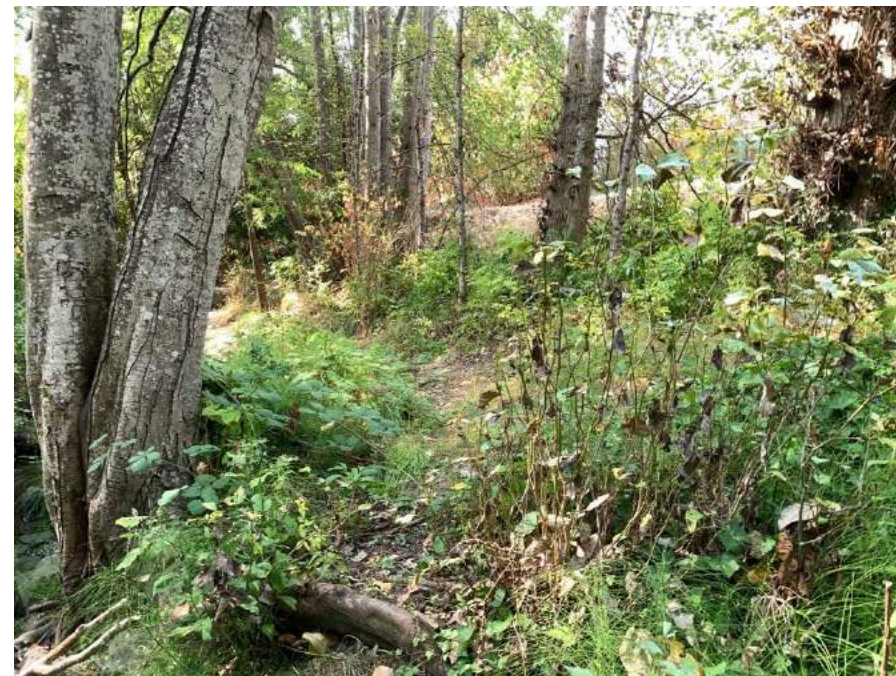
Photo 12B-5. West bank, low slope riparian area, mix of native and invasive species, and example of informal, rogue trail and trampling (view downstream).

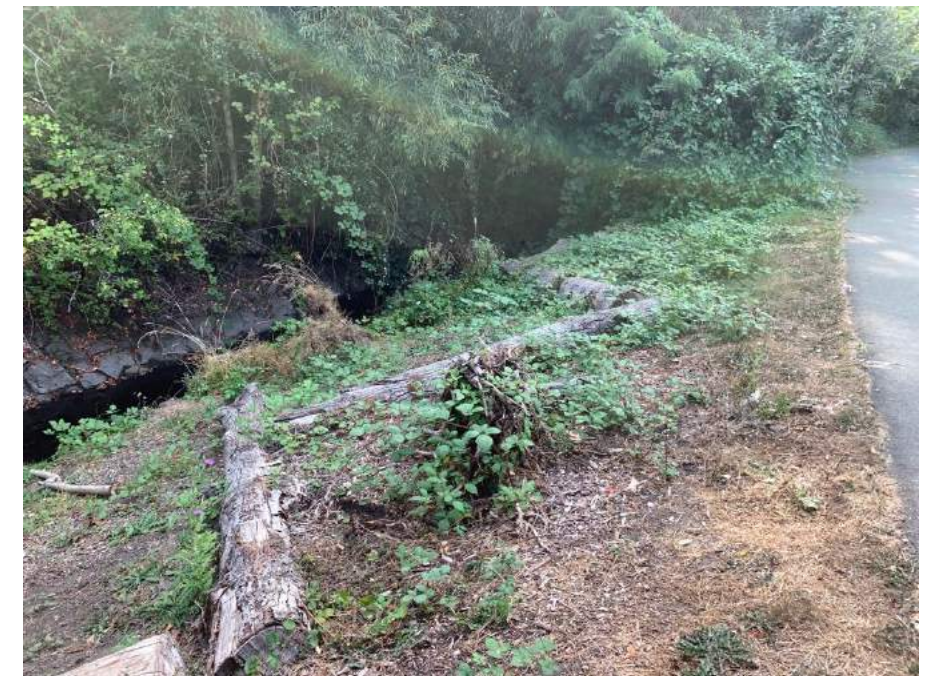
Photo 12B-6. Recent District of Saanich Riparian restoration on the east bank, needs maintenance to remove invasives becoming established (view downstream).

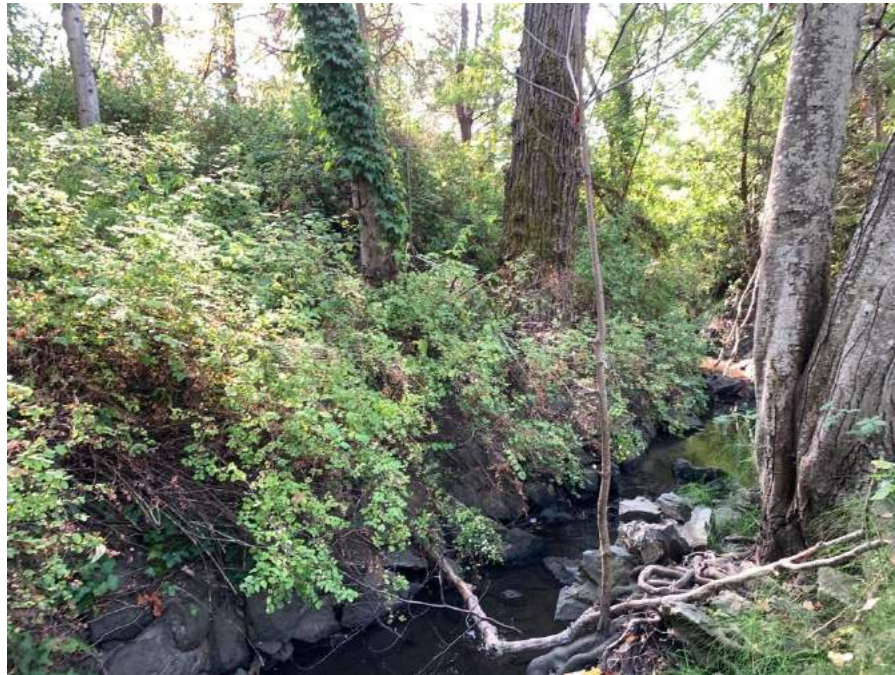
Photo 12B-7. Steeper east bank with mix of native and invasive vegetation (ivy on trees) and armoring at the base of the slope (view downstream).

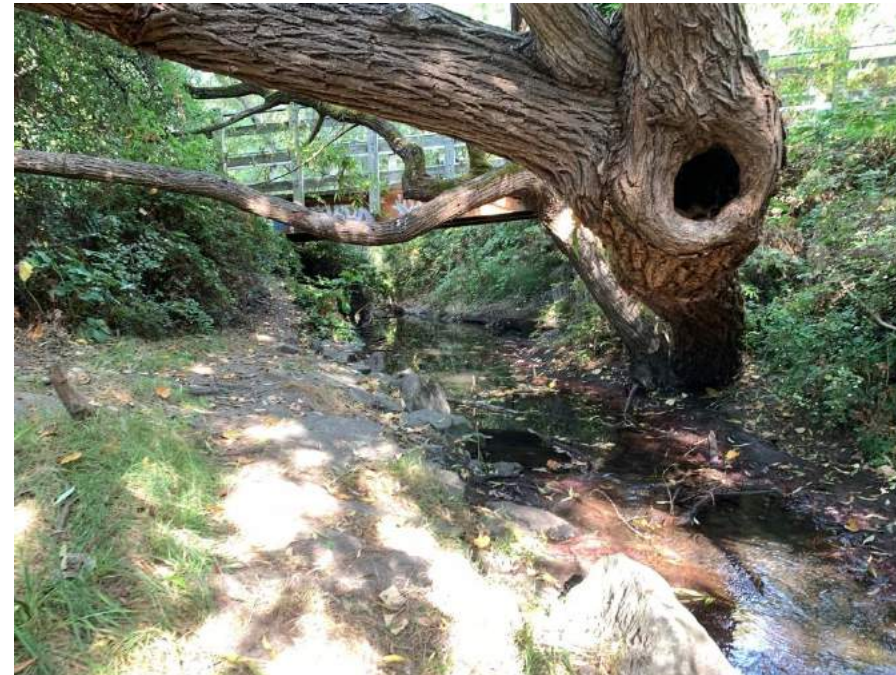
Photo 12B-8. Golden willow and ivy, downstream of the footbridge, with informal, rogue trail and trampling. CRD 316-4b water quality sampling site (view upstream).

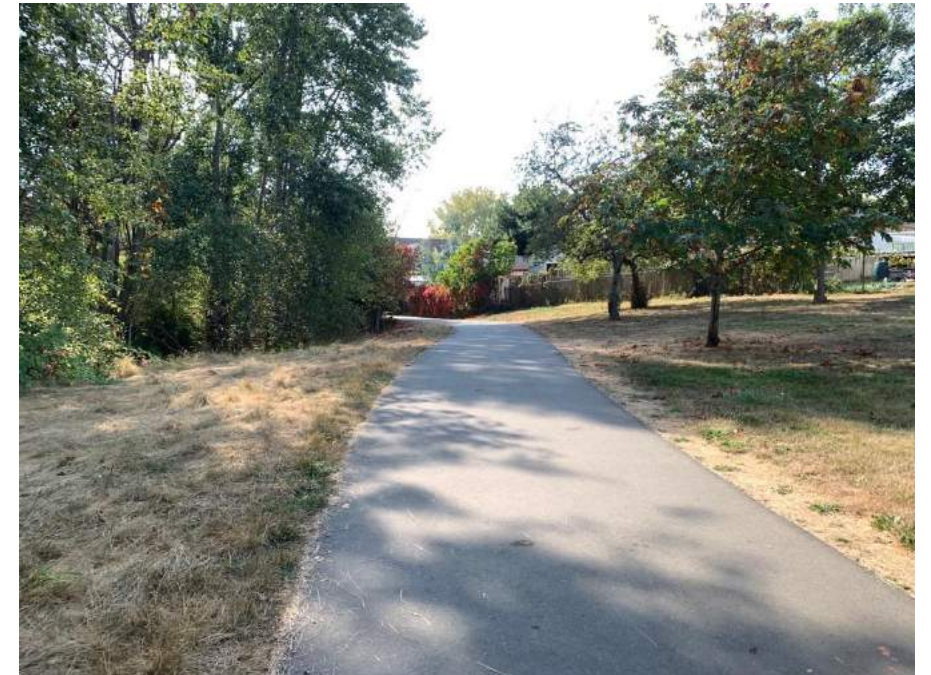
Photo 12B-15. Grassed area on the west side of the park is a potential area to re-grade and widen the riparian area, creek is on the left (view downstream).

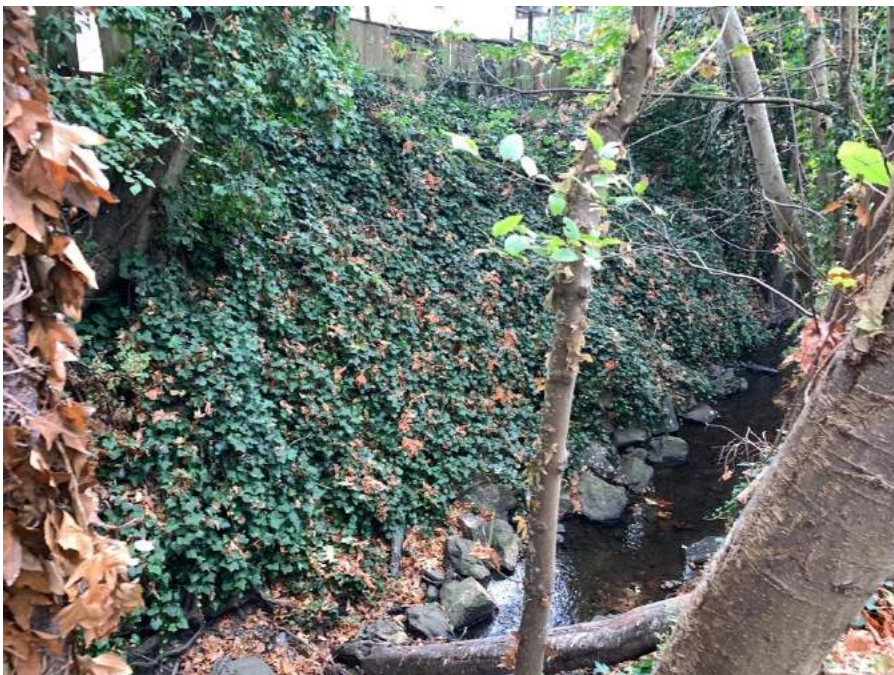
Photo 12B-16. Armoured east bank at the upstream end, covered in English ivy (view downstream).

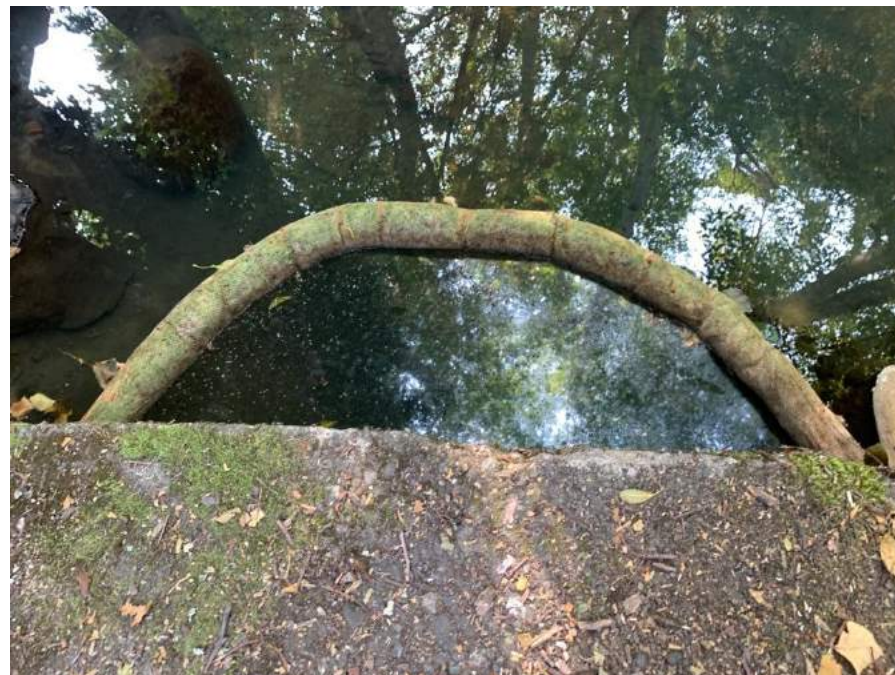
Photo 12B-17. Oil absorbent boom at the Knight Street (right-of-way) culvert outlet at upstream end: odour of hydrocarbons in the area. CRD flow meter is immediately downstream (view downstream).

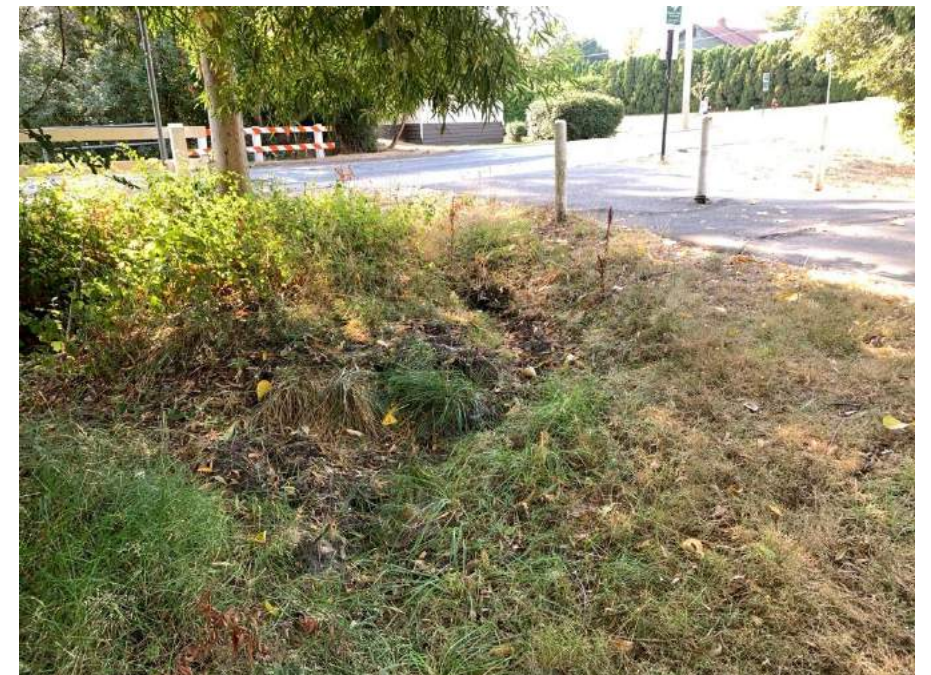
Photo 12B-18. Possible rain garden location to treat runoff from McRae Avenue at downstream end of the reach (view downstream).

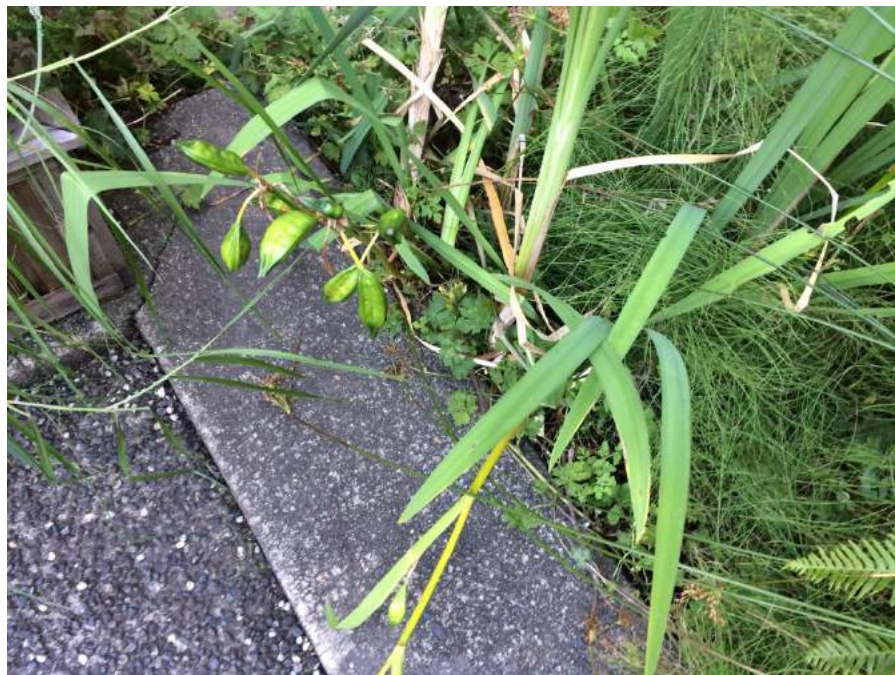
Photo 15A-4. Yellow flag iris – problematic invasive species in the upper reaches of the watershed should be targeted for removal to prevent downstream spread (view east).

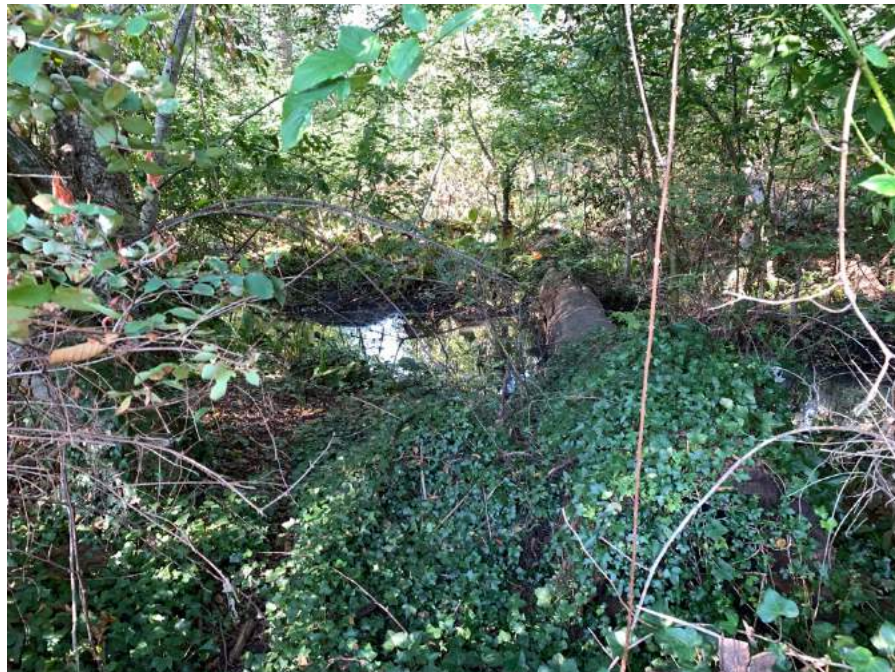
Photo 15B-4. English ivy along the creek edge smothers other vegetation.

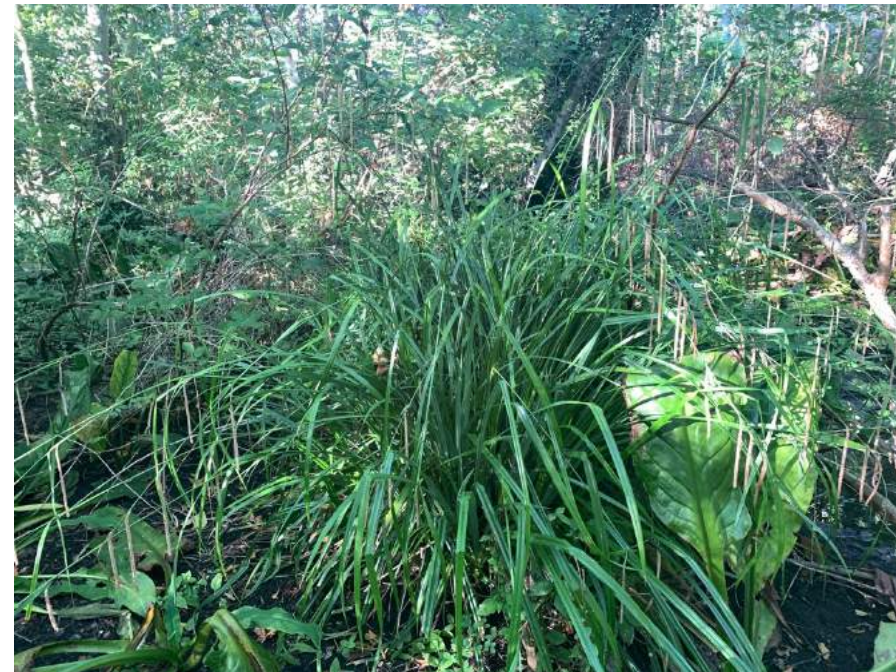
Photo 15B-5. Hanging sedge (*Carex pendula*) in creek adjacent to Parking Lot 9.

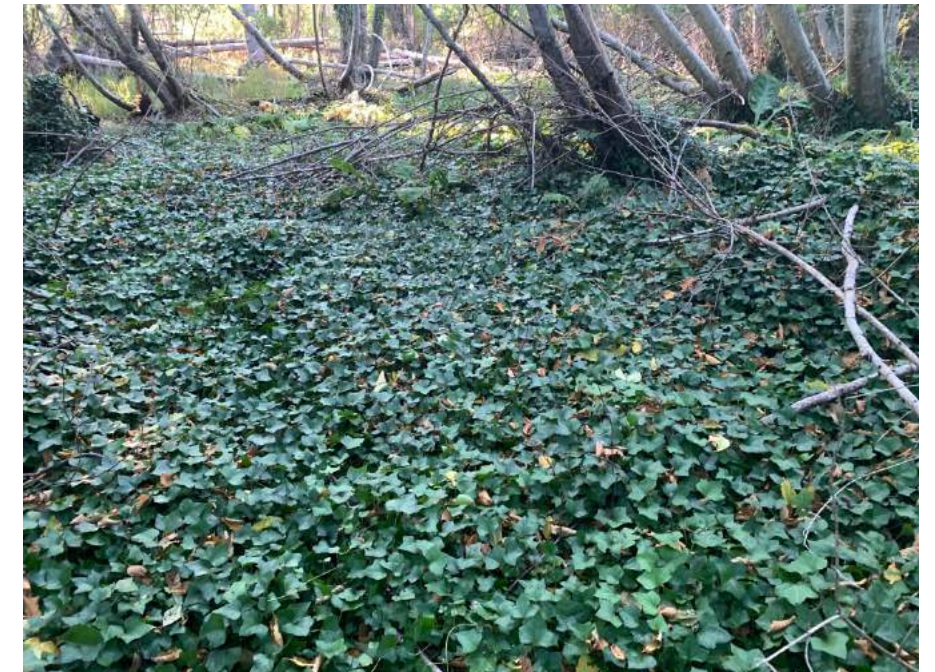
Photo 15B-6. Extensive English ivy in the understory of this large wetland.

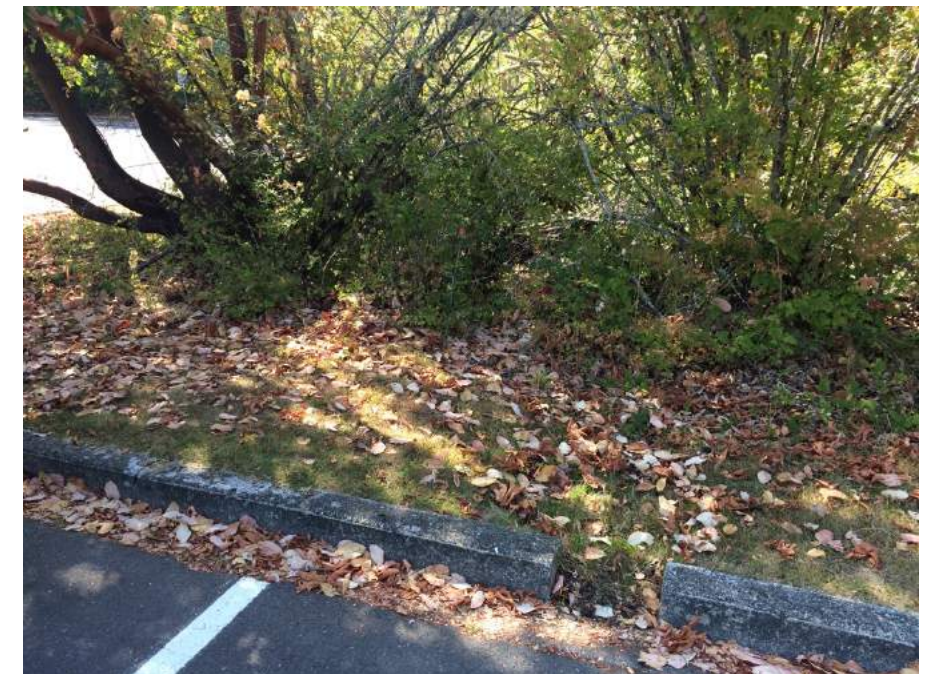
Photo 15B-12. Curb cuts in Parking Lot 8: some lawn/runoff areas need to be slightly deepened to create a ponding area for runoff.

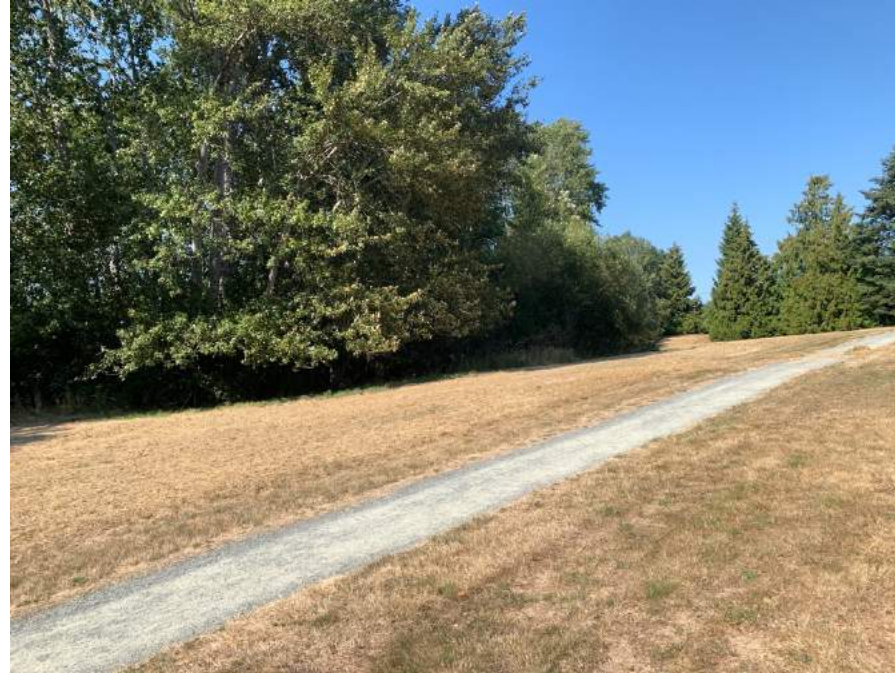
Photo 15C-3. Himalayan blackberry patch at the north end of the channel, near McKenzie Ave, east side of channel.

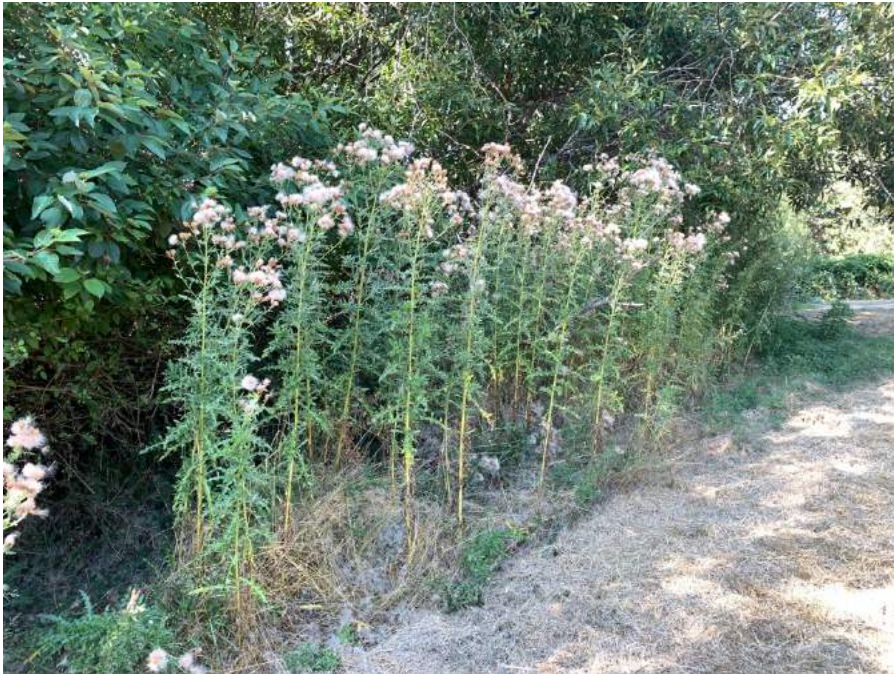
Photo 15C-4. Thistle establishing where grass is left unmown, east side of channel.

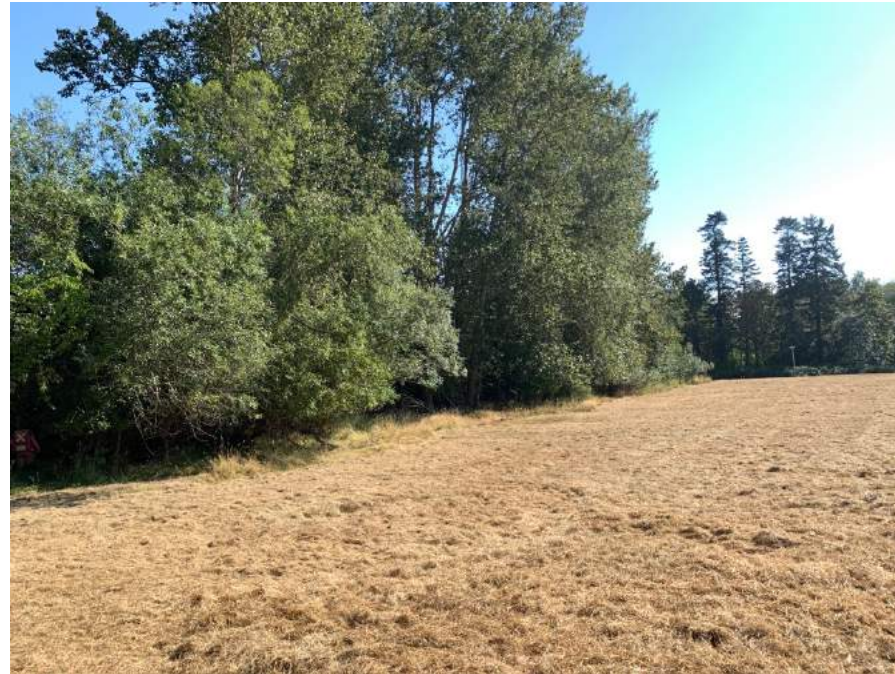
Photo 15C-5. Black cottonwood and willow, with mown grass, west side of the channel

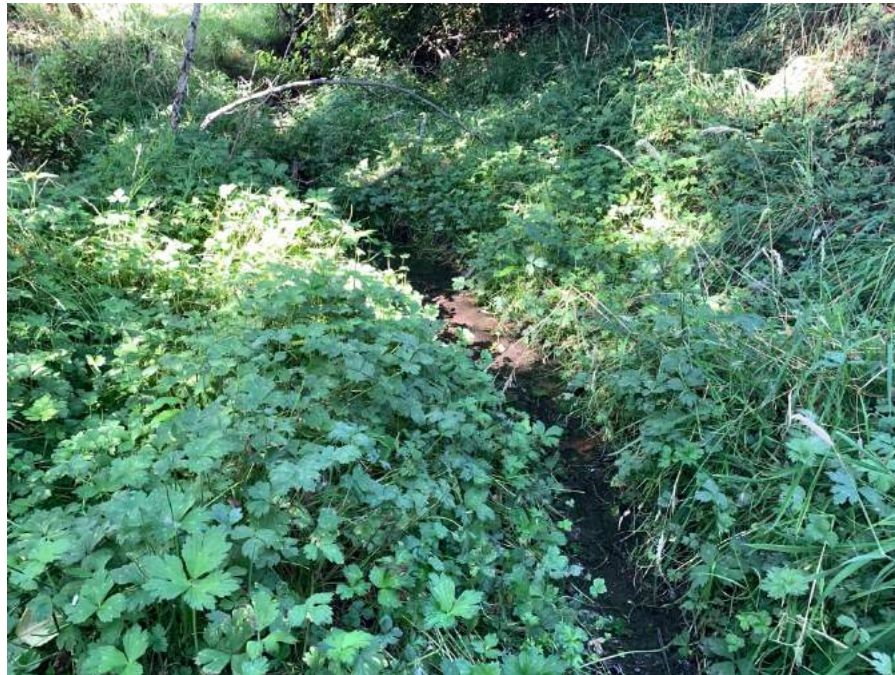
Photo 15C-7. Channel with creeping buttercup and reed canary grass.

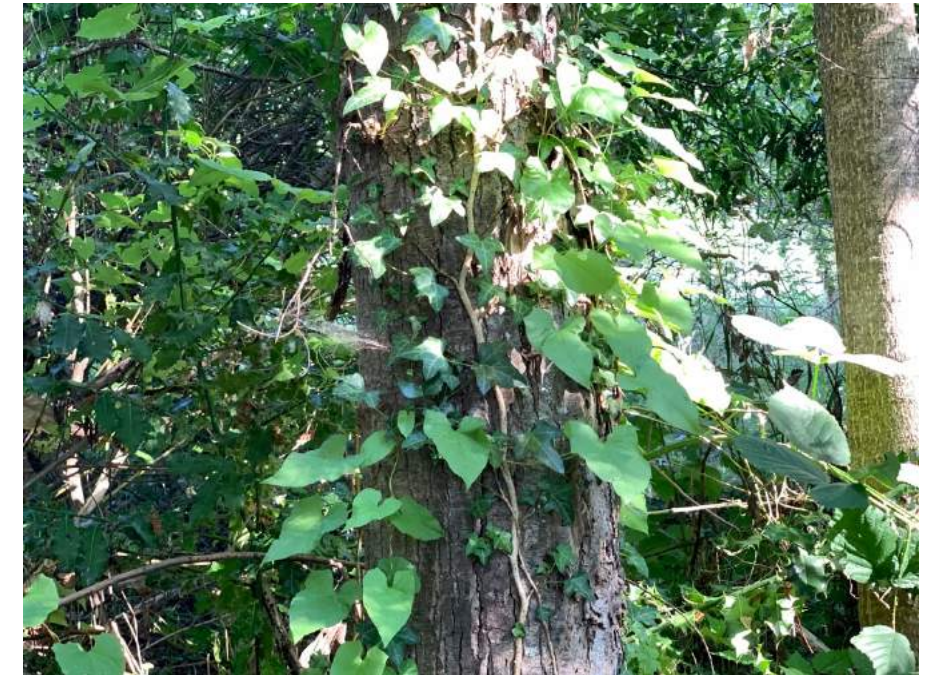
Photo 15C-9. English ivy and morning glory on trees adjacent to the channel.

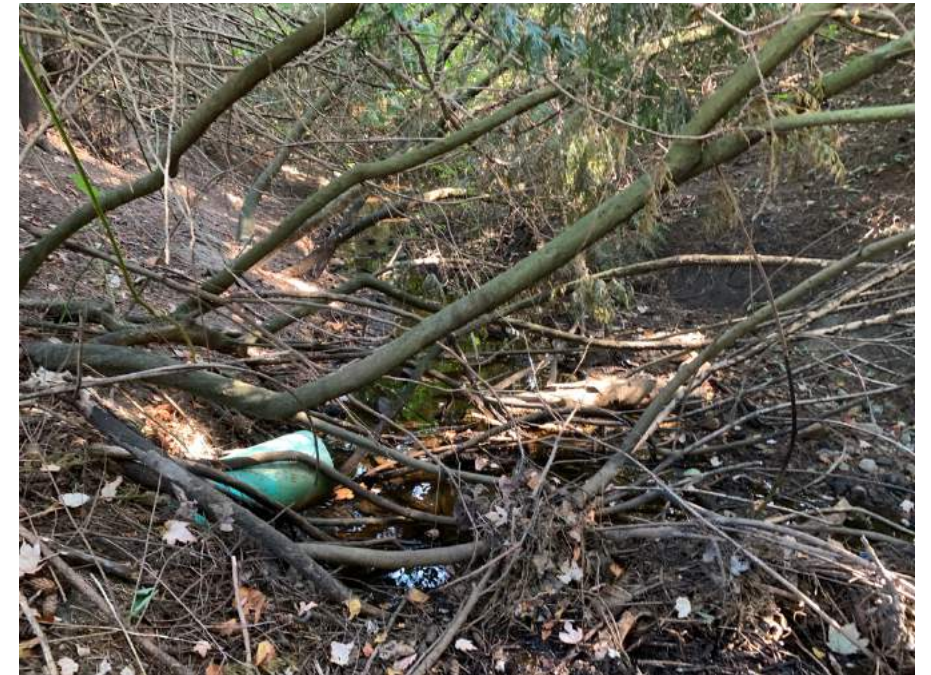
Photo 17A-3. Sparse understory under young conifer trees in lower section of the reach (view downstream).

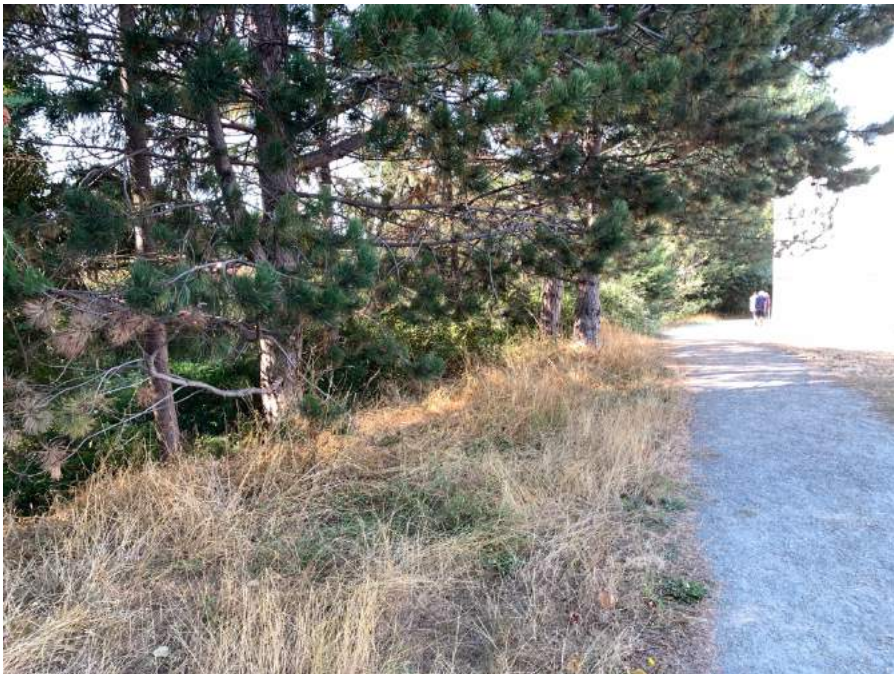
Photo 17A-4. Path and building close to the creek, young conifers and grass in the riparian area in the upper section of the reach (view upstream).

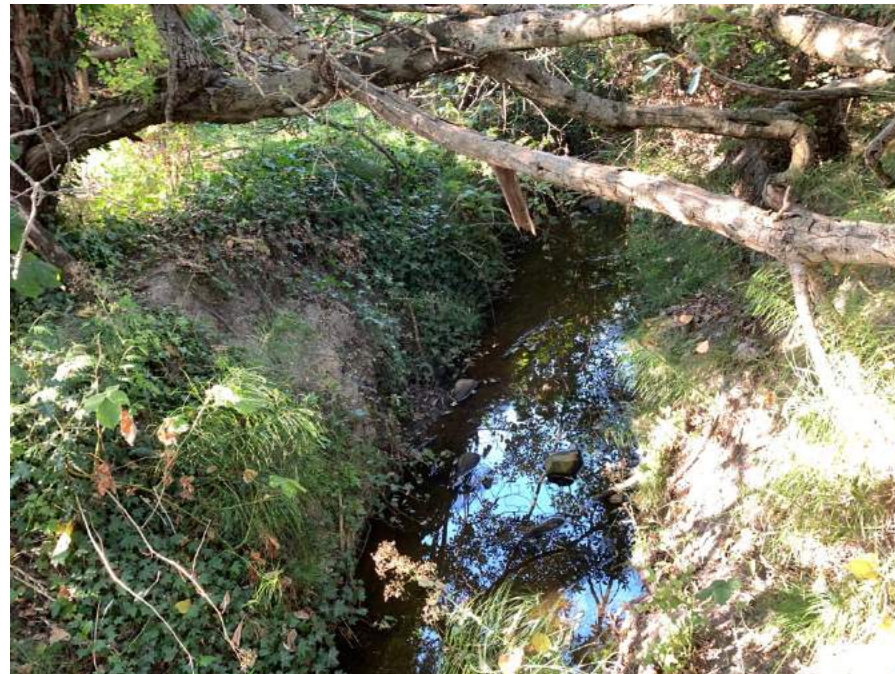
Photo 17A-5. English ivy in the understory along the creek channel in the lower section of the reach.

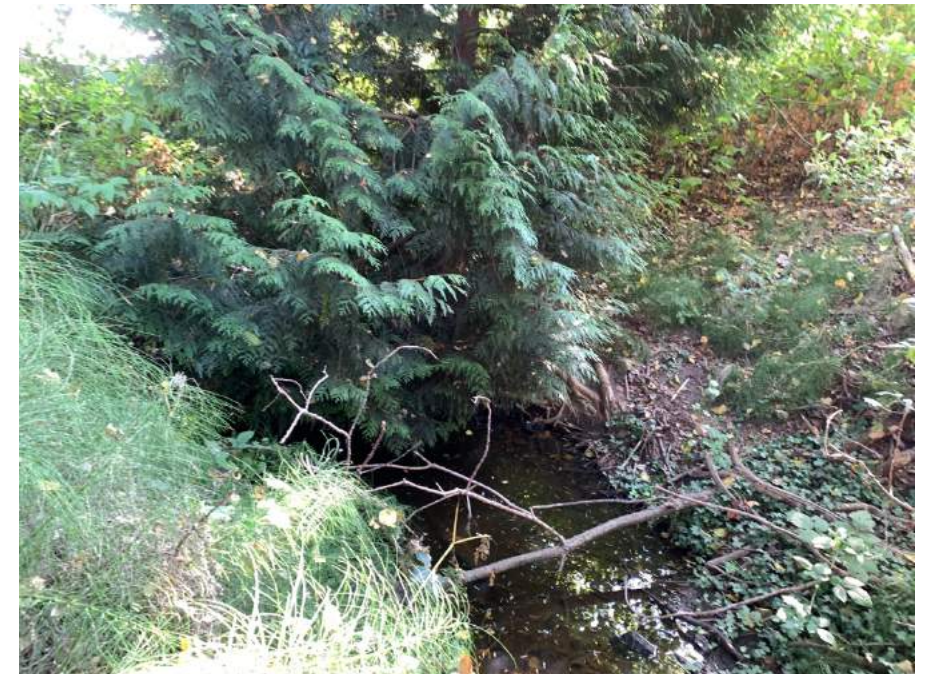
Photo 17A-6. Young western redcedar with horsetail and English ivy, downstream of the first footbridge, in the lower section of the reach.

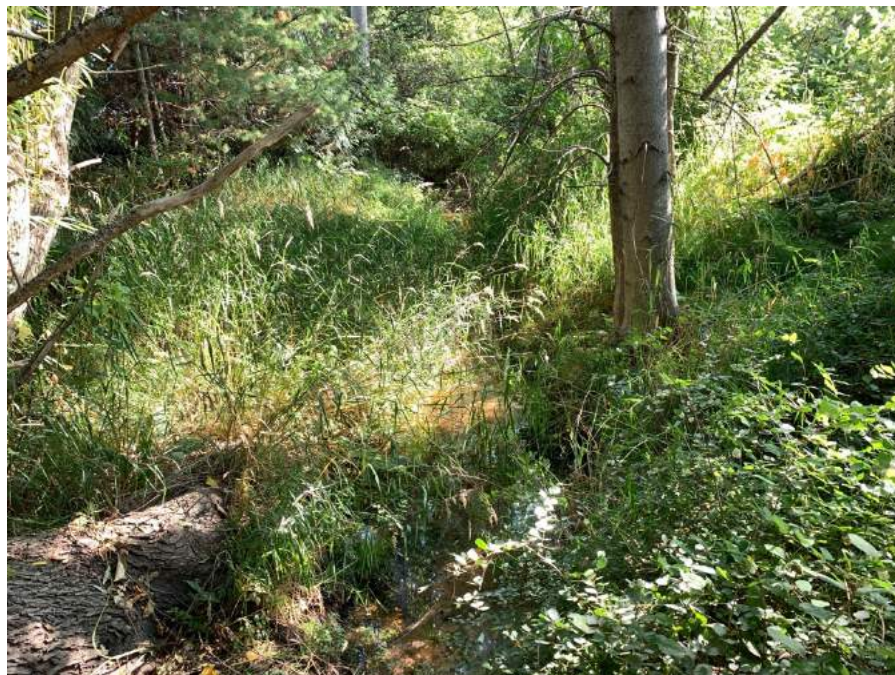
Photo 17A-9. Looking downstream from the second footbridge at the upper section of the reach, reed canary grass in the channel.

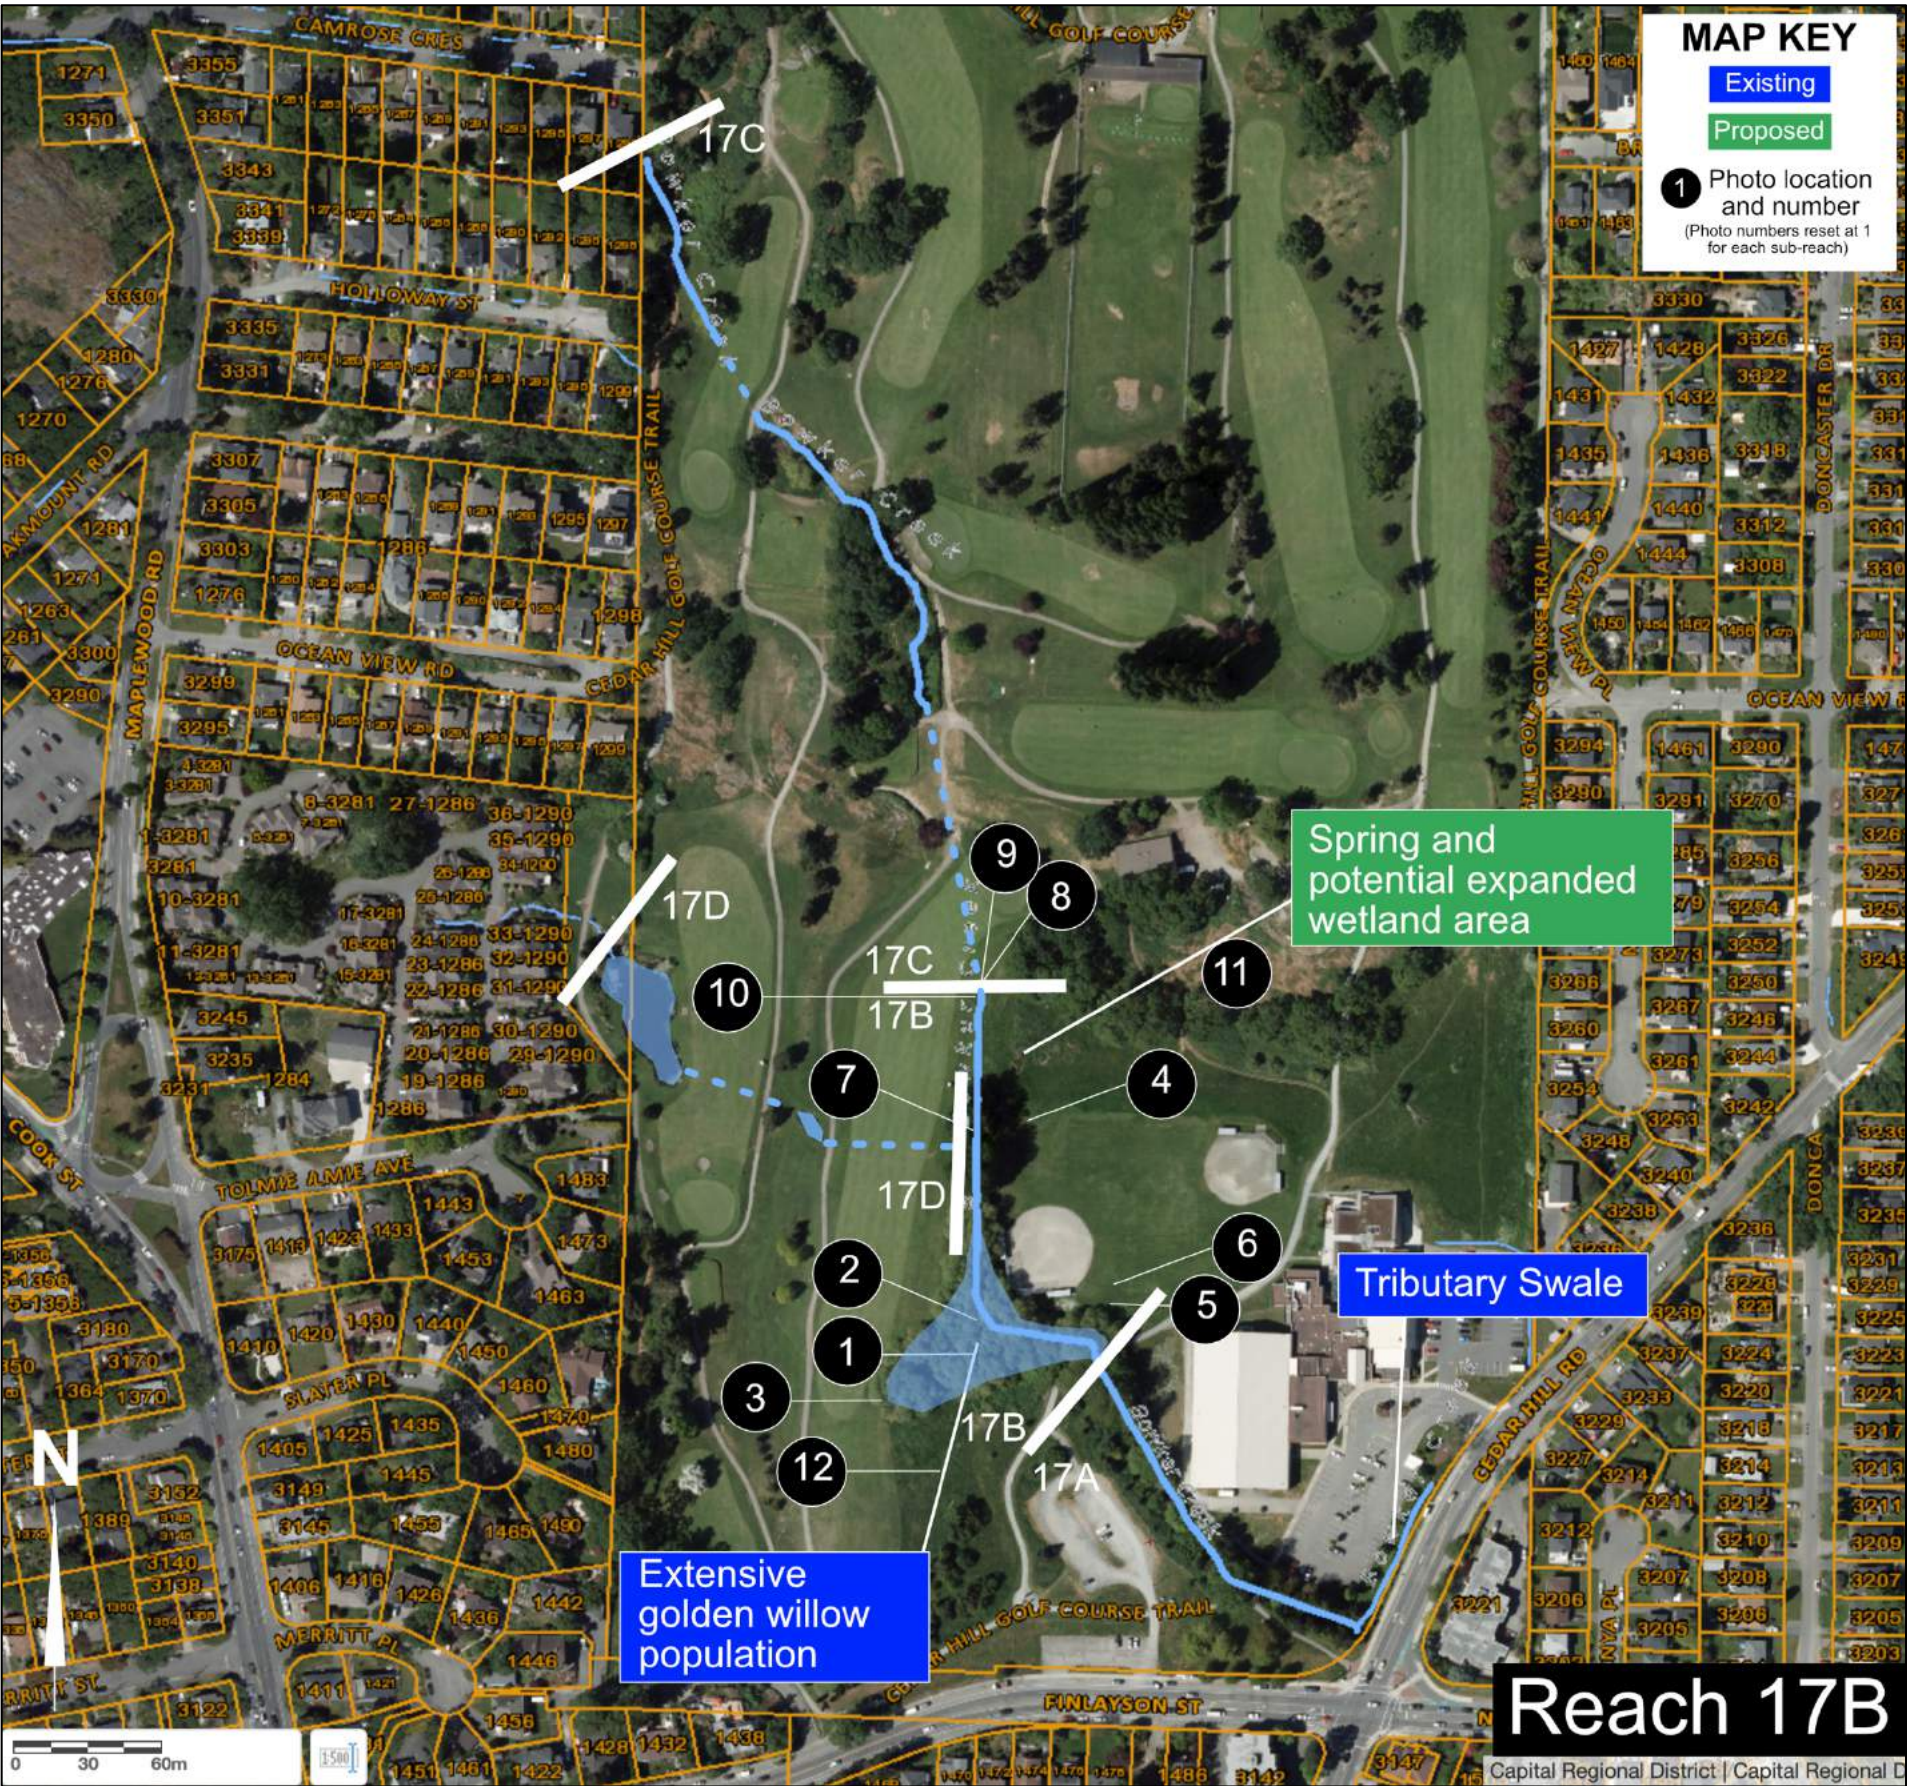
Photo 17A-10. Historic fill area increases steepness of the south slope of this reach. This riparian area could be re-sloped and expanded into the undeveloped parking area. This area has seen concerted volunteer efforts in invasive species removal and native plantings (view upstream/north).

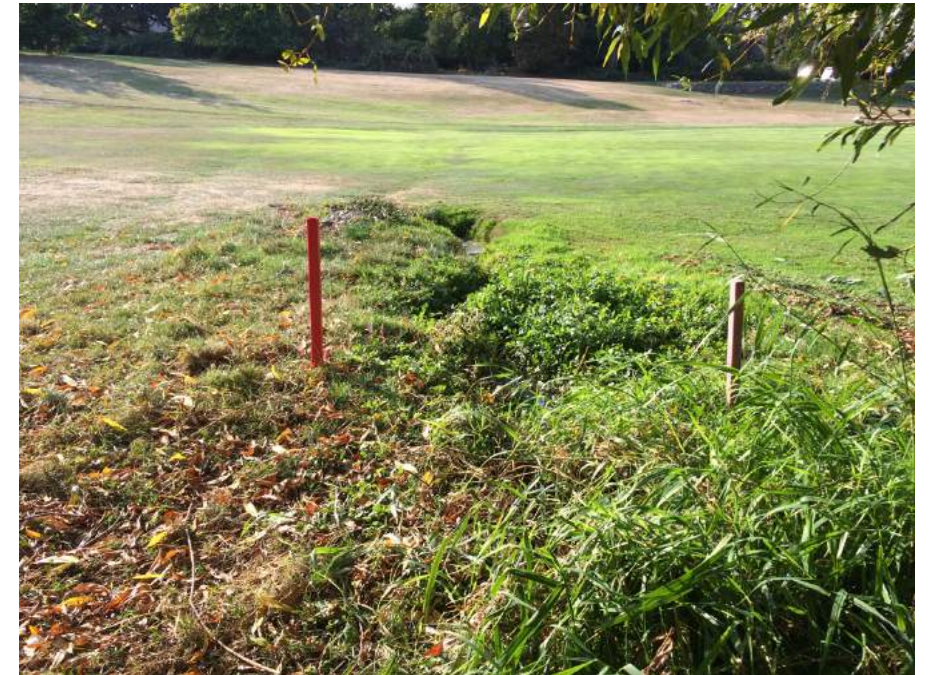
Photo 17B-3. Additional un-mapped water source from under golf course Fairway 7 where it enters the west edge of the golden willow wetland (right) (view west).

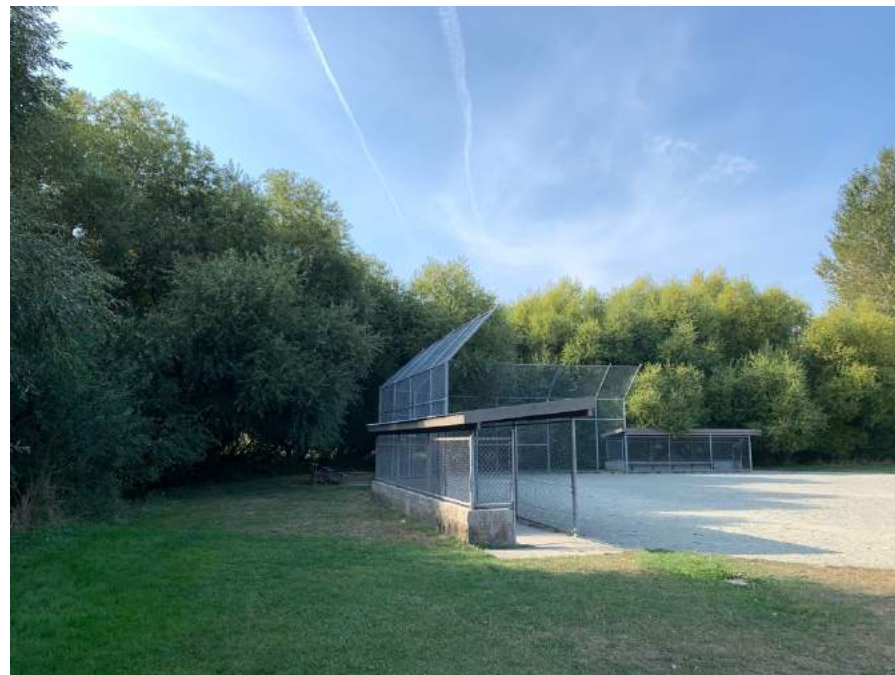
Photo 17B-6. Ball diamond adjacent to upper section of reach with black cottonwood trees and mowing close to edge of the creek (view upstream).

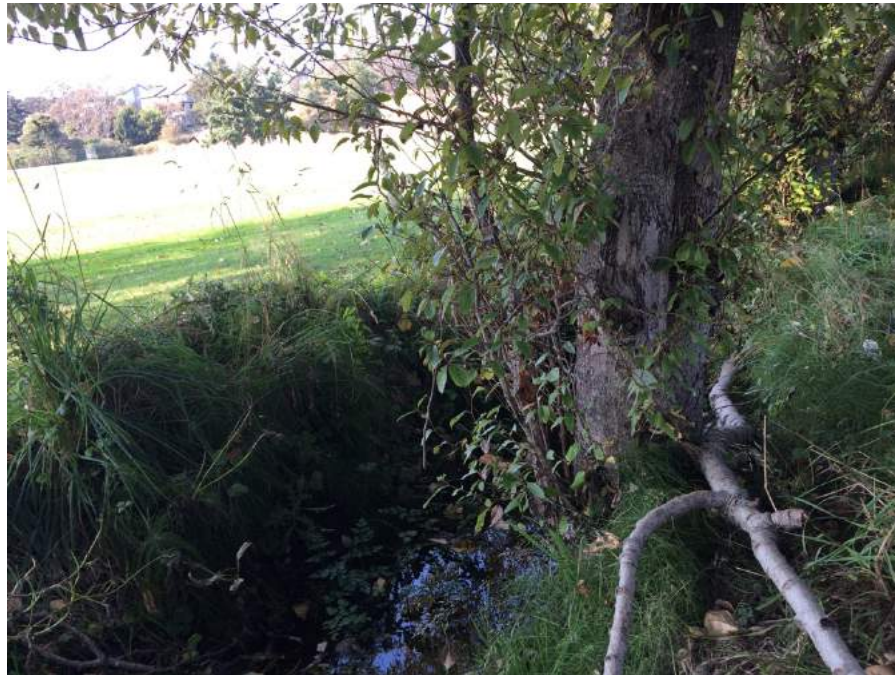
Photo 17B-7. Upper section of reach near confluence with reach 17D, demonstrating mowed creek edge adjacent to golf course Fairway 7 (view upstream/northwest).
