TABLE OF CONTENTS

BOWKER CREEK ASSESSMENT SUMMARY

REACH 1A
Reach # 1A – Creek mouth into Oak Bay to upstream (west) end of 1776 Beach Drive) (140m) 2733, 2717, and 2713 Somass Drive; 1725, 1762, and 1776 Beach Drive (privately owned)
Channel Description Channel banks are primarily concrete, mortared rock and concrete sandbags (Photos 1-6,8-10,12-15). The channel bottom is a mix of bedrock, heavily silted substrate of sand, gravel, cobble, and boulders, and extensive concrete and asphalt armouring (Photos 3,8,9,12,13,16). Thick algal mats and root mats from golden willow are present. Vertical armoured banks 1-2m tall, channel width 3.0m – 5.5m, wetted width 0.4m-3.5m (summer). The creek is channelized and straightened with a gradient range from 1.5-4% with a narrow strip of riparian vegetation (Photos 17 & 18). There is a 22m long pool downstream of the culvert which is suitable as a holding location for juvenile fish prior to entering the marine environment, and also for adults entering the stream to hold while awaiting higher flows and while maturing. Tidal influence occurs downstream of Beach Drive. Concrete box culvert at Beach Drive (3.0m wide x 2.2m tall x 15m long). Small a

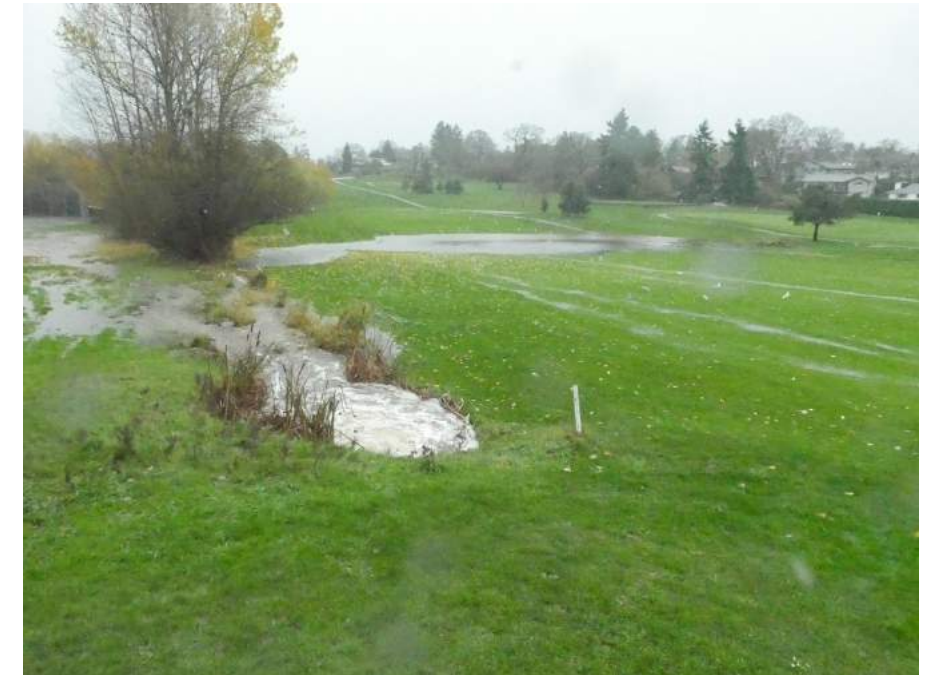
Photo 17B-9. Widespread flooding during the atmospheric river event in November 2021 overwhelmed the piped flows from Reach 17D (right) (view downstream of Reach 17B and 17D confluence) (Photo Peter Haddon).

Additional Observations/Notes 2022 – This reach experience major flooding during the atmospheric river event of November 2021 (see Photo 17B-9 in Reach 17B section). 2011 – was not assessed		
Resources & Further Reading Aqua-Tex Scientific Consulting Ltd. 2007. Bowker Creek Watershed Bowker Creek Watershed Proper Functioning Condition Assessment Saanich Parks, Recreation, and Community Services Department. 2020. Cedar Hill Park Management Plan 2020 to 2040 Friends of Bowker Creek – www. bowkercreek.org Quadra Cedar Hill Neighbourhood Association Friends of Cedar Hill Park		
Summary Condition: <ul style="list-style-type: none">- Mostly culverted (130m)- Large pond, recirculating pump and narrow riparian vegetation around the perimeter- Small vegetated wetland between two culverted sections. Opportunities: <ul style="list-style-type: none">- Short term focus on invasive species control and increasing riparian planting width.- Long-term channel daylighting and restoration, invasive species and native riparian plantings.- Continue plans toward achieving certification in the Audubon Cooperative Sanctuary Program for Golf.

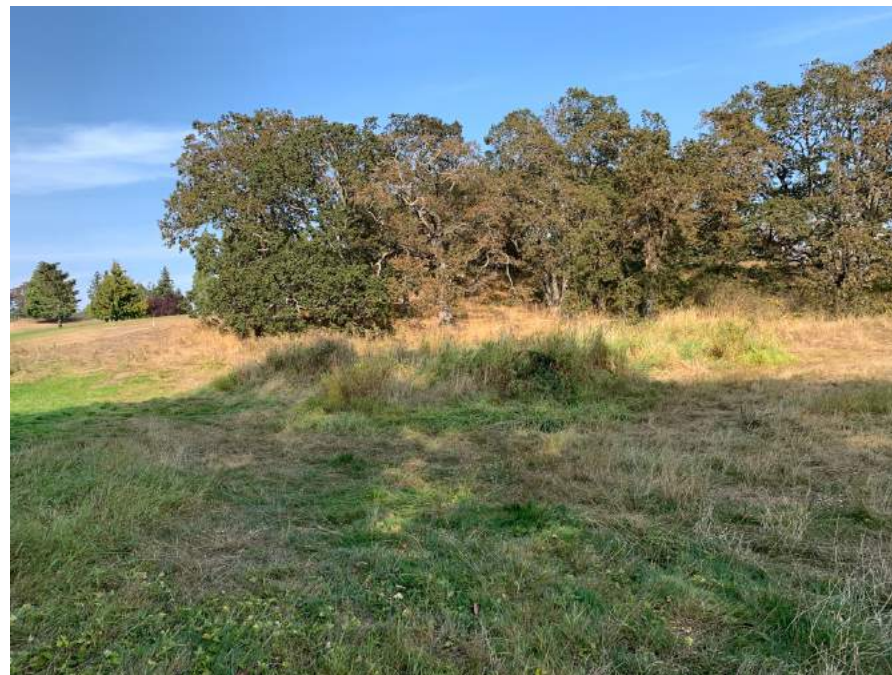
Photo 17B-11. This area of reed canary grass and historical fill immediately east of the source culvert for the reach is a spring from the hill and identified as an opportunity to create additional wetland habitat in the Cedar Hill Park Management Plan 2020 to 2040 (Figure 5.3) (view north/upstream).

- The spring and foreign fill area to the east of the upper section has been identified in the Cedar Hill Park Management Plan as an opportunity to create additional wetland habitat and flood response.

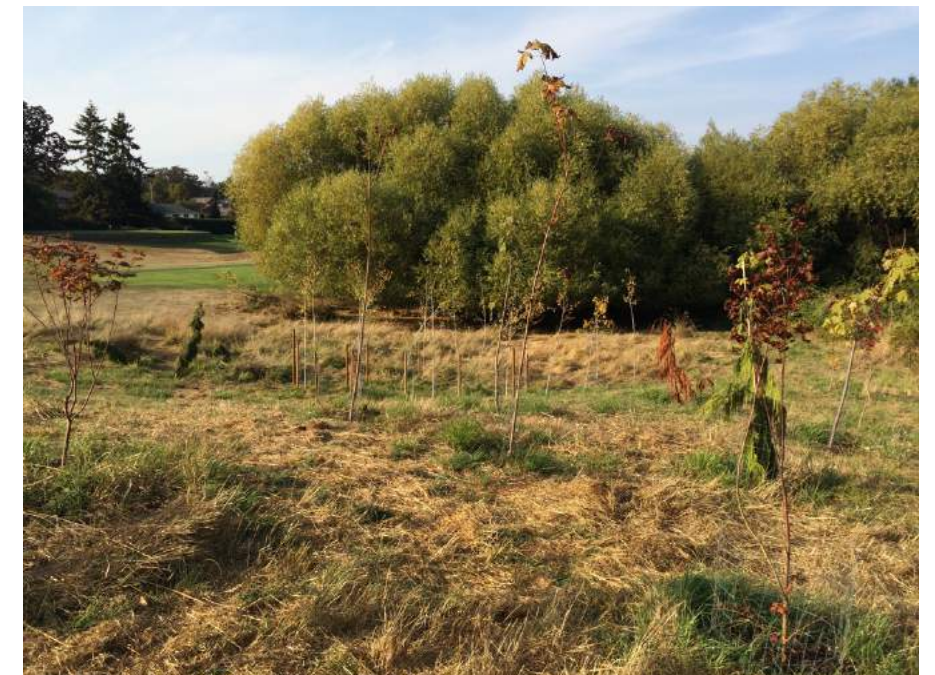
Photo 17B-12. A young forest has been recently planted on the south slope above the wetland, which will improve wildlife connectivity to the riparian area. The addition of tree species such as trembling aspen adjacent to the invasive golden willow wetland would eventually allow for the thinning of the invasive trees with reduced impact to water temperatures and wildlife habitat (view north).

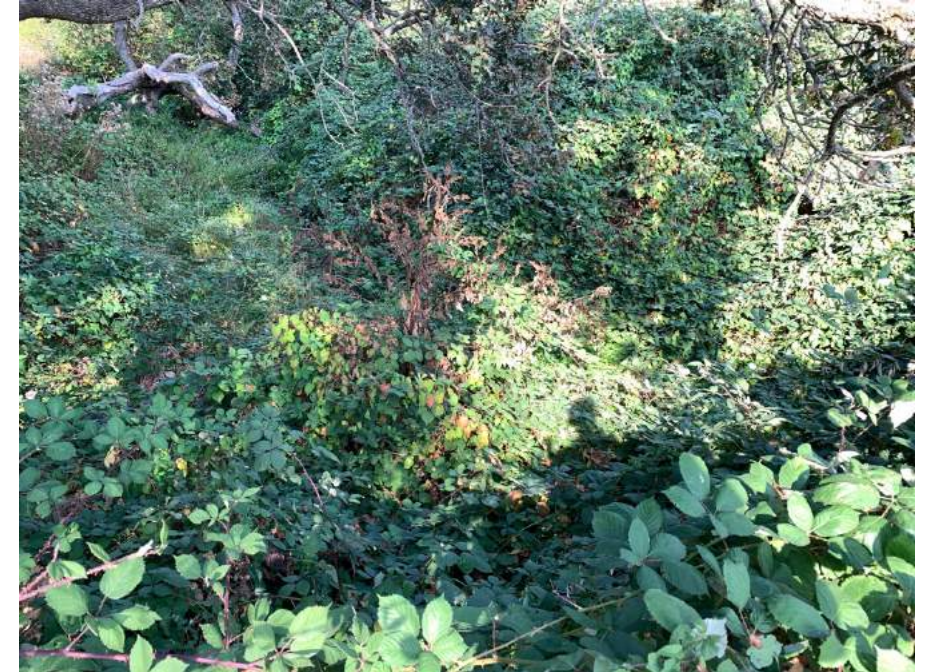
Photo 17C-3. Gully section with Himalayan blackberry and English ivy (view across stream/east).

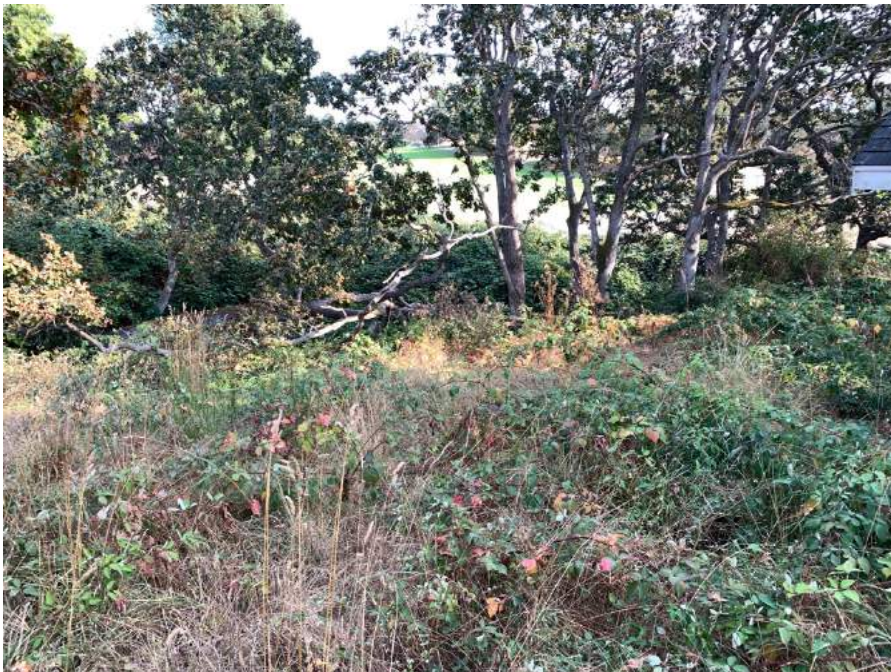
Photo 17C-4. Upland area of gully section where golf course staff have removed Scotch broom and Himalayan blackberry, but it is re-establishing (view downstream/southeast).

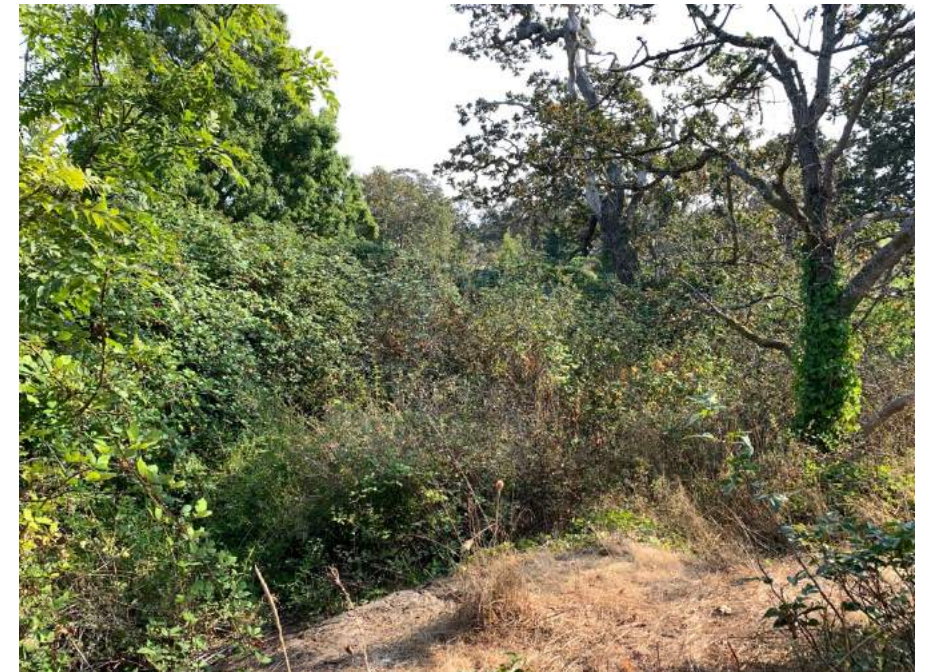
Photo 17C-6. Gully section with Himalayan blackberry on the east side of the channel and Garry oak with snowberry and tall Oregon-grape on the west side.

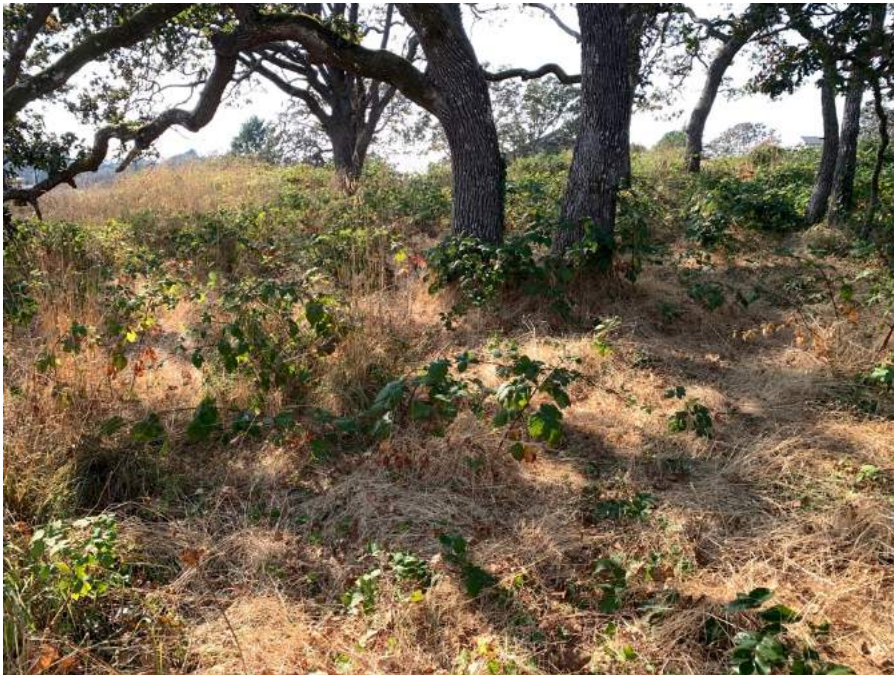
Photo 17C-7 Upland area of gully section where golf course staff have removed Scotch broom and Himalayan blackberry, but it is re-establishing.

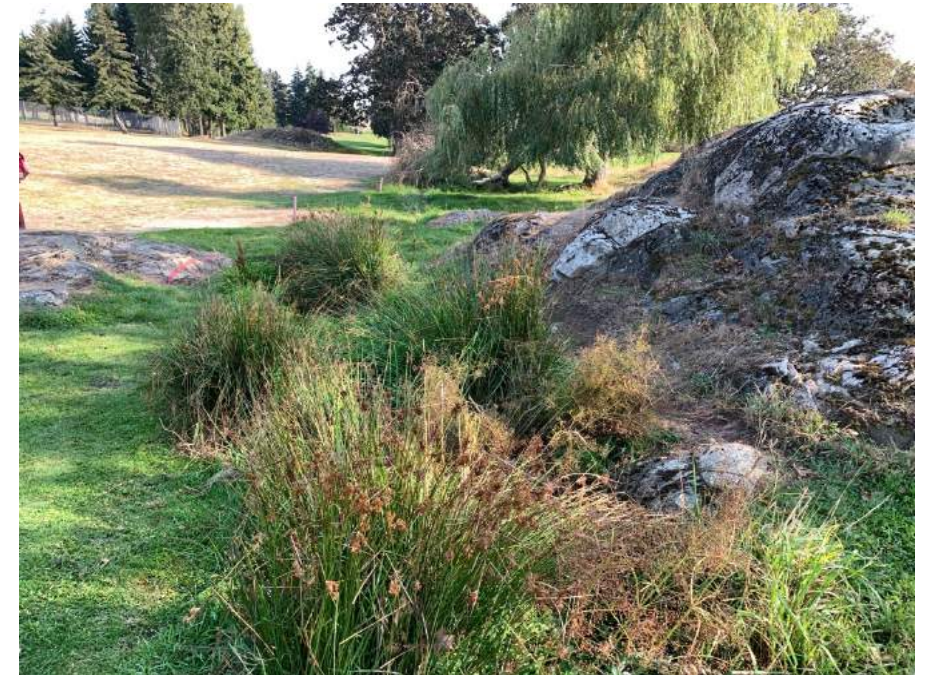
Photo 17C-8. Upper section above the gully, Himalayan blackberry section (view upstream).

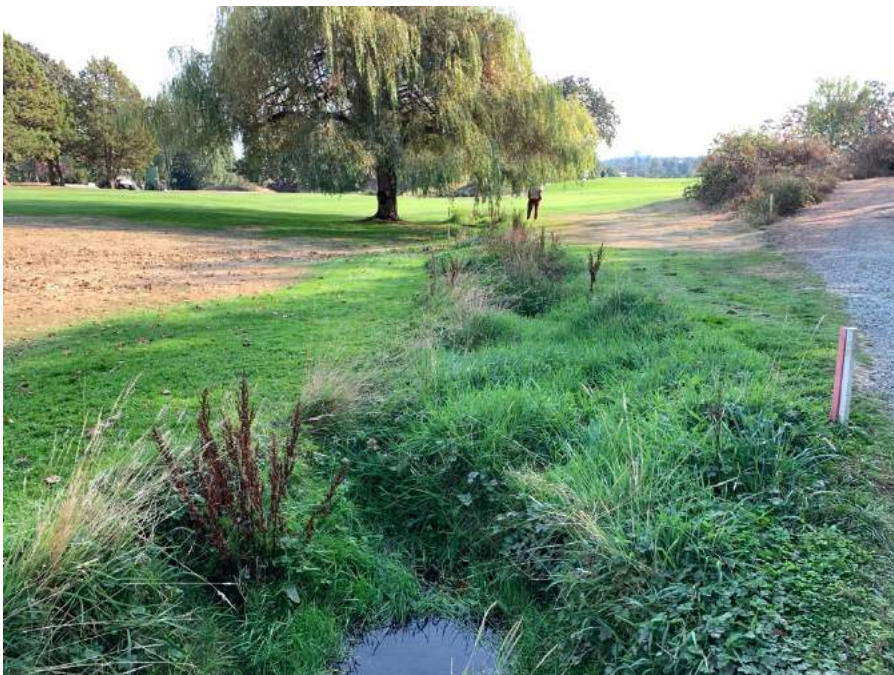
Photo 17C-9. Upper section through the golf course (view downstream).

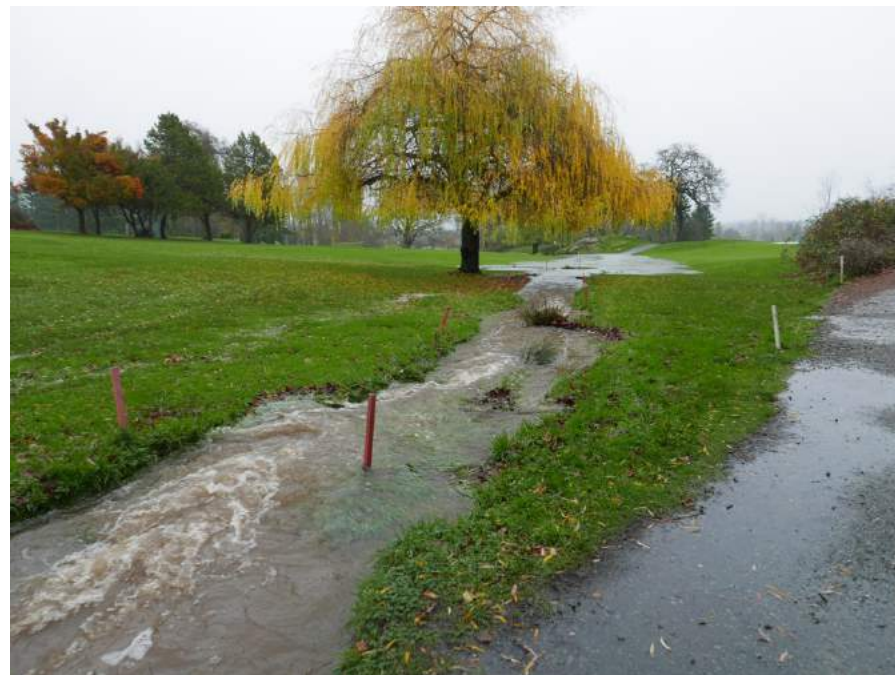
Photo 17C-10. Upper section through the golf course (view downstream).

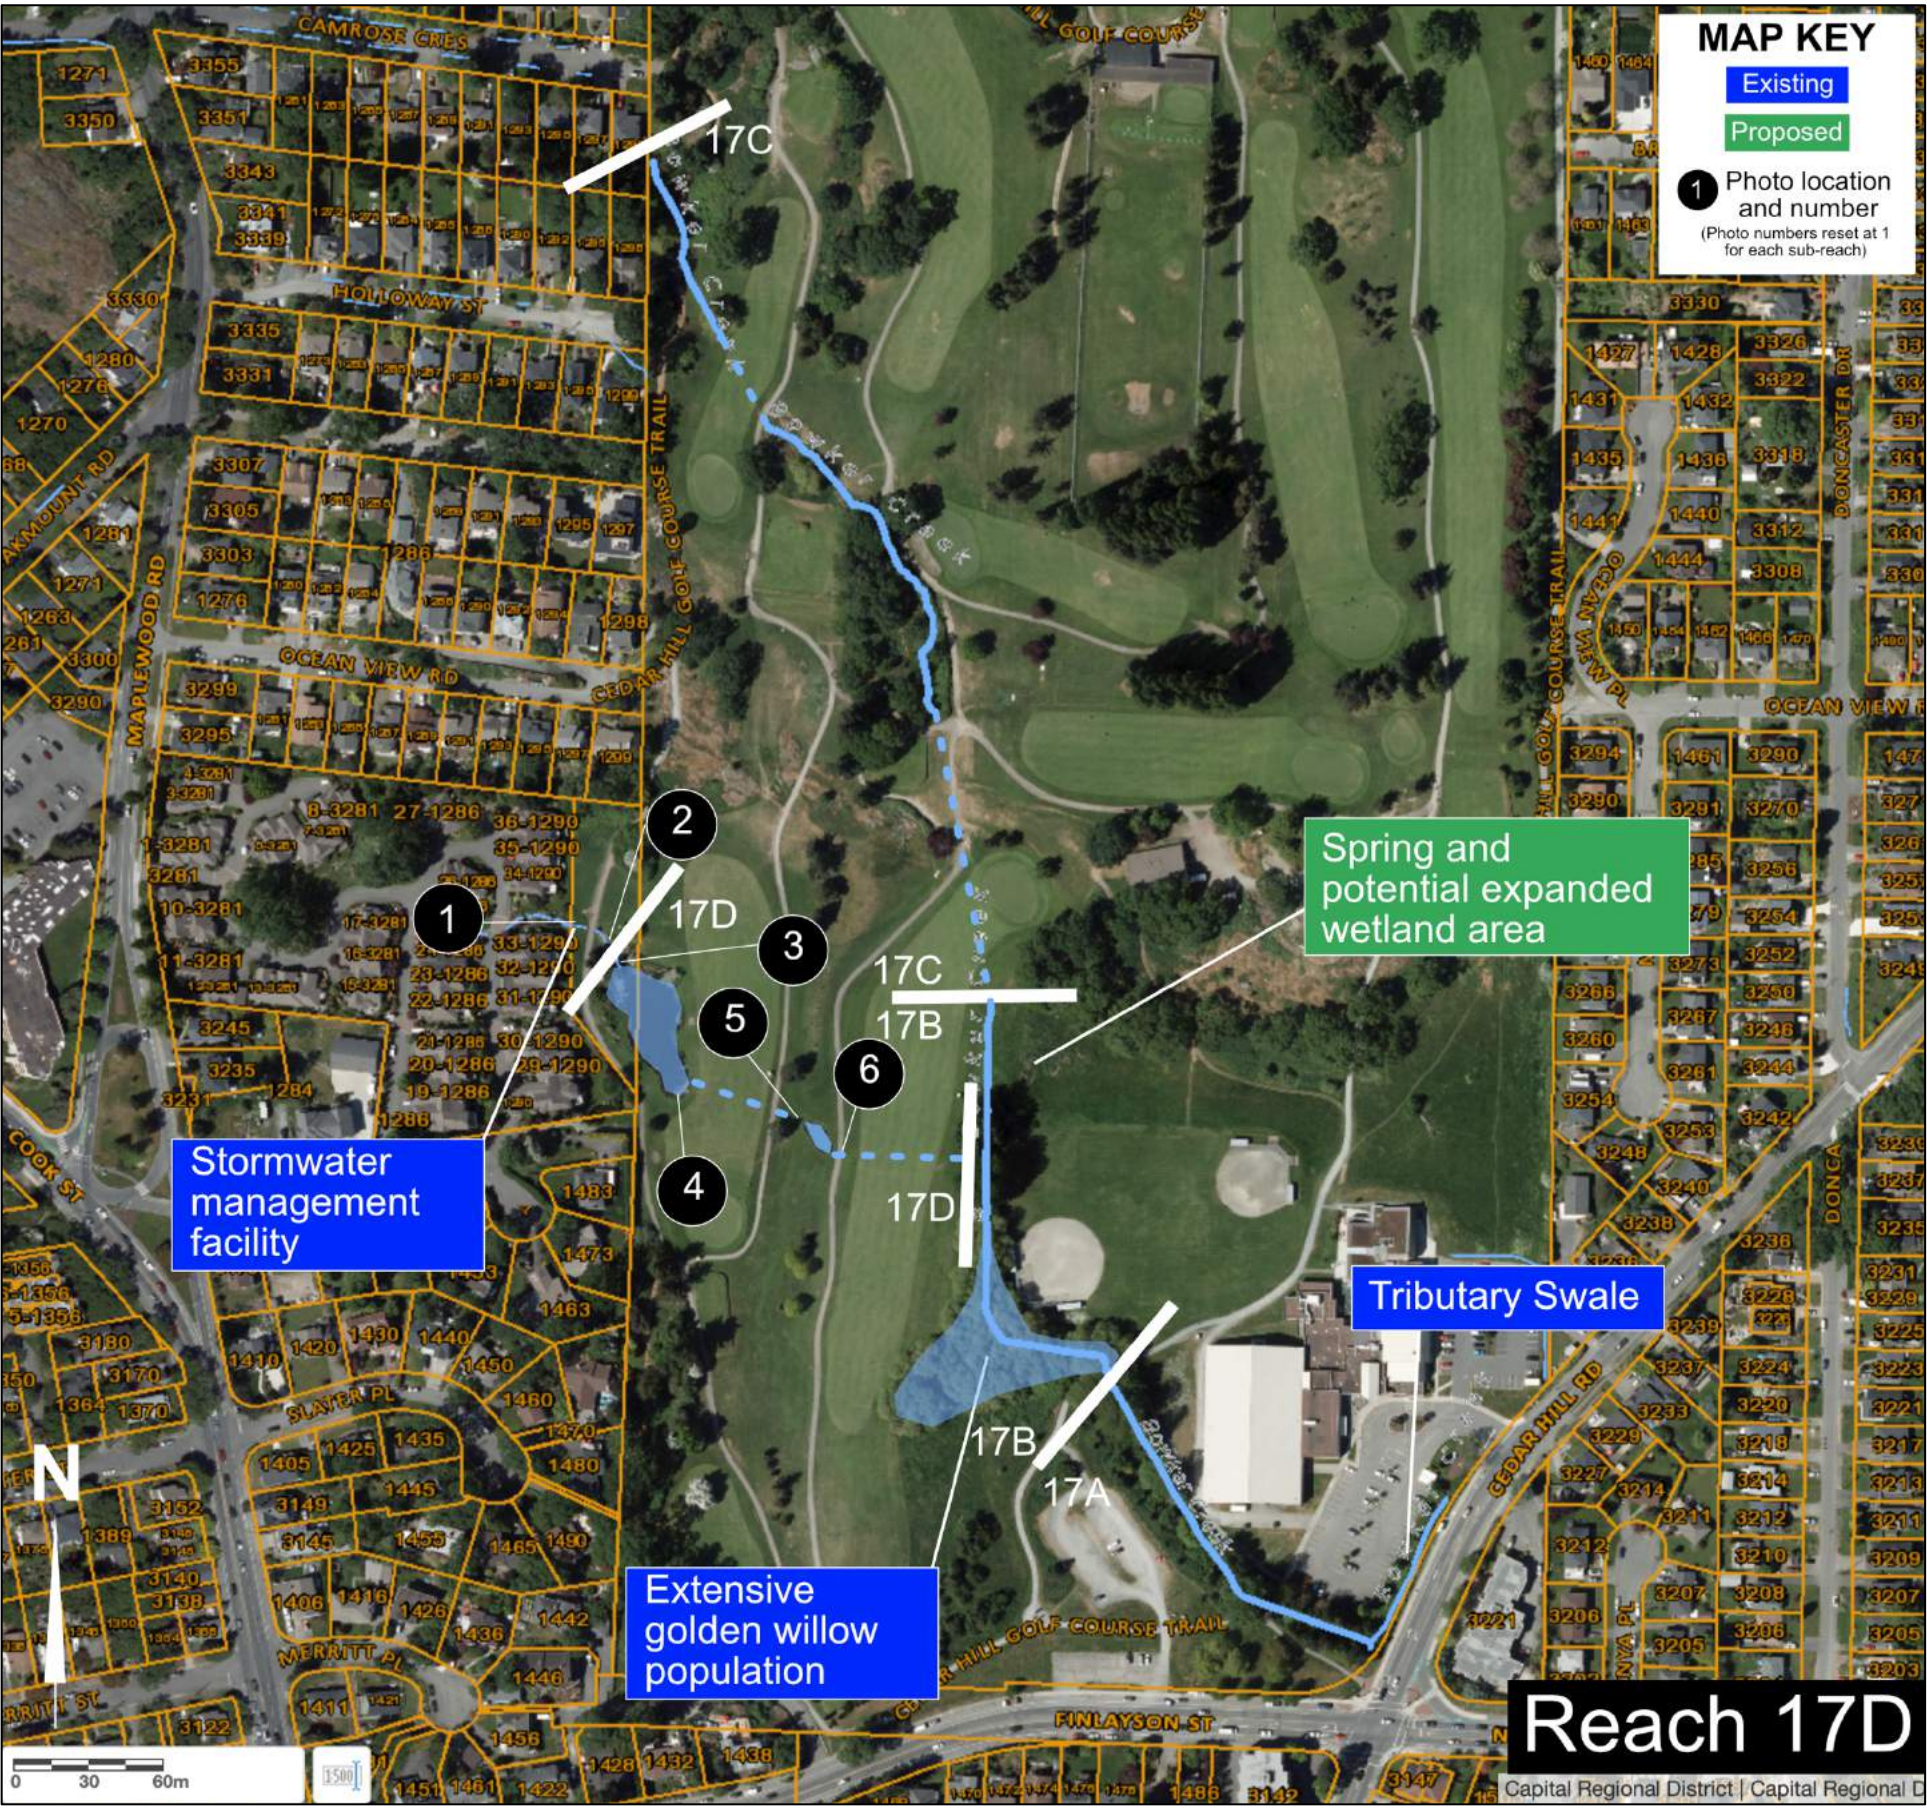
Photo 17C-12. Upper section discharging from culvert at 1299 Camrose Crescent (view upstream).

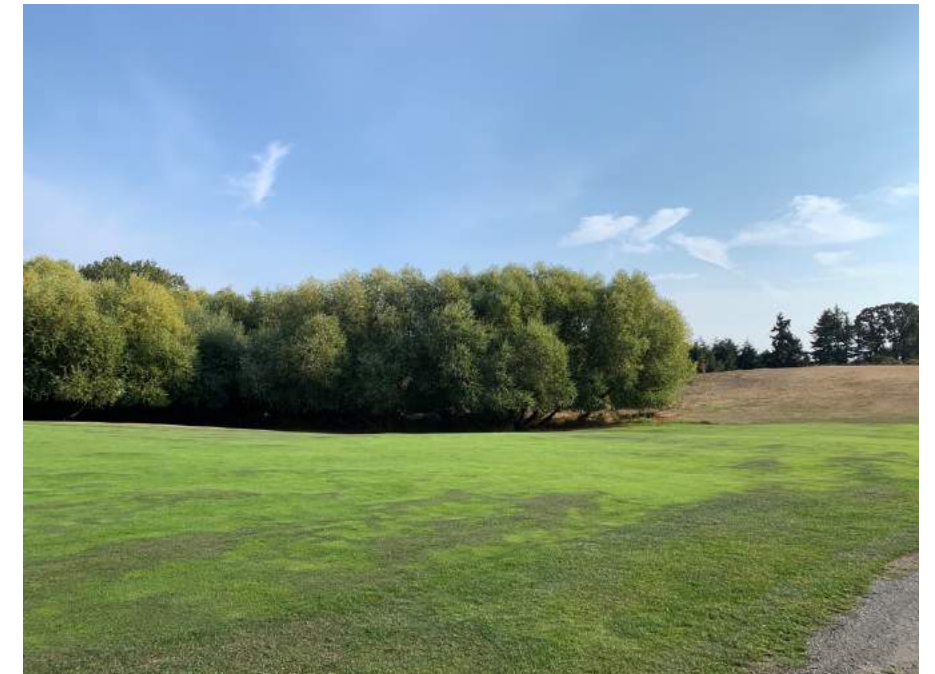
Photo 17D-5. Small wetland between the two long culverted sections under Fairways 5 and 7, mix of native and non-native vegetation (view downstream toward Reach 17B tree line).
