SUMMARY AS-BUILT PROJECT COMPLETION REPORT

SAANICH AND VIEW ROYAL, BC

DFO Authorization No. 11-HPAC-PA3-00772

AESC Project No.: 211-018-1

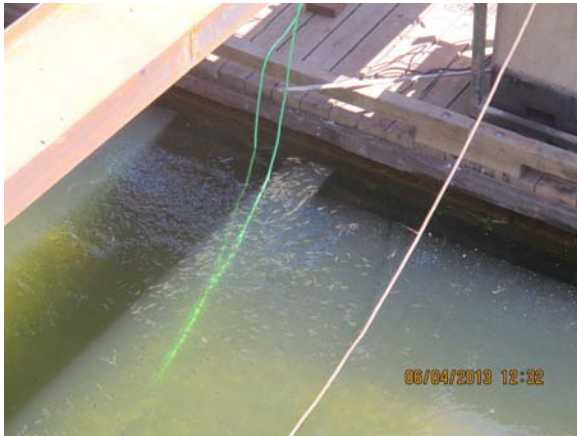
Photo 9.7-1 Threespine Stickleback schooling around worksite.

In the event fish were observed to be impacted by in-water construction activities, those activities would be temporarily terminated until other mitigation efforts could be initiated. There were no instances of observed fish distress (e.g. change in swimming behaviour).

Threespine Stickleback and other fish species were routinely observed schooling around the worksite with no indication of stress or other impact. Coho smolts were periodically observed mid-channel while shiner perch were observed moving with the tide at the north end of the site.

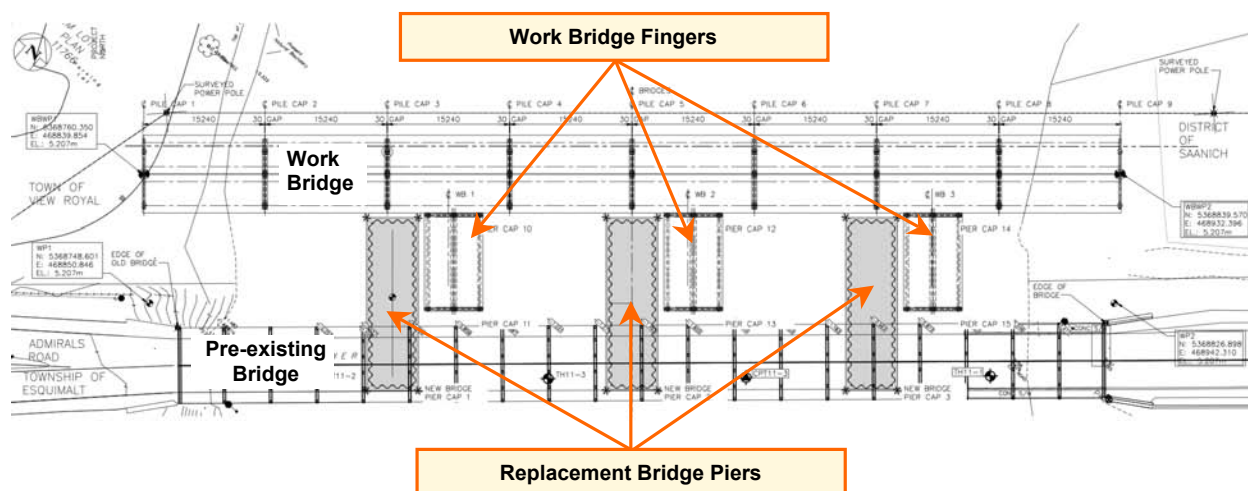
Figure 2 Temporary work bridge design plan view (designed by All-Span⁷ for Ruskin).

The 8-span work bridge was not considered or included in the application for Authorization of this Project, nor was it included in the Authorization document. However, DFO was fully consulted on the proposal to install the bridge. Consequently, the Contractor was required to prepare and submit an Environmental Impact Assessment to DFO for review and acceptance prior to initiating the construction of this structure.

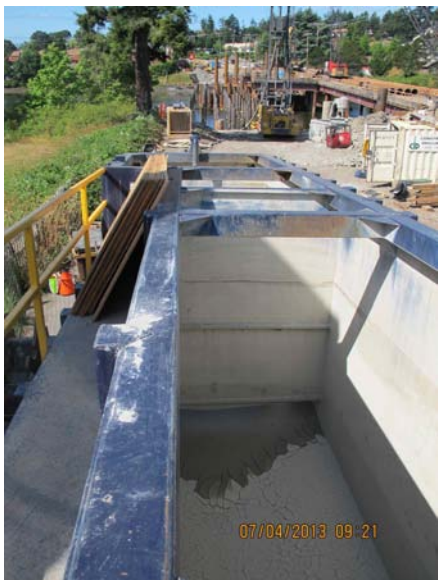
Photo 9.15-1 Silt-laden water treatment tank prior to filling.

The use of settlement hoppers (discussed in Section 9.15, above) was effective in providing mechanical settlement of suspended sediments prior to release to the Gorge Waterway. Some insignificant leakage occurred from these steel containers, as they were not 100% watertight. In response, a combined installation of silt fencing and straw bales was deployed at the discharge point of the leakage to filter as much of the leakage as possible. These releases were considered negligible and no further action was required.

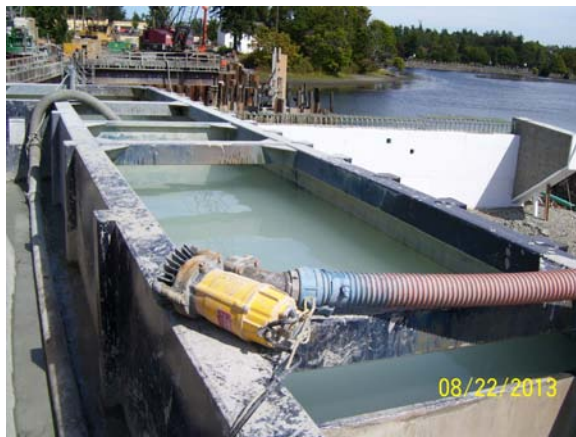
Photo 9.15-2 Operational water treatment tank.

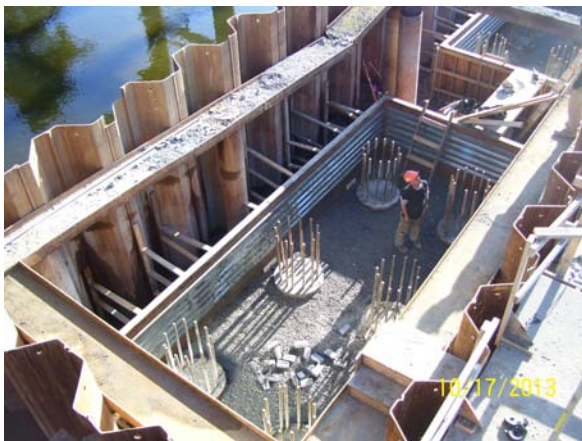
Photo 11.1.2-1 Forming the corrugated oyster colonization panels.

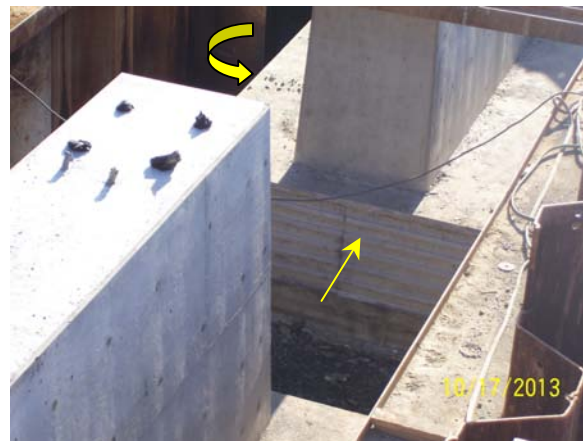
To replace this loss of habitat, WFT recommended that horizontally corrugated panels be incorporated into the replacement bridge pier design. Originally, these panels were to be attached directly on the portion of the bridge pier footings, which extend above the bed of the Gorge Waterway. Horizontal corrugations were specifically recommended as it was concluded by WFT that this orientation provided a better attachment medium for Olympia Oyster than vertical corrugations. Further, it was concluded that competing species such as mussels preferred vertical corrugations. Ultimately, these corrugations were formed directly onto all four walls of each of the six pier footings, providing a total of 180m^2 of replacement vertical habitat.

Photo 11.1.2-2 Exposed corrugated oyster colonization panels.

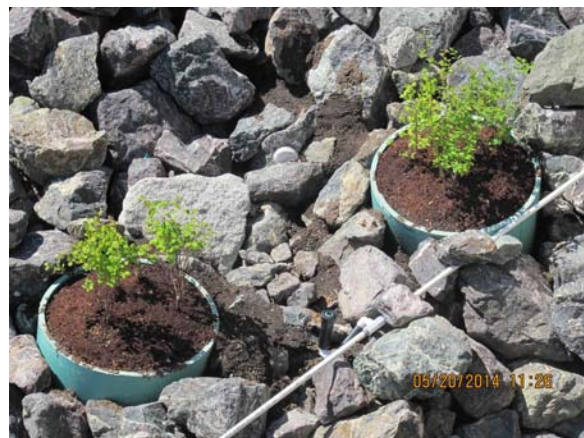
An intensive riparian planting initiative was undertaken on the upstream banks. Plants were installed at approximately 1m spacing using a native plant species prescription comprising trees and shrubs developed in consideration of pre-existing conditions and accepted guidelines. Riprap bank armouring around the abutments extended into the downstream bank areas. It is difficult to plant these areas. However, to provide a nominal amount of riparian replacement, planting wells using vertical pipes were installed within the riprap. This is rarely done. Shrub plants were installed into these wells as a measure that over time will establish localized vegetated cover.

Photo 11.3-6 Planting wells in riprap on southeast quadrant.
