Capital Regional District Core Area Liquid Waste Management Plan

Management of Inflow & Infiltration Biennial Report

for 2007 and 2008

Prepared by:
Engineering Design
Services
Environmental Services

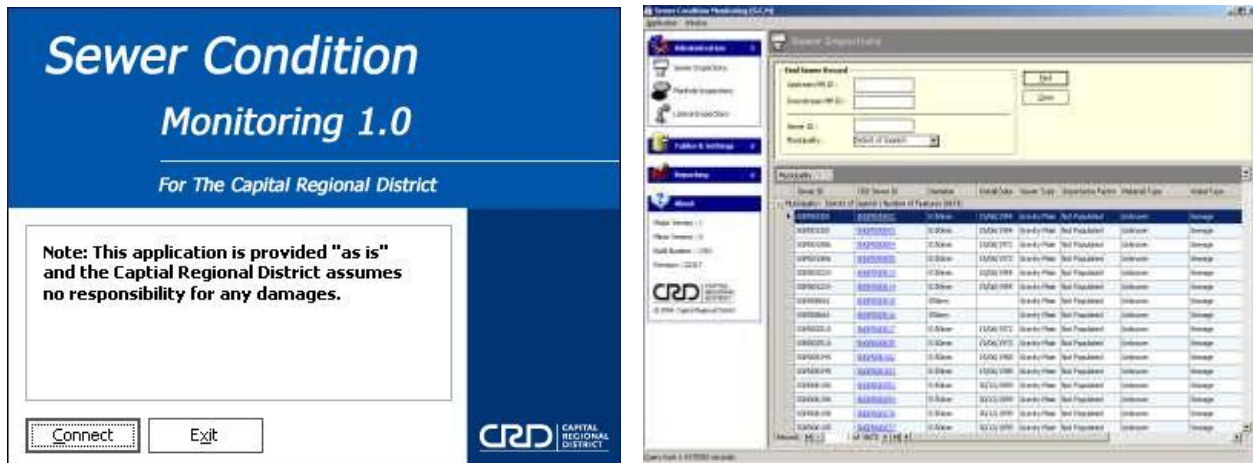
Figure 2.1 – Sample Screen Shots of Data Entry Program

The CRD created a custom sewer condition monitoring database that allows municipalities to proactively enter sewer inspection and maintenance information as the works are being completed. The information entered into the database can be exported to the GIS for analyses or exported as custom summary tables.

Figure 2.1 provides a couple of "screen shot" looks of the data entry program.

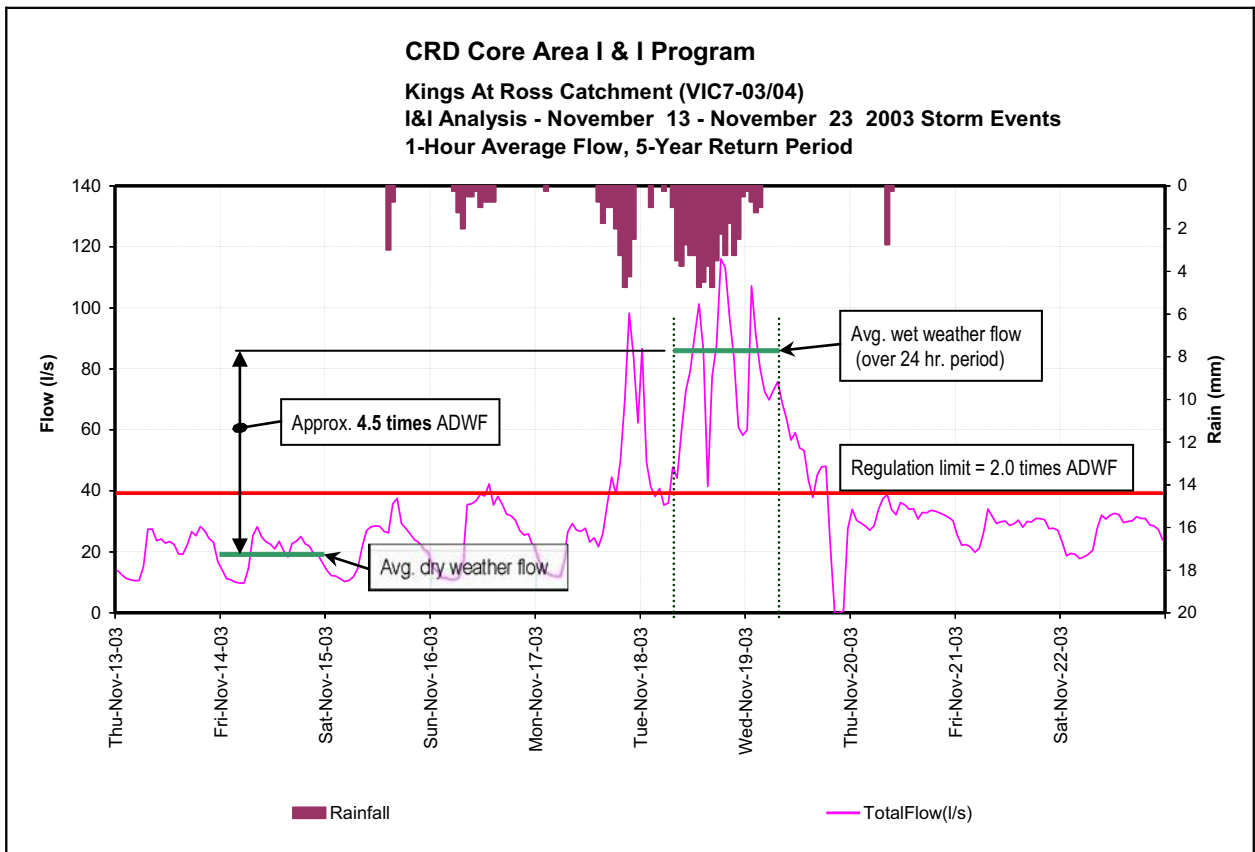
Figure 3.3 – Kings at Ross Flow Hydrograph

The provincial Municipal Sewage Regulation states that I&I shall not exceed the amount which causes the “average wet weather flow” (AWWF) to “average dry weather flow (ADWF) ratio to exceed 2.0 for storm events having less than a 5-year return period. Compliance with the regulation can be determined using the hydrographs located in the I&I analysis reports. The process for doing this is illustrated in Figure 3.3 and explained in the paragraph that follows Figure 3.3.

The hydrographs in the I&I analysis reports can also be analysed, in a cursory way, to better understand I&I in the catchments and to help select appropriate investigation techniques for further study. For example, a rapid increase in flow may indicate inflow or rapid infiltration. This would indicate potential storm sewer cross connections and/or leaky sewer pipes that allow groundwater to rapidly enter the pipe during storm events. Conversely, a slower flow increase and length of time for flow subsidence after a rain event would likely indicate infiltration rather than inflow.

The storm event hydrograph chart at the Kings and Ross site, shown in Figure 3.3, indicates that the maximum average wet weather flow is about 4.5 times greater than the average dry weather flow. That ratio exceeds the acceptable rate of 2.0 times ADWF as stipulated in the Municipal Sewage Regulation. Note how the flow quickly responds to rainfall intensity changes and after the storm event subsides. The peak daily flow of about 38 l/s is still higher than the peak flow of

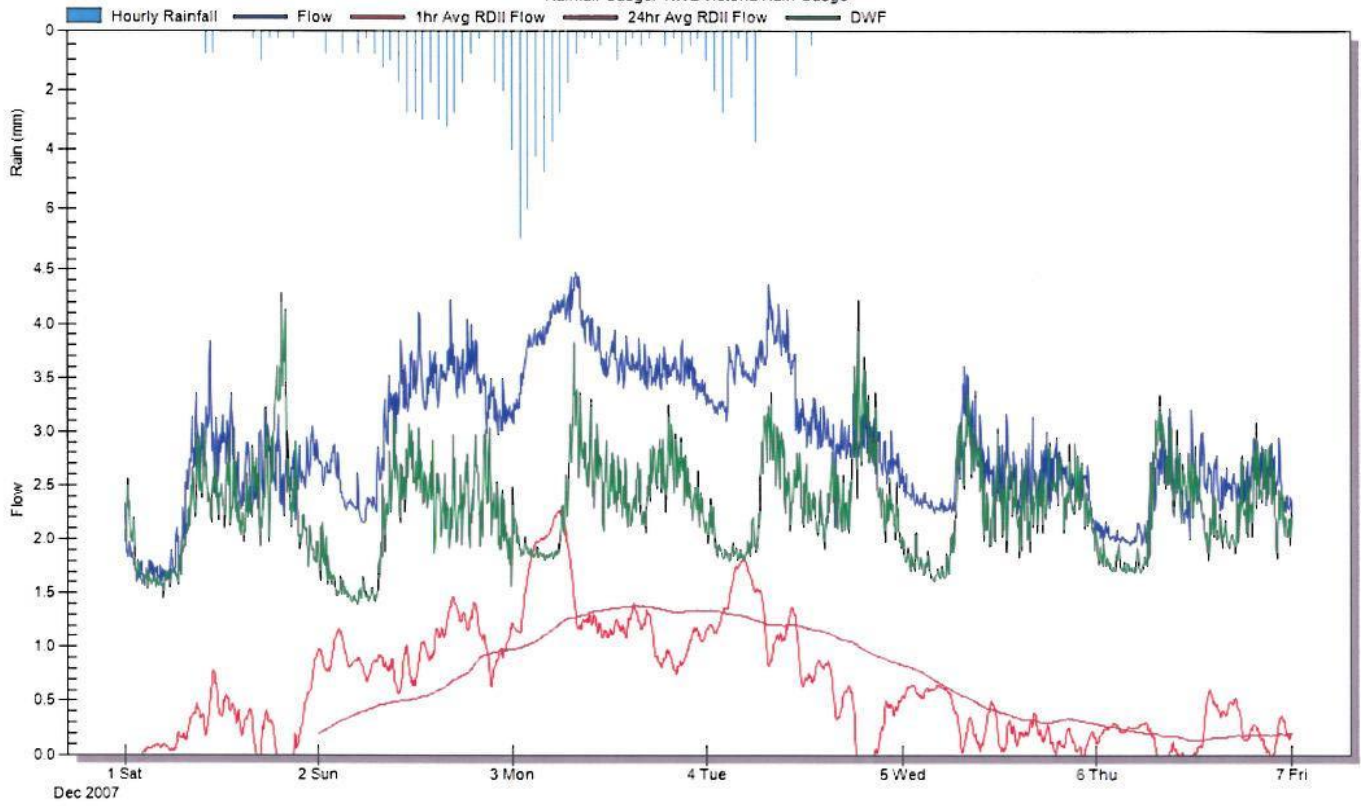
Site: Lafayette
Start Date: Dec 1, 2007
End Date: Dec 6, 2007

Flow Measurement: Weir Flow
Dry Weather Pattern: Dry Weather (Wet Season)
Rainfall Gauge: KWL Victoria Rain Gauge

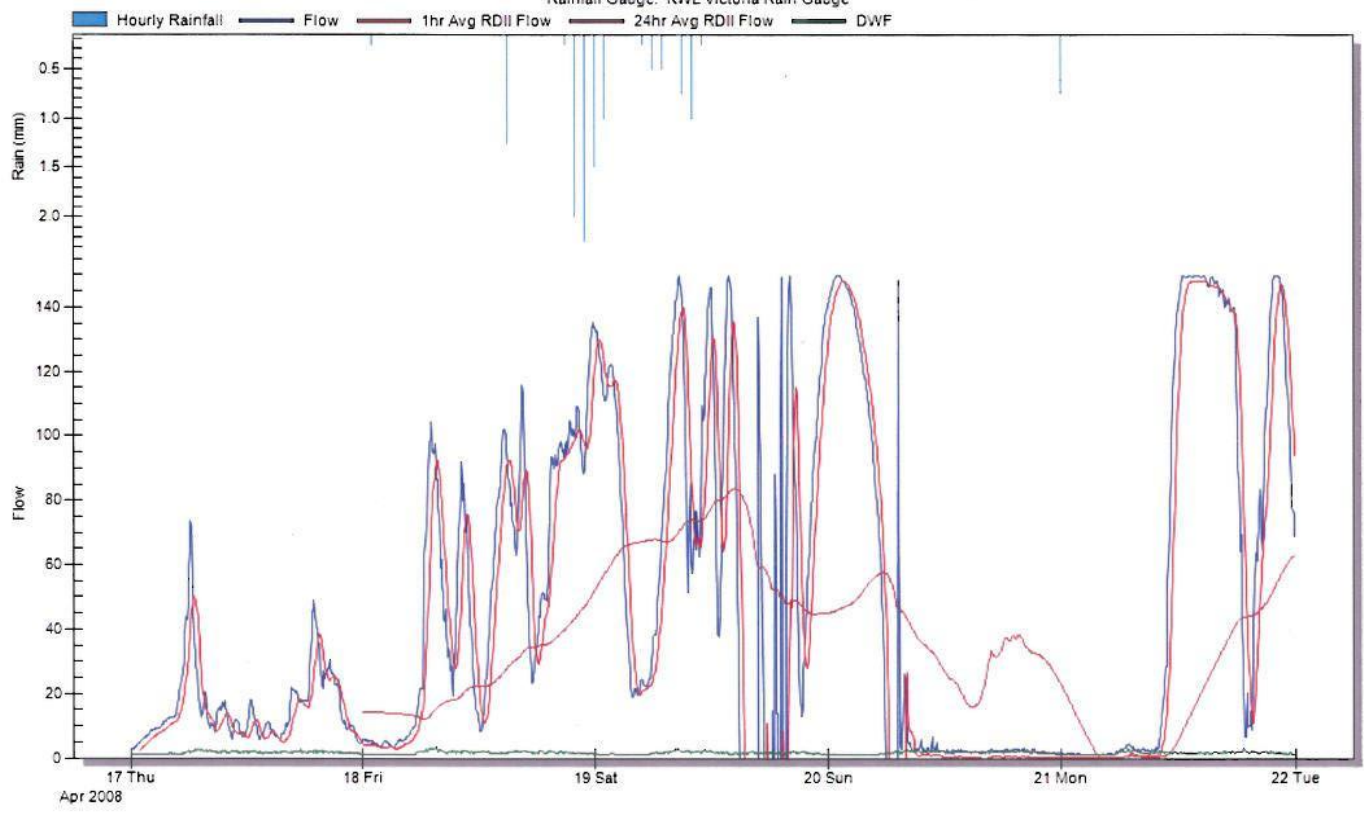
Site: Lafayette
Start Date: Apr 17, 2008
End Date: Apr 21, 2008
Flow Measurement: Weir Flow
Dry Weather Pattern: Dry Weather (Dry Season)
Rainfall Gauge: KWL Victoria Rain Gauge

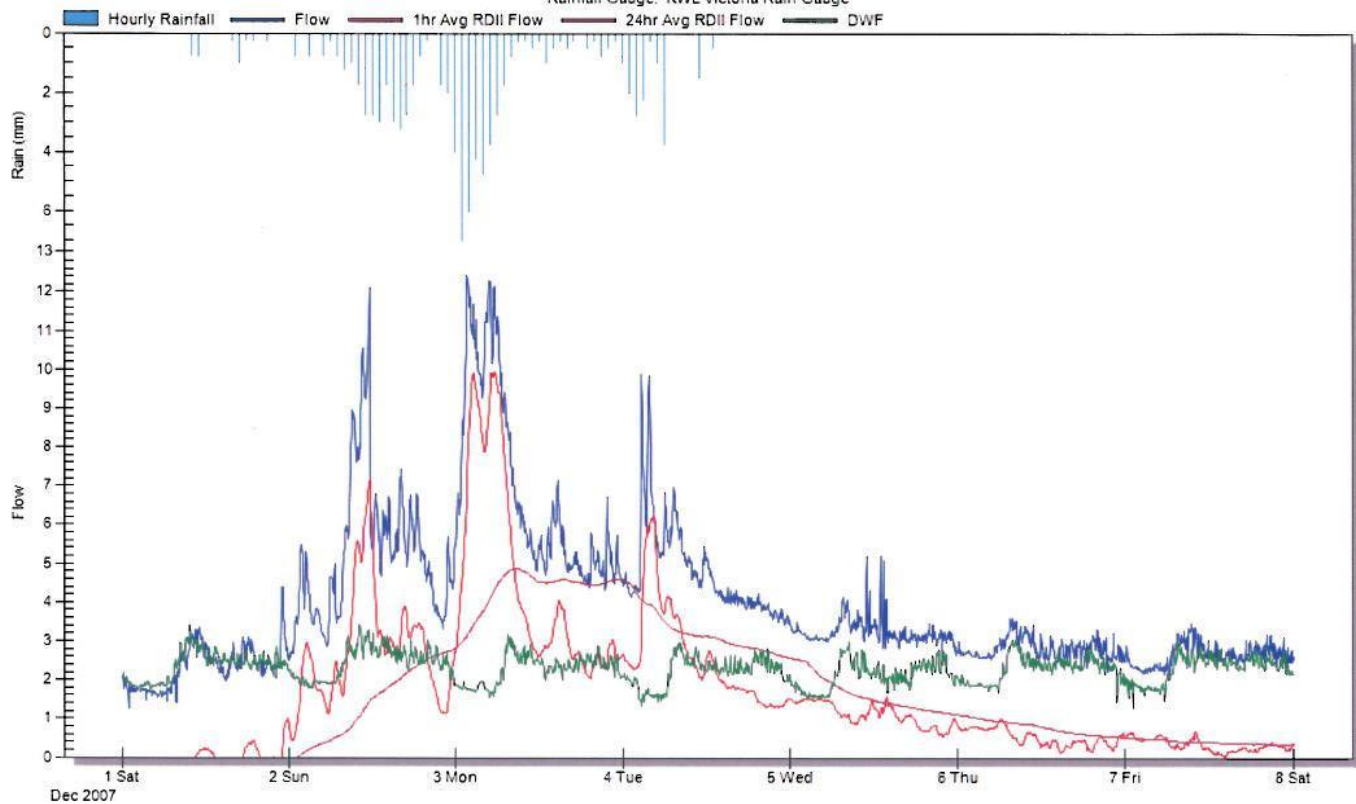
Site: Linkleas
Start Date: Dec 1, 2007
End Date: Dec 7, 2007

Flow Measurement: Weir Flow
Dry Weather Pattern: Dry Weather (Wet Season)
Rainfall Gauge: KWL Victoria Rain Gauge

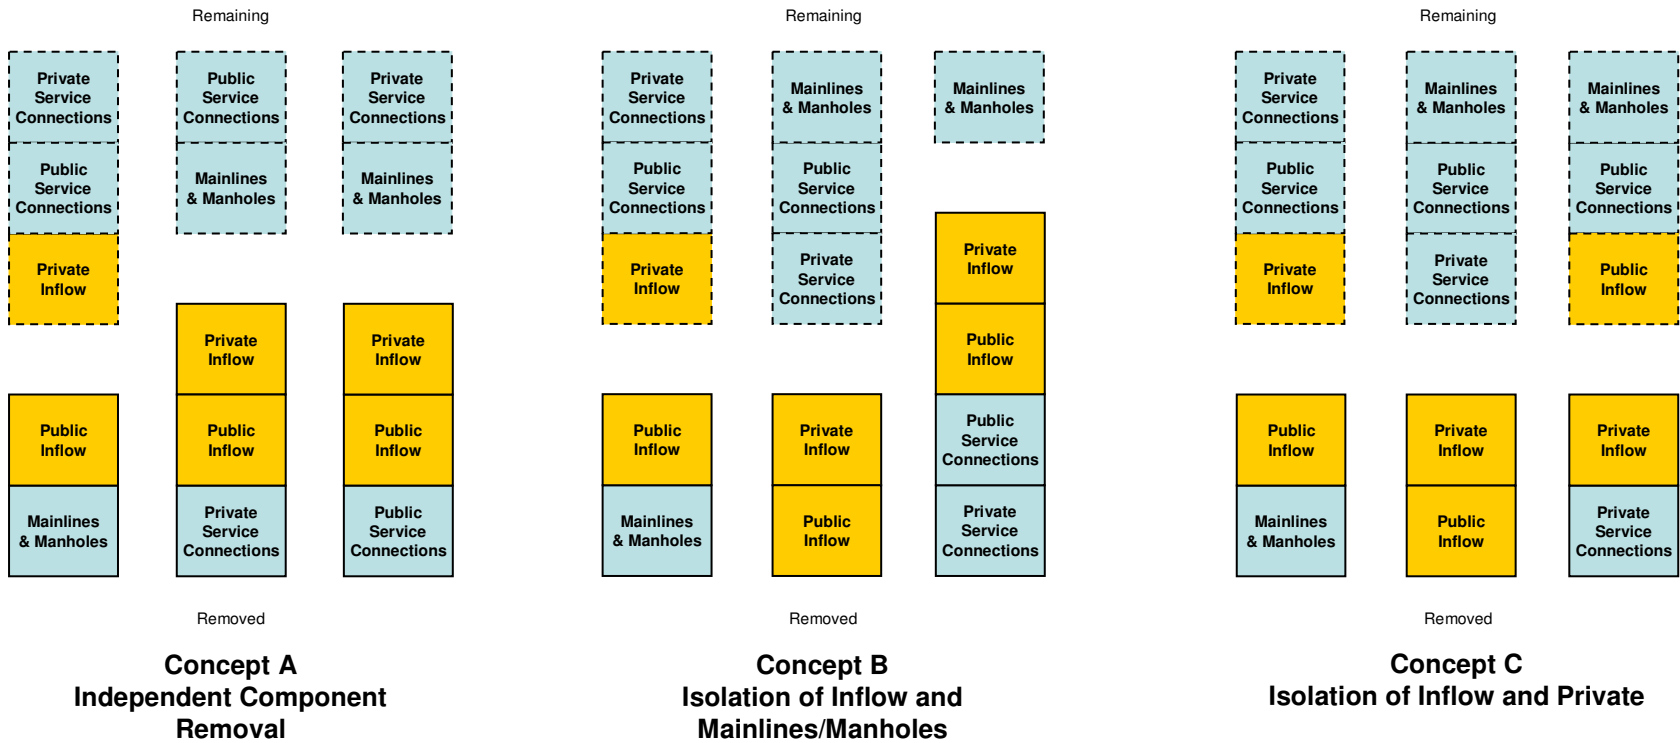
Figure 6-1

I&I Reduction Concepts

Three base I&I reduction concepts are presented below. These concepts relate to the I&I components that will be targeted. Further to this, each concept has two alternative arrangements in which individual study areas have been identified for removal of the I&I components. This is illustrated in Figure 6-1.

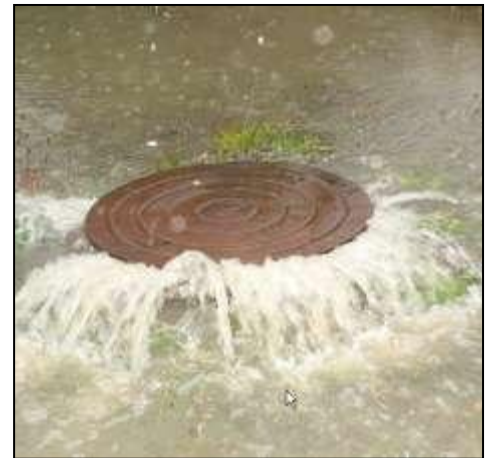
As shown in the picture, when the flow exceeds the capacity of the system it results in a sewer overflow usually at low lying areas and/or back-ups into basements, etc.

A sewer overflow from a surcharging manhole.
