THURBER ENGINEERING LTD.

**GARDOM POND DAM – NORTH PENDER ISLAND
PRELIMINARY GEOTECHNICAL ASSESSMENT OF WATER SUPPLY PIPES**

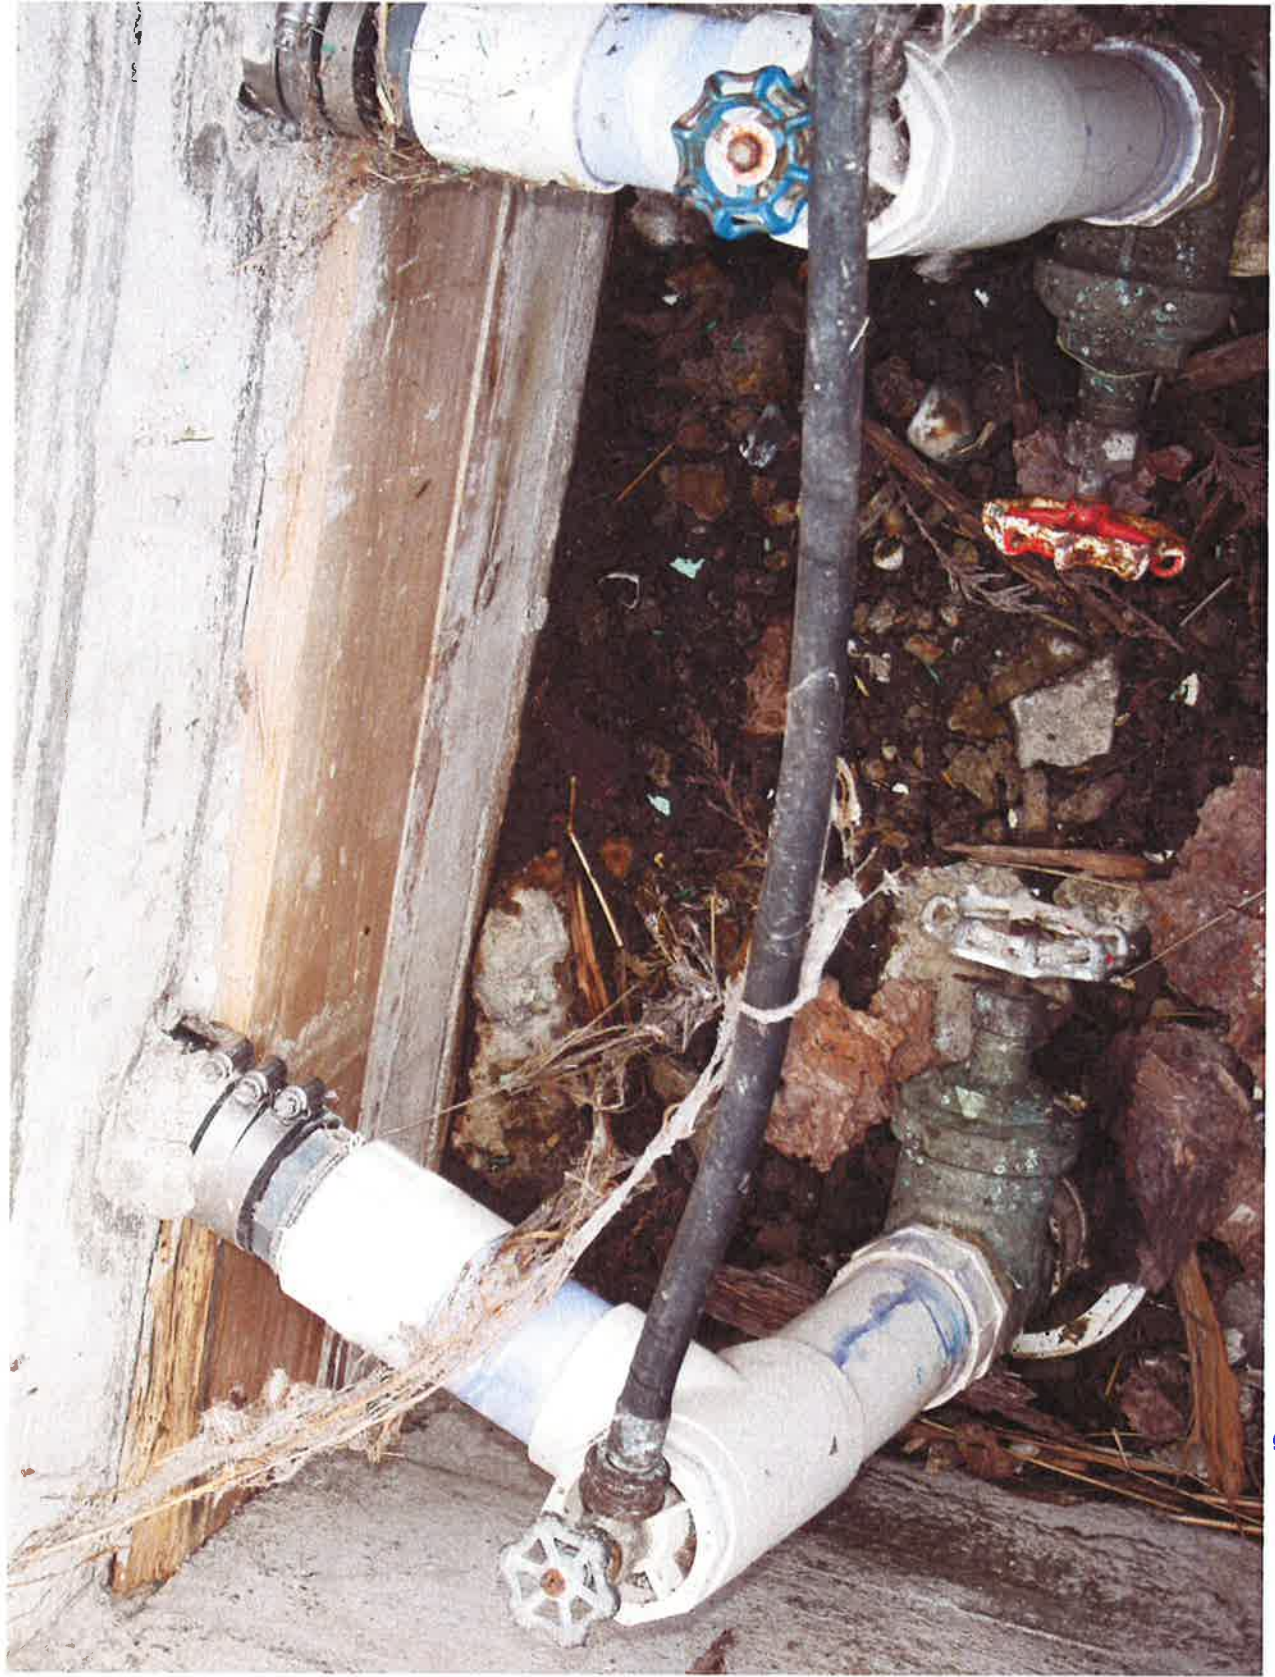
→ well location Razor Point Improvement District

The RPID water supply system utilizes water obtained from a pumped well upstream of the Gardom Pond Dam. The well water is pumped into two water supply tanks, also located upstream of the dam. A supply pipe is connected to each of the reservoirs, and crosses the dam crest before connecting to a common header pipe on the downstream face of the dam. As noted previously, the two water supply pipes cross through the dam at approximately 0.9 to 1.0 m depth. This is approximately the full supply level of the pond. Both pipes were installed in the same trench, and the pipes were reportedly bedded in sand.
