Making a difference...together

LYALL HARBOUR - BOOT COVE WATER LOCAL SERVICE 2014 ANNUAL REPORT AUGUST 15, 2015

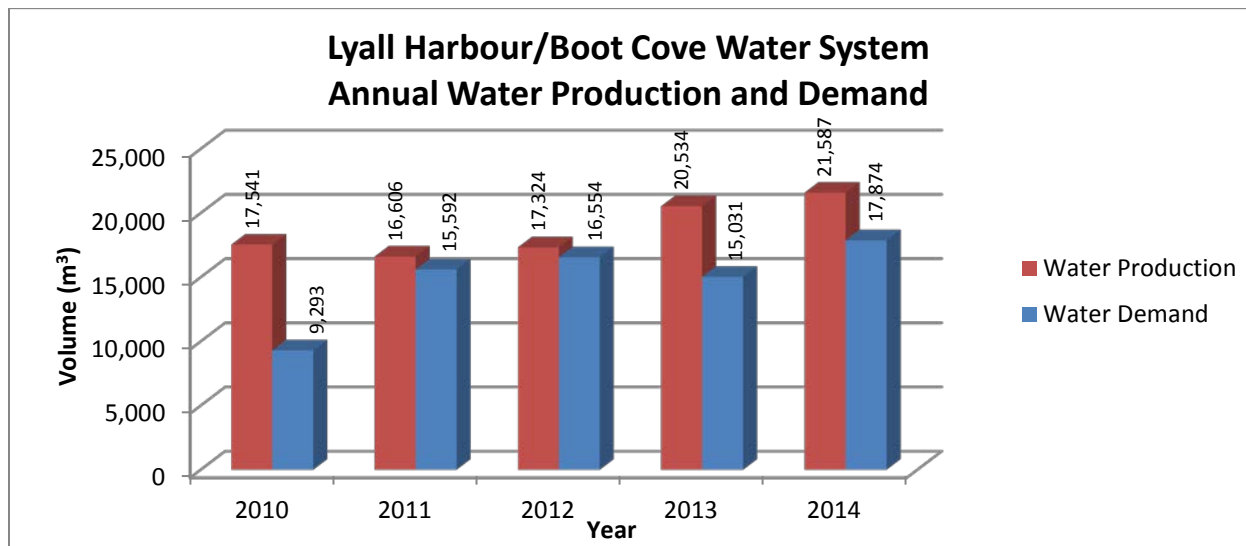
A total of 17,874 m³ was consumed by individual customers of the Lyall Harbour/Boot Cove Water Service in 2014, which is 19% more than the previous year and 14% more than the previous three year average. The annual water production and the annual water demand from 2010 to 2014 are shown in **Figure 1** below.

Figure 1 – Lyall Harbour/Boot Cove Water System Annual Water Production and Demand

The difference between annual water production and annual customer demand is referred to as non-revenue water and can include; water system leaks, water system maintenance and operational use (e.g. water main flushing), potential unauthorized consumption, backwashing of filtration equipment and fire-fighting use.

The 2014 non-revenue water represents about 17% of the total water production for the service area. Through the operation of the water system, the Capital Regional District (CRD) staff has and will continue to monitor water production and customer demand in an effort to identify and mitigate any water loss.

Referring to Figure 1, it should be noted that in 2010, the customer water meters were in progress of being installed and the difference between the water produced and customer demand reflects that not all water delivered to the customers was recorded.

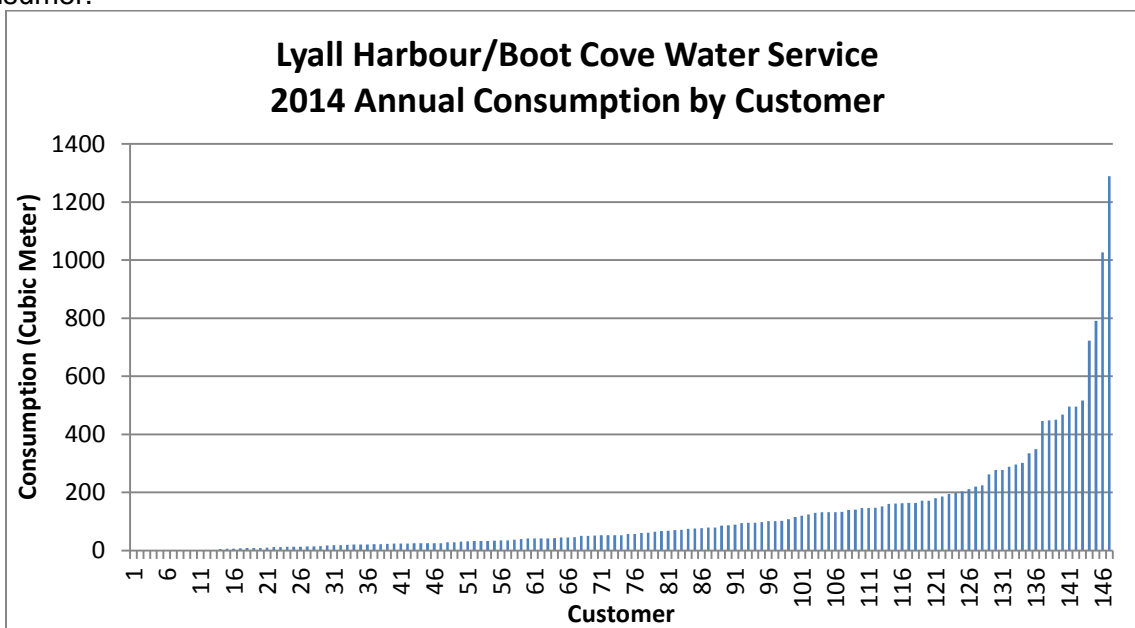
Individual 2014 water demand for each customer connected to the water service is detailed in **Figure 2**. It is important to note the highest consumption customer identified in the chart below was the result of a leak that occurred during the fourth quarter billing period. This leak was brought to the customer's attention by Operations Staff as a result of looking for potential water system leaks. The customer immediately made the necessary repairs. The second highest consumer was not identified as having a leak. This particular customer is a high seasonal water consumer.

Figure 2 – Lyall Harbour/Boot Cove Water System 2014 Annual Consumption by Customer

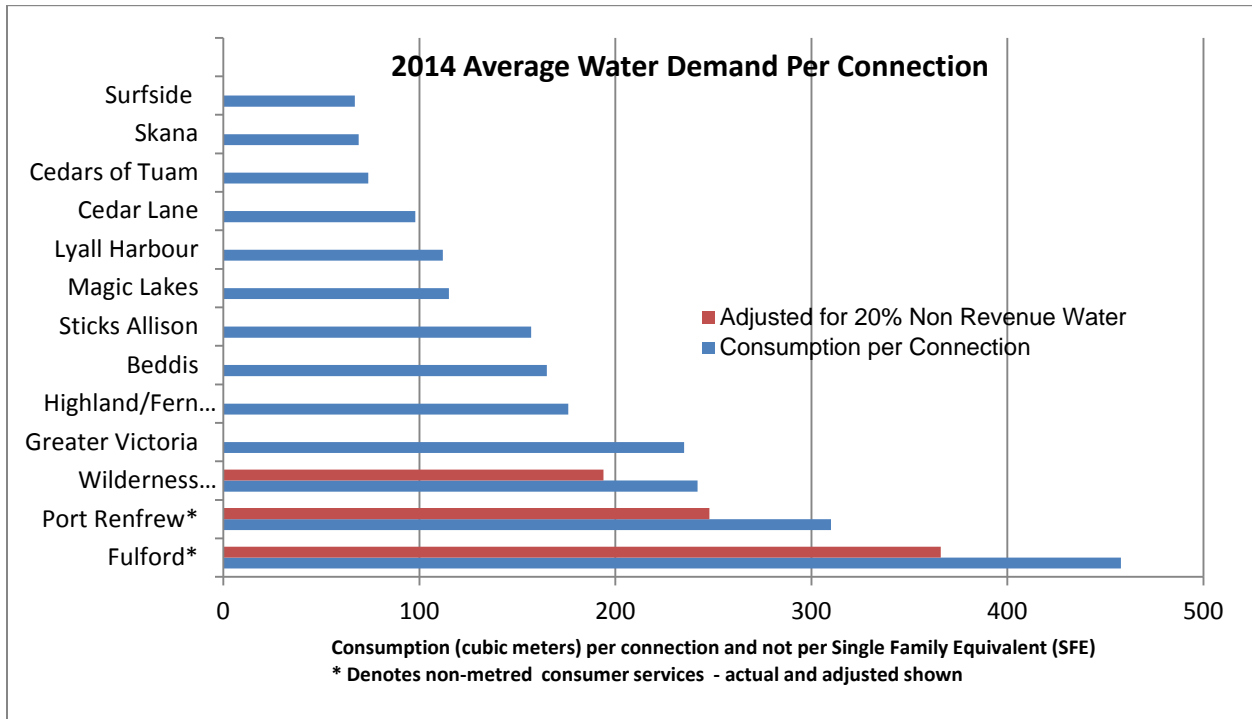
An average water demand by residential service connection for water service areas operated by the CRD is shown in **Figure 3**. This comparison shows that Lyall Harbour/Boot Cove customers, on average, use approximately half of what Greater Victoria area customers use on an annual basis. This is likely the result of seasonal residential customer use and awareness of the limited raw water supply.

Figure 3 – 2014 Average Water Demand per Connection

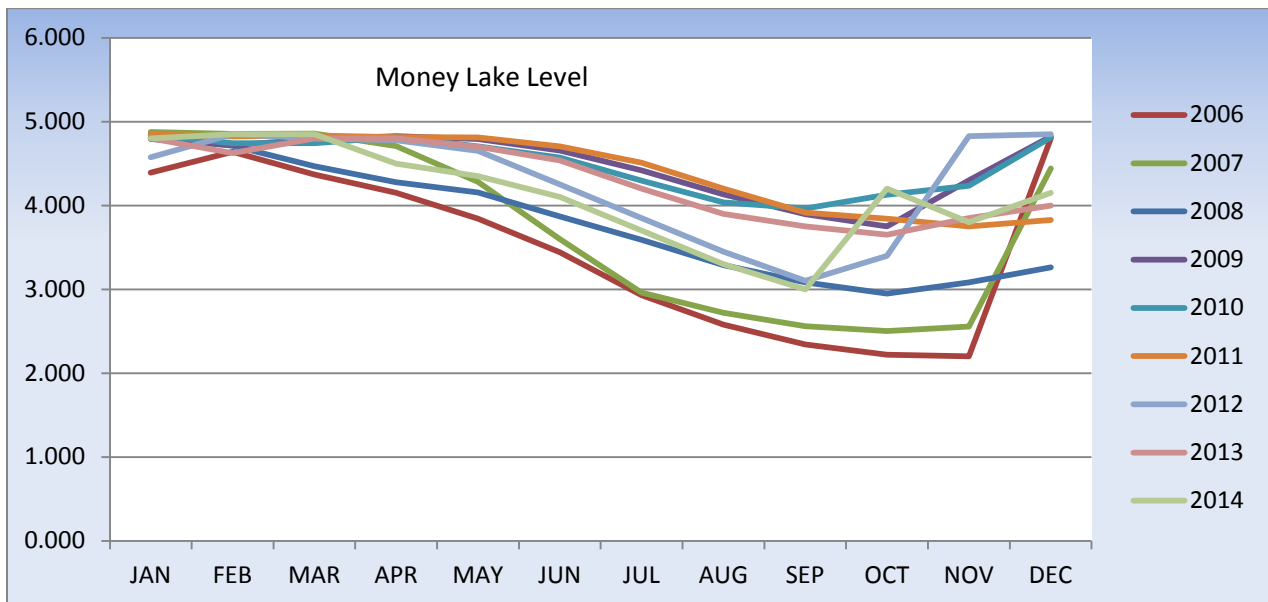
The water surface level of Money Lake is routinely measured and recorded and the lake level has been maintained at a higher level, especially during the summer months, since about 2008 when the seepage collection and return system was installed.

Figure 4 – Money Lake Level (meters)
