# Lyall Harbour – Boot Cove Water System

2017 Annual Report

CRD | Drinking Water

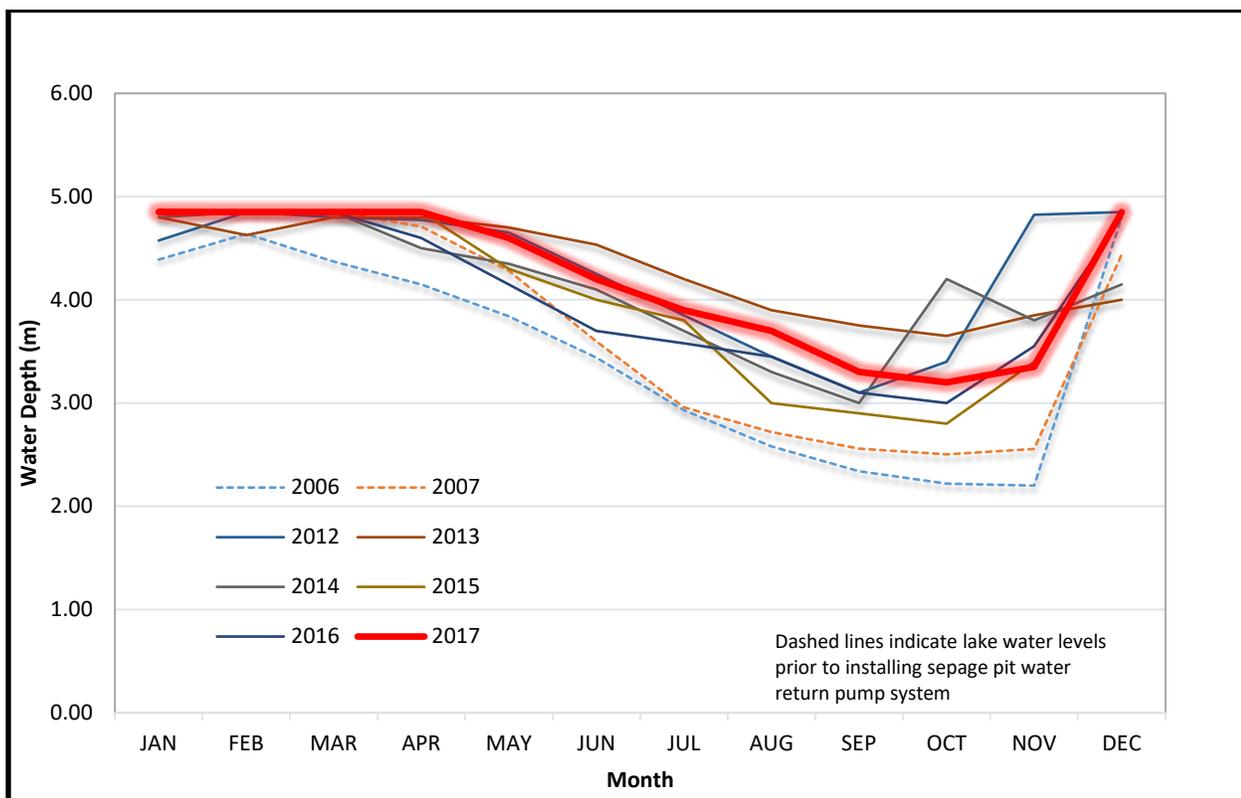
**Figure 2: Lyall Harbour/Boot Cove - Money Lake Monthly Water Level**

Referring to Figure 2 below, Money Lake surface water supply monthly water levels are highlighted for 2017. Water supply levels for the year are within historical limits. It is important to note that water supply levels in Money Lake, prior to 2008, were historically lower during the summer period. An upgrade to mitigate the low water levels involved the installation of a groundwater seepage spring recirculation pumping system. Excess water from the seepage spring is pumped back to Money Lake in order to keep the Lake as full as possible. The groundwater seepage spring water levels is not monitored; seepage spring weekly flow rate is monitored to confirm production rate. The seepage spring typically provides 100% of the winter water system demand for the community.

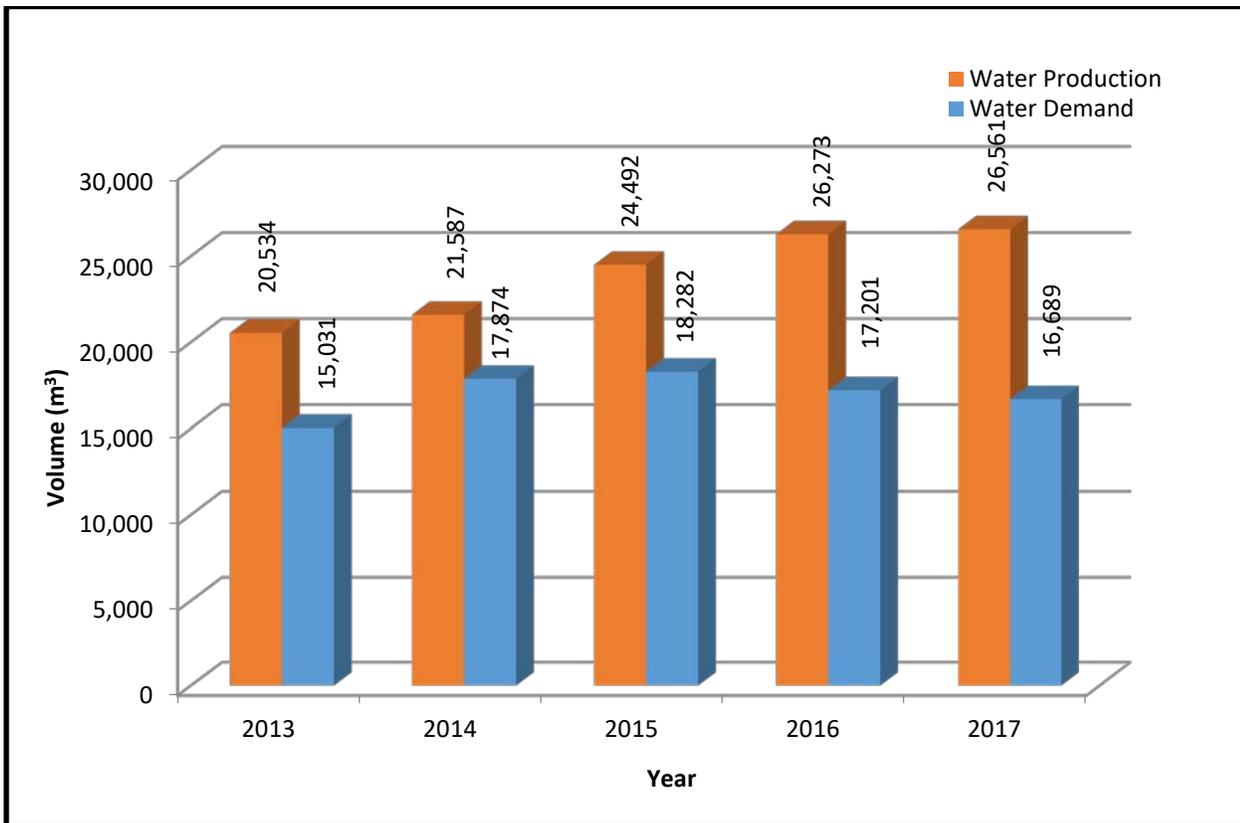
**Figure 3: Lyall Harbour/Boot Cove Water System Annual Water Production and Demand.**

Referring to Figure 3, 26,561 cubic meters of water were extracted (water production) from the seepage spring and Money Lake Reservoir in 2017; a 1% increase from the previous year and 21% increase from the 5 five year average. Water demand (customer water billing) for the service totaled 16,689 cubic meters of water; a 3% decrease from the previous year and a 2% decrease from the five year average.

The difference between annual water production and annual customer demand is referred to as non-revenue water and can include water system leaks, water system maintenance and operational use (e.g. water main flushing, filter system backwashing), potential unauthorized use and fire-fighting use. As previously noted, operational water use increased beginning in 2013 when the new water treatment plant became operational.

The 2017 non-revenue water represents about 37% of the total water production for the service area. However, almost 20% of the non-revenue water can be attributed to operational use which includes a significant volume of water flushed from the system in order to keep chlorine residuals at acceptable levels at the extremities of the water system. Therefore, the non-revenue water associated with system losses is approximately 17% which is considered typical for most water systems the size of Lyall Harbour/Boot Cove.

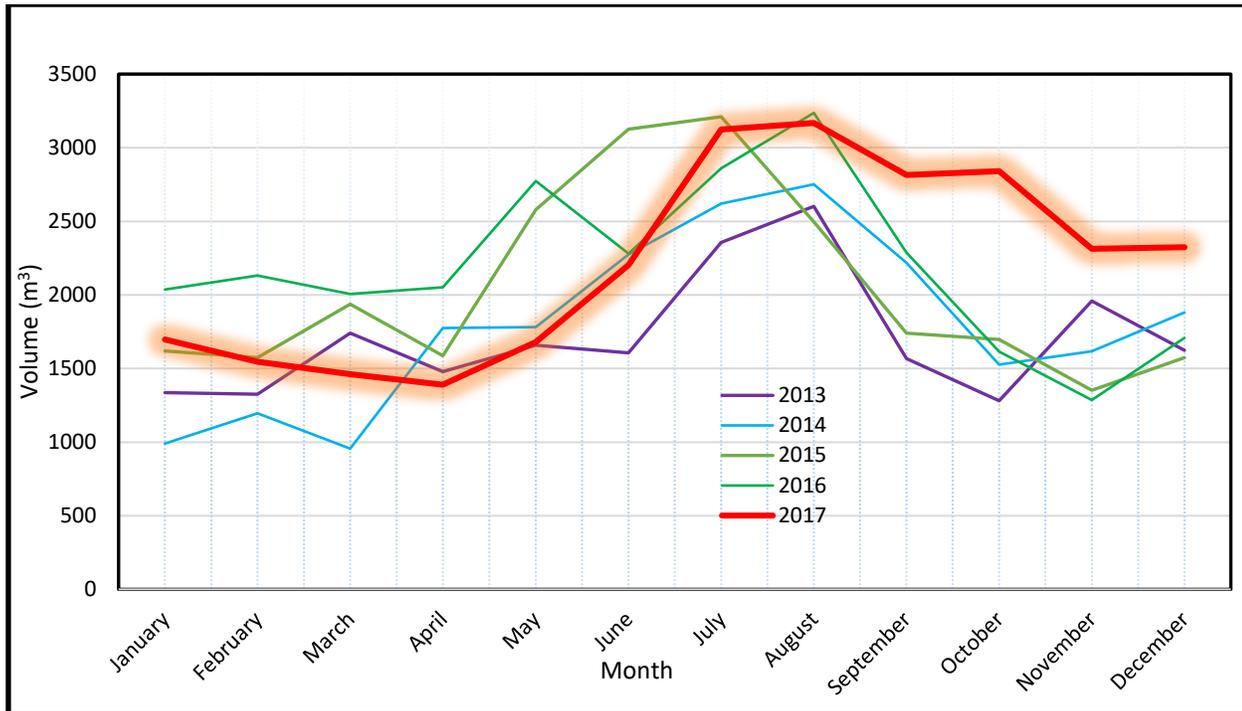
**Figure 4: Lyall Harbour/Boot Cove Water Service Monthly Water Production.**

Figure 4 below illustrates the monthly water production for 2017 along with the historical water production information. The monthly water production trends are typical for small water systems such as the Lyall Harbour/Boot Cove water system. Water production during the last quarter of 2017 is higher than average is the result of:

- water system leaks that were identified and subsequently repaired.
- an increase in water system flushing activities at the extremities in order to maintain minimum free chlorine residuals.
