The Lyall Harbour/Boot Cove water system is primarily comprised of:

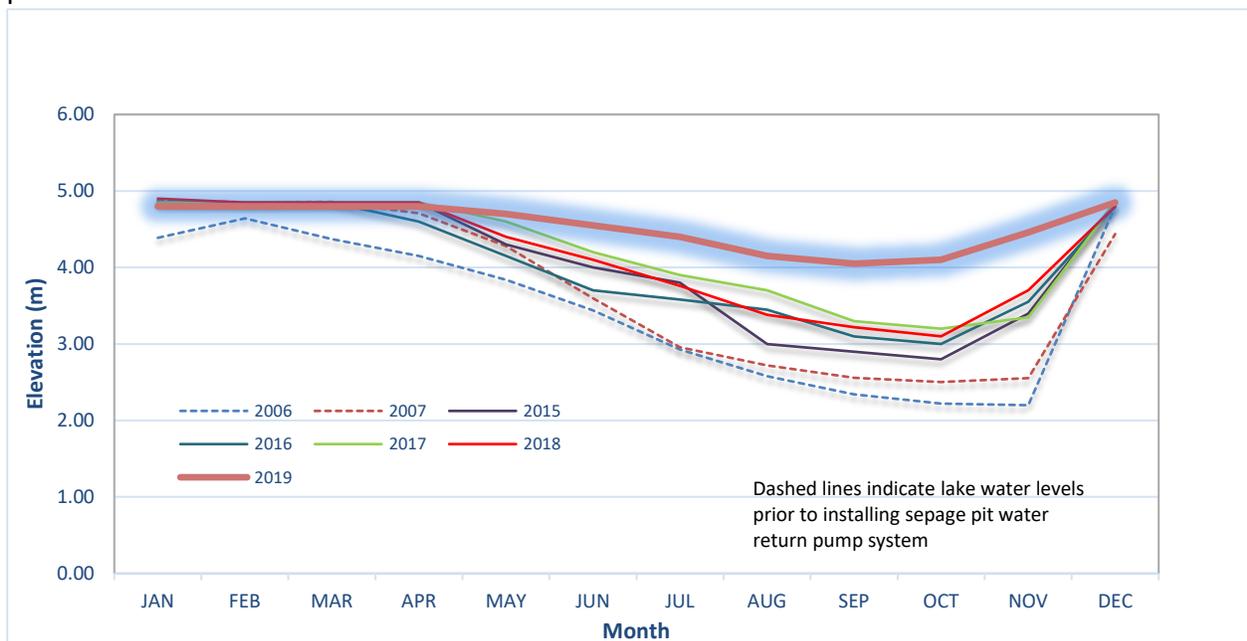
Referring to Figure 2 below, Money Lake monthly water levels are highlighted for 2019. Water supply levels for the year are higher in 2019 than historical limits. It is important to note that water supply levels in Money Lake, prior to 2008, were historically lower during the summer period. An upgrade to mitigate the low water levels involved the installation of a groundwater seepage spring recirculation pumping system. Excess water from the seepage spring is pumped back to Money Lake in order to keep the Lake as full as possible. The groundwater seepage spring water level is not monitored; however the seepage spring weekly flow rate is monitored to confirm production rate. The seepage spring typically provides 100% of the winter water system demand for the community. However Money Lake water is used periodically to supplement seepage spring flows, typically during the dry period.

Figure 2: Money Lake Monthly Water Level

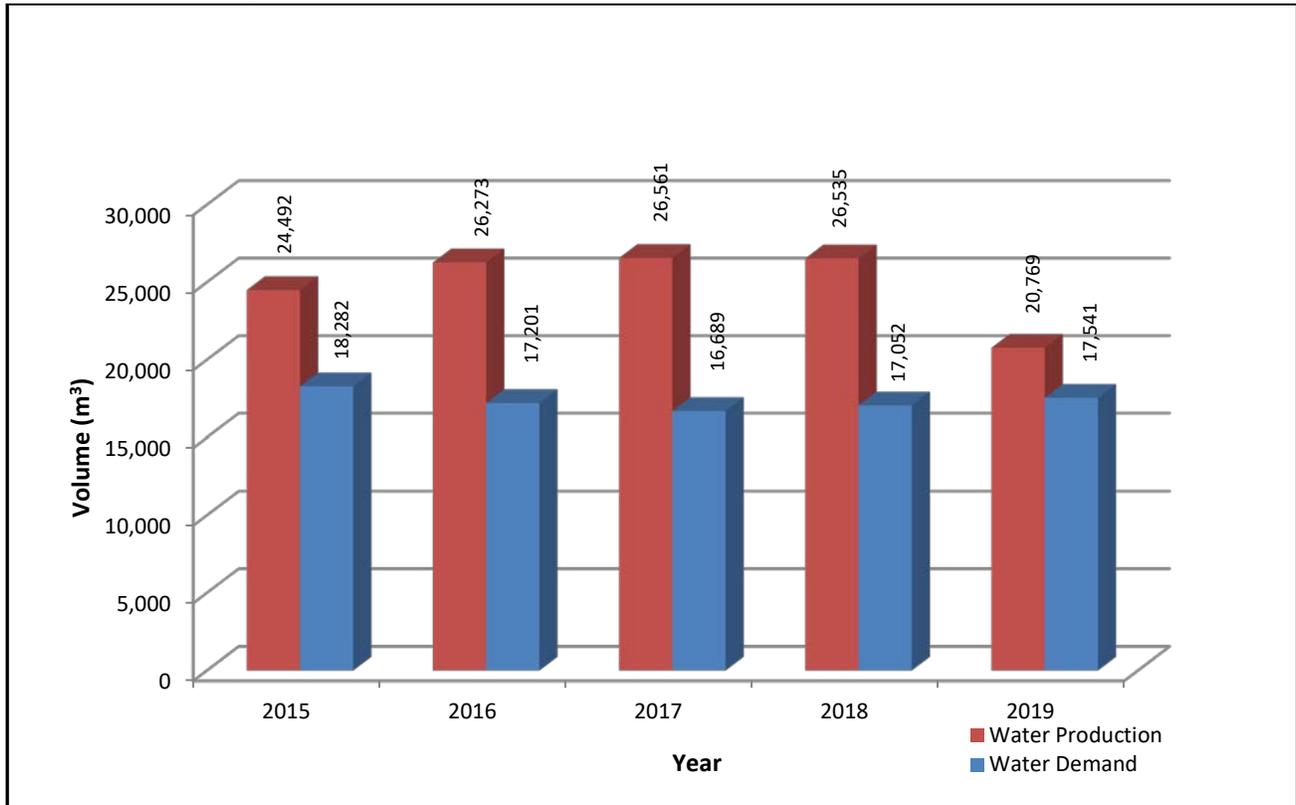
Referring to Figure 3, 20,769 cubic meters of water was extracted (water production) from the seepage spring and Money Lake Reservoir in 2019; a 22% decrease from the previous year and a 17% decrease from the 5 five year average. Water demand (customer water billing) for the service totaled 17,541 cubic meters of water; a 3% increase from the previous year and a 1% increase from the five year average. The lower water production is partially the result of water system leak repairs.

Figure 3: Lyall Harbour/Boot Cove Water System Annual Water Production and Demand.

The difference between annual water production and annual customer demand is referred to as non-revenue water and can include water system leaks, water system maintenance and operational use (e.g. water main flushing, filter system backwashing), potential unauthorized use and fire-fighting use.

The 2019 non-revenue water (3,228 cubic meters) represents about 16% of the total water production for the service area. However, almost 10% of the non-revenue water can be attributed to operational use which includes a water main flushing to keep chlorine residuals at acceptable levels at the extremities of the water system and water treatment filtration system backwashing activities. Therefore, the non-revenue water associated with system losses is approximately 6% which is considered acceptable for small water systems.

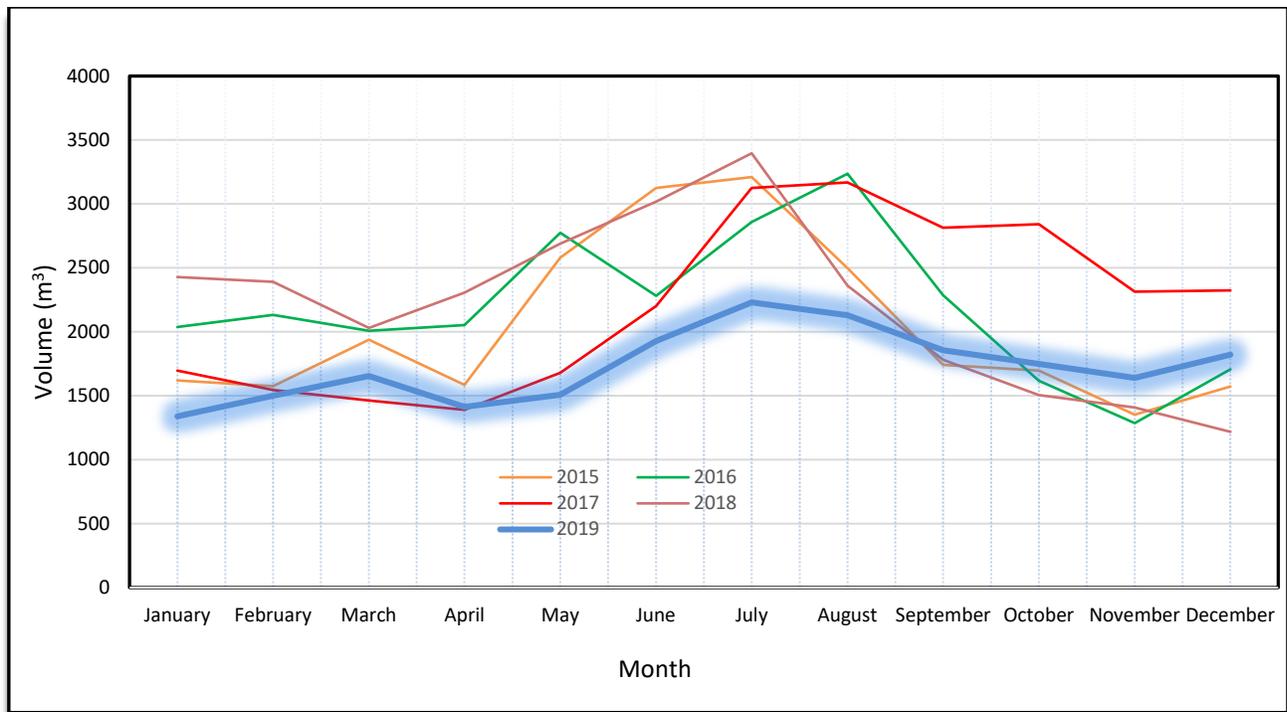
Figure 4 illustrates the monthly water production for 2019 along with the historical water production information. The monthly water production trends are typical for small water systems such as the Lyall Harbour/Boot Cove water system.

Figure 4: Lyall Harbour/Boot Cove Water Service Monthly Water Production.
