**THURBER** ENGINEERING LTD.

**OAK BAY HIGH SCHOOL REPLACEMENT  
GEOTECHNICAL INVESTIGATION FOR  
DESIGN-BUILD PROPONENTS**

This report presents the results of the geotechnical investigations conducted to date at the site of the proposed Oak Bay High School Replacement in Oak Bay, BC. The recent investigation was completed for the Greater Victoria School District (GVSD) #61 to supplement the earlier preliminary investigation in order to provide the Design Build (D-B) proponents with geotechnical data across the property to assist in preparation of their bids.

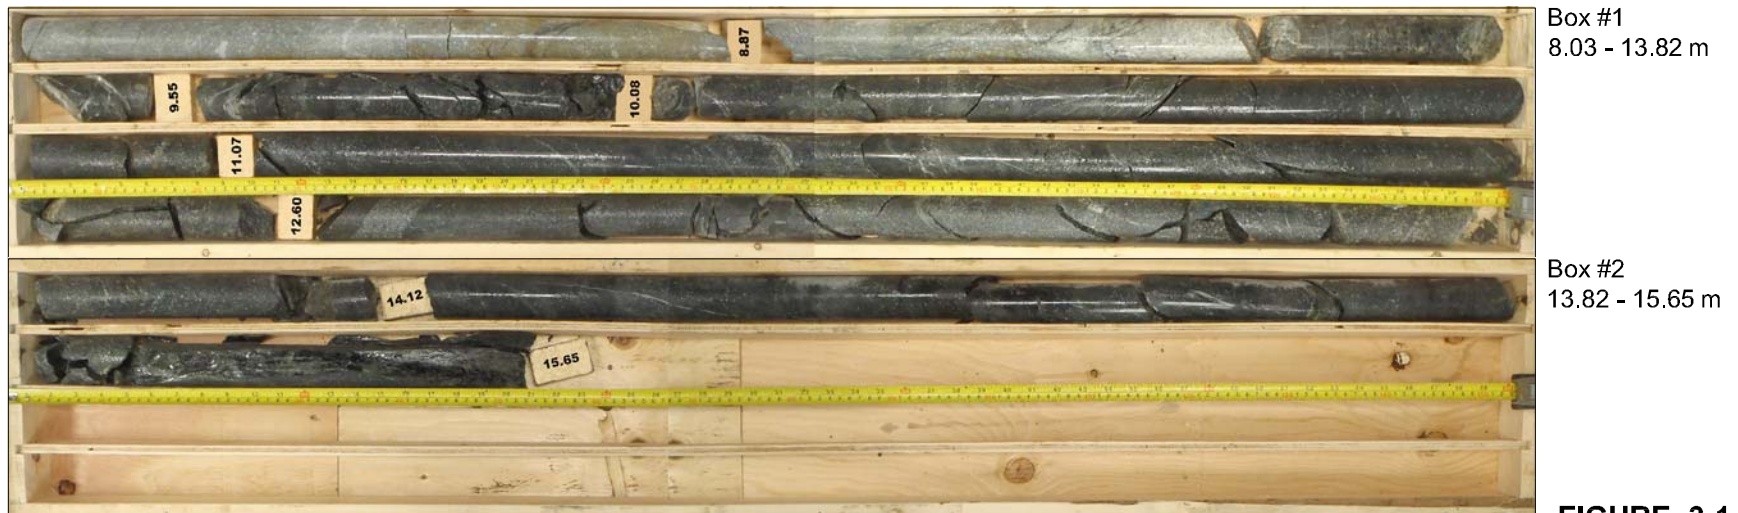
**FIGURE 3-1**

**OAK BAY HIGH SCHOOL REPLACEMENT  
TEST HOLE 12-30; CORE PHOTOS**

The rock core from TH12-30 and TH12-33 was returned to our laboratory and visually logged. The rock type, core recovery and condition, rock quality designation (RQD), degree of weathering, intact rock strength and a description of the structural discontinuities were recorded and are summarized on the attached core logs in Appendix A. Test holes TH12-34, -35 and -37 were probe holes only. These holes were advanced 1 m into bedrock without sampling or testing.

The bedrock was cored at TH12-30 and TH12-33. At TH12-30, the upper 2 m of rock core was logged as quartz diorite. The rock core is solid and has a Rock Quality Designation (RQD) of about 82 to 89%. Two unconfined compression tests on samples from this rock type gave compressive strengths of 69 MPa and 125 MPa which indicates strong to very strong rock. The rock core below the quartz diorite is broken to solid gneiss that generally has an RQD of 60% to 68%. Four unconfined compression tests on samples from this rock type gave compressive strengths of 119 MPa to 251 MPa which indicates very strong to extremely strong rock. A 400 mm thick very broken zone (RQD of 0%) was encountered at the surface of the gneiss.

Rock core photo logs (Figures 3-1 and 3-2) are provided in Appendix A.

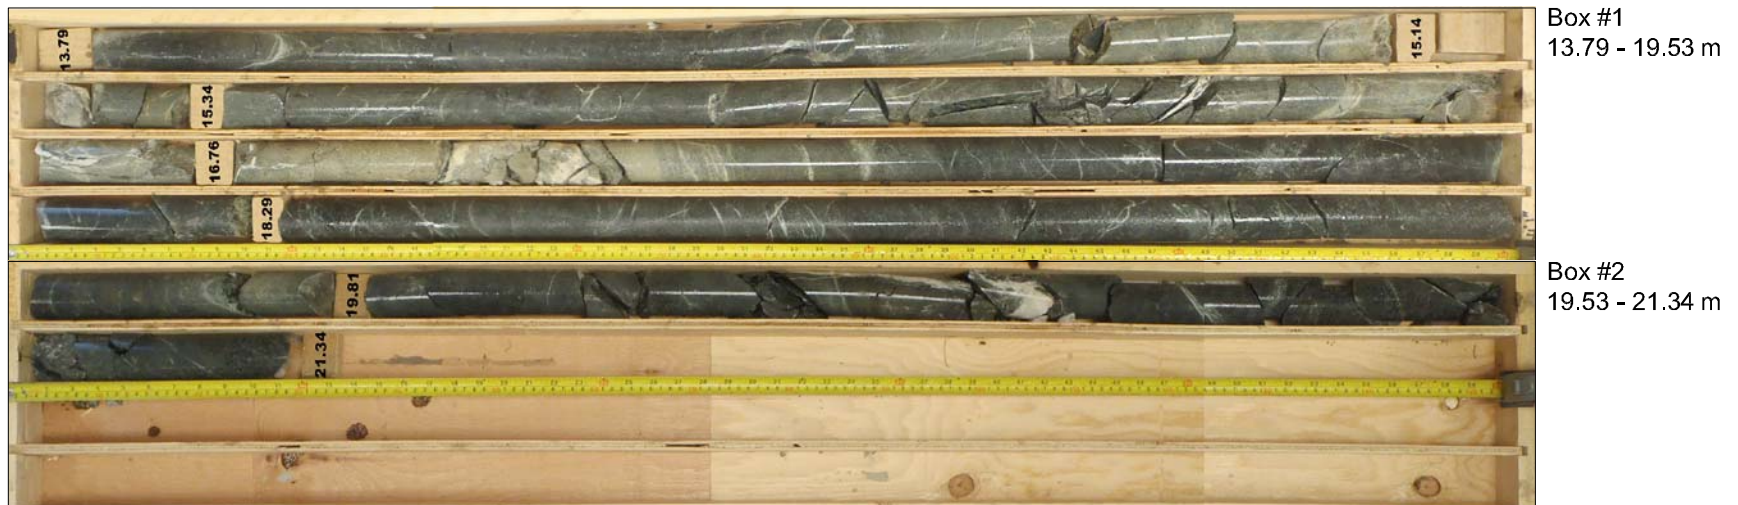
**FIGURE 3-2**

# **OAK BAY HIGH SCHOOL REPLACEMENT TEST HOLE 12-33; CORE PHOTOS**

At TH12-33, the entire core length was logged as gneiss. The rock core is broken to solid with an RQD of 0% to 87%. Four unconfined compression tests on selected samples gave compressive strengths of 130 MPa to 206 MPa which indicates very strong rock. A 200 mm thick very broken zone was encountered at about 3.1 m below the surface of the rock.
