MEMORANDUM

Clover Forcemain Geotechnical Summary

Capital Regional District

November 27, 2017

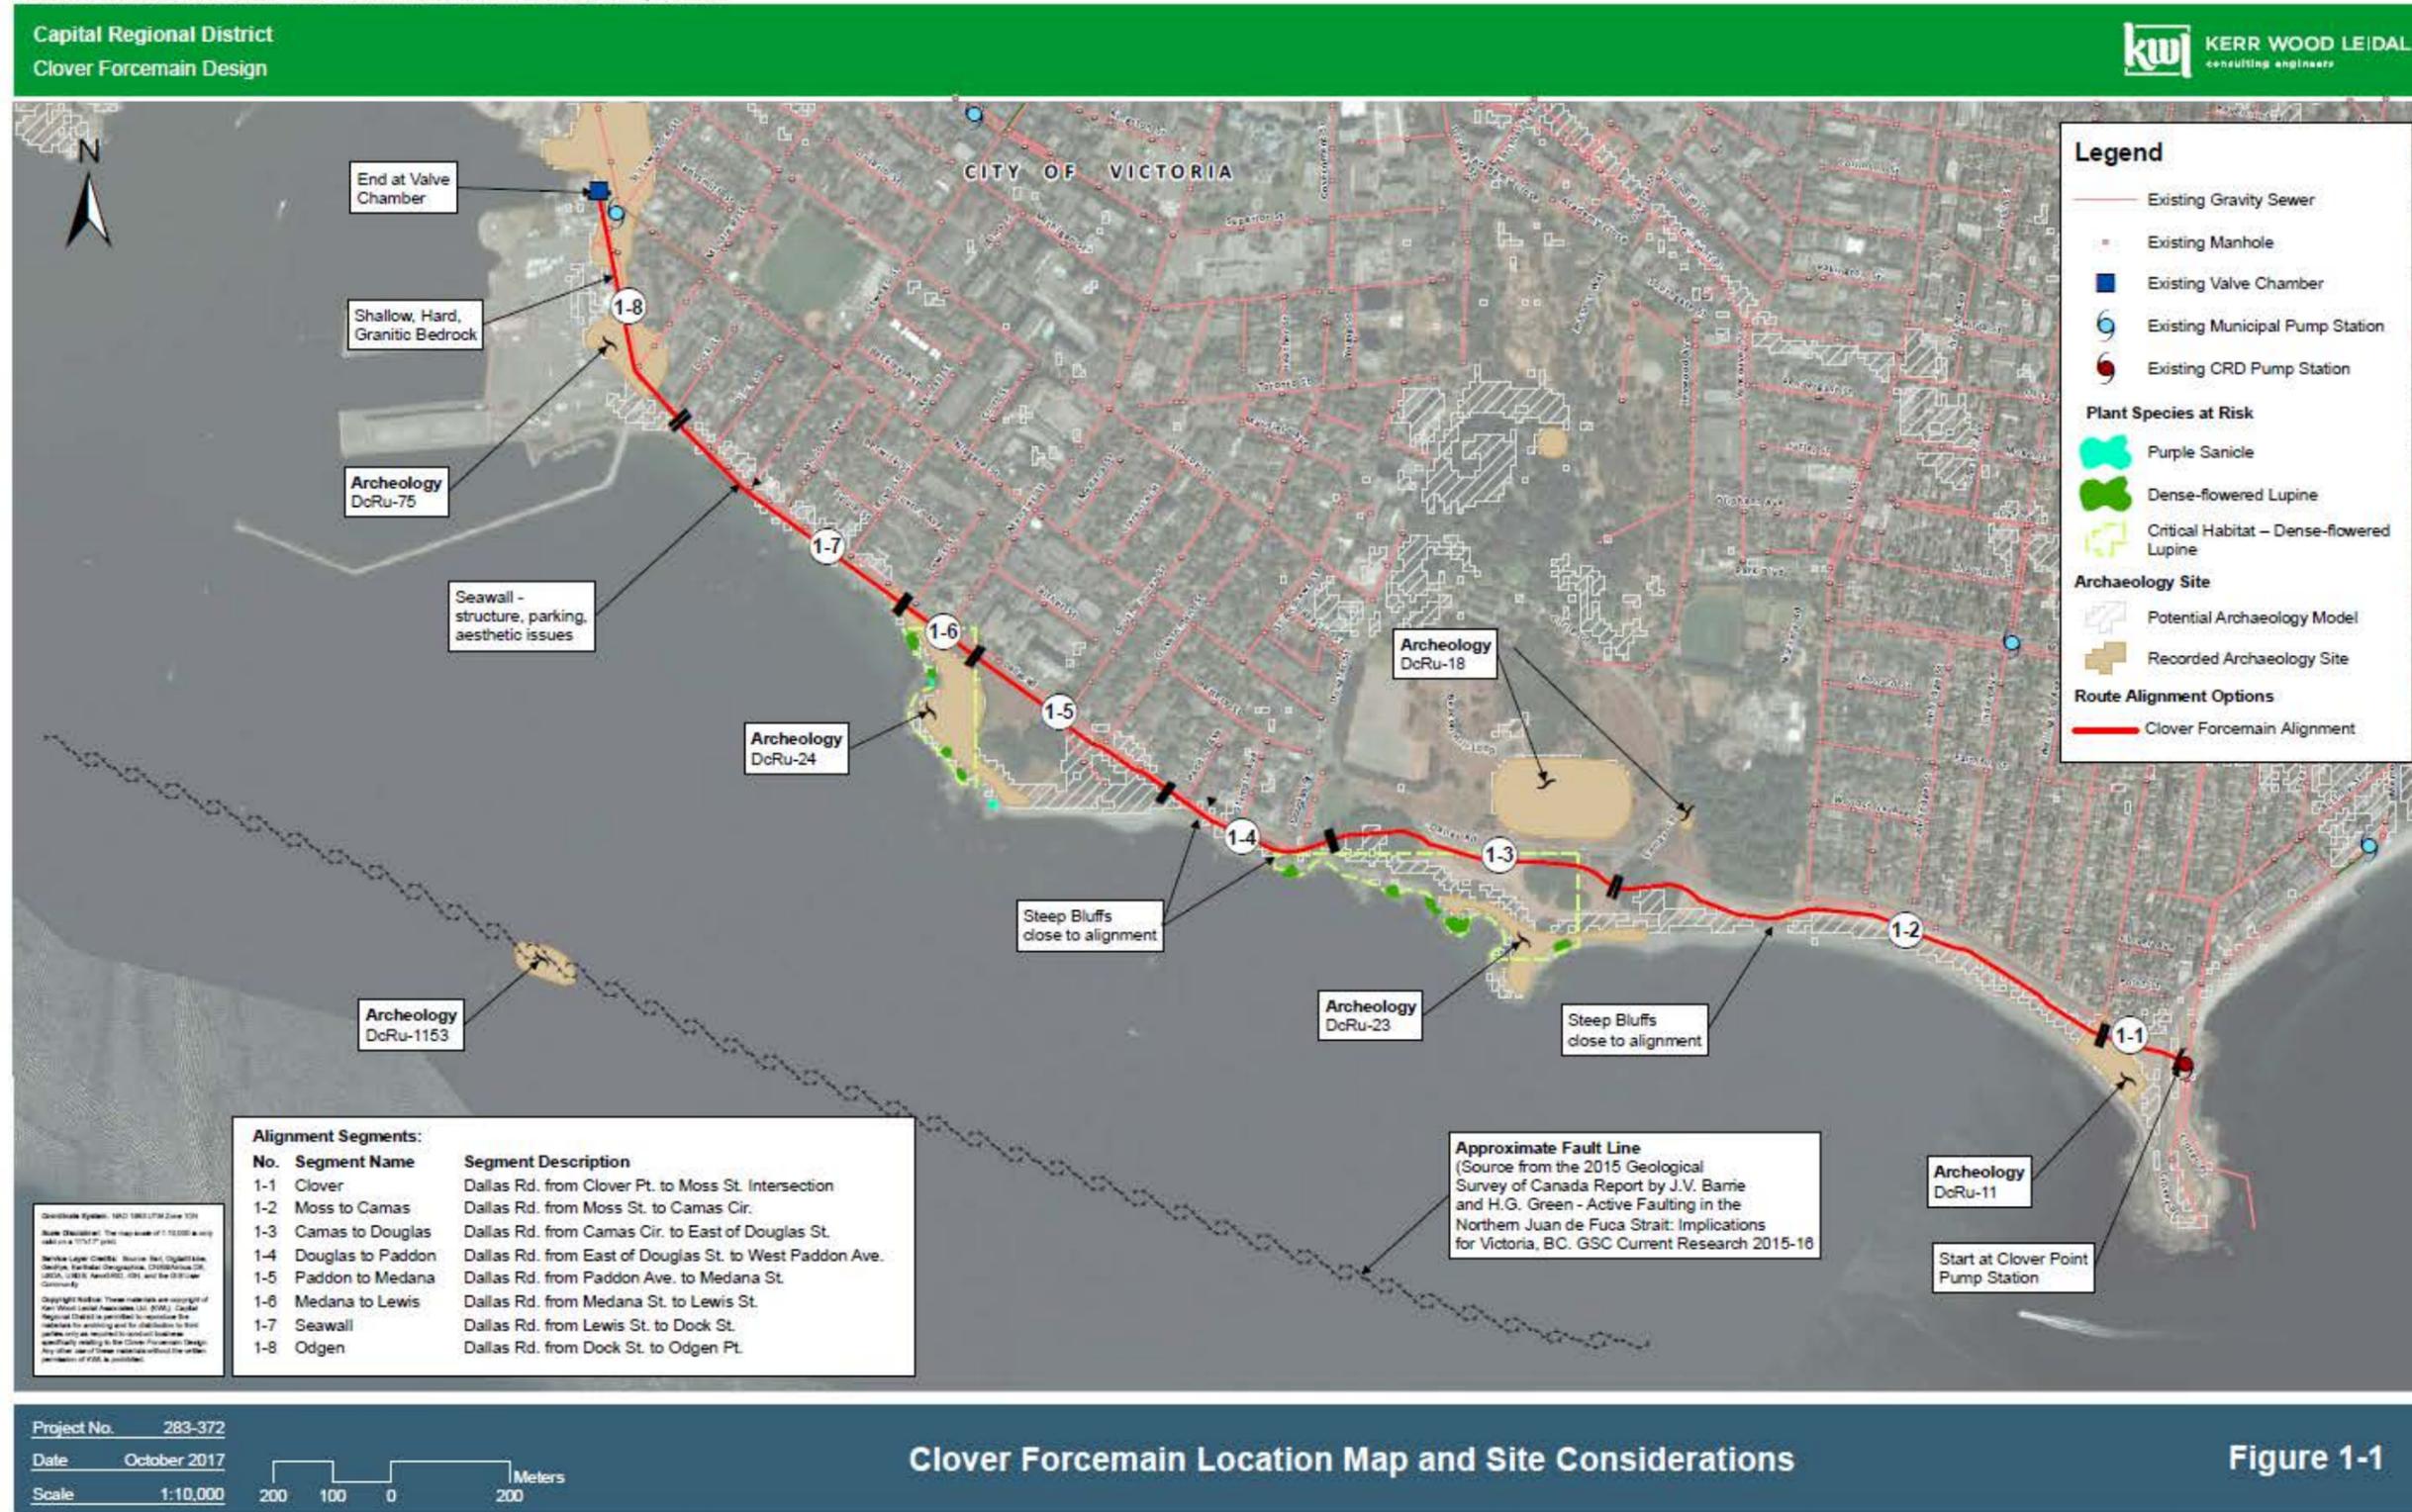
Figure 1-1. Clover Forcemain Location Map and Site Considerations

Figure 1-1 shows the alignment of the Clover Forcemain as developed by the indicative design.

The shoreline along Dallas Road consists of bedrock points and steep south facing bluffs of glacial deposits up to about 20 m high. The bluffs are subject to a number of processes including toe erosion from storm waves, rotational landslides, colluvial creep and sloughing, wind, groundwater discharge, spalling by frost action and human activity that lead to slope regression. Over the last 100 years or so the City of Victoria has attempted to reduce the rate of natural regression through the construction of seawalls, revetments, stairways, retaining walls, drainage improvements, bioremediation (vegetation), off shore reefs and other methods. These bluffs are a prominent feature of the Victoria landscape, requiring that the forcemain be designed and constructed such that the rate of natural regression is unaffected by the forcemain project, and at locations where the existing risk of bluff instability is too high, stabilized to protect the forcemain from the natural regression of the bluff.

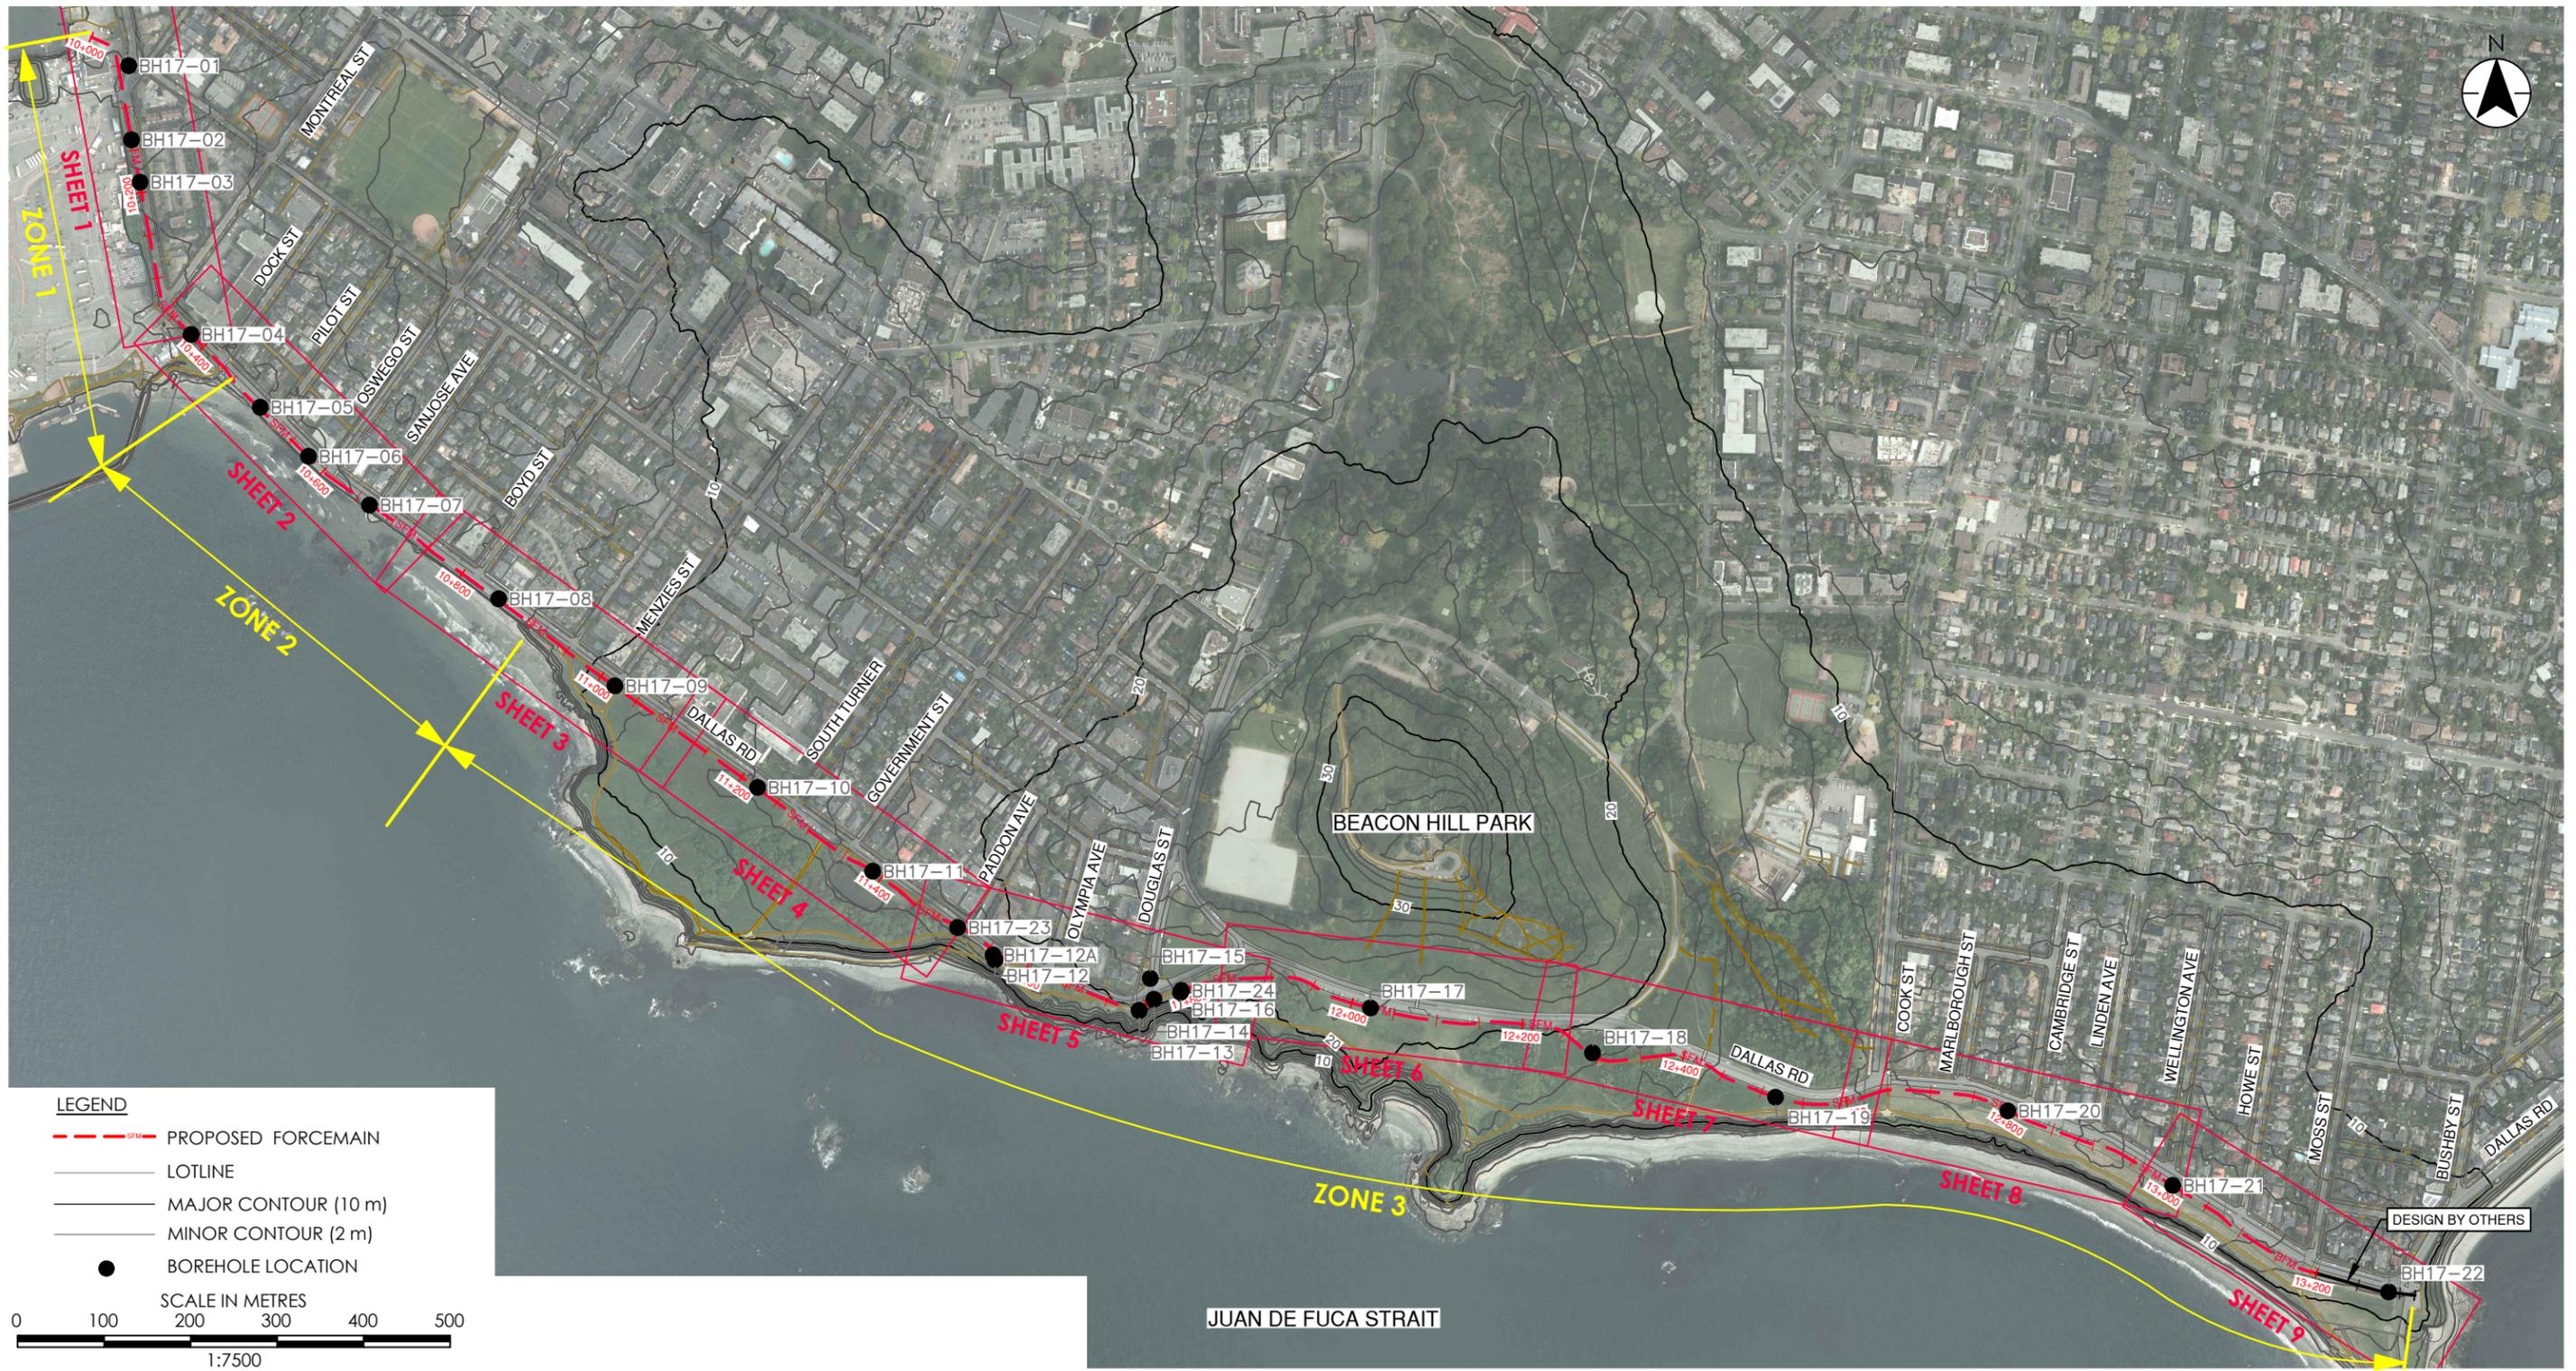
Test hole coordinates were recorded with a handheld Global Positioning System (GPS) device with an accuracy of approximately +/-3 m, with additional measurements taken in the field referenced to fixed landmarks (roadway intersections, curb returns, etc.). Upon plotting the GPS coordinates onto the drawings, if substantial error was noted when compared with the additional measurements to the fixed landmarks, the test hole location was adjusted on the drawing in accordance with the additional field measurements. Test hole elevations were approximated using LiDAR elevation contours provided by the CRD, as well as a topographic survey of the preliminary forcemain alignment sub-contracted by Stantec to McElhanney Surveys. Contour lines are shown on plan drawings included in Appendix B.
