CORE AREA WASTEWATER TREATMENT PROJECT BOARD

**Core Area Wastewater Treatment Project Board
Agenda – April 30, 2020**

**Minutes of a Meeting of the Core Area Wastewater Treatment Project Board
Held Monday April 6, 2020 in the Center for Engagement, 625 Fisgard Street, Victoria, BC**

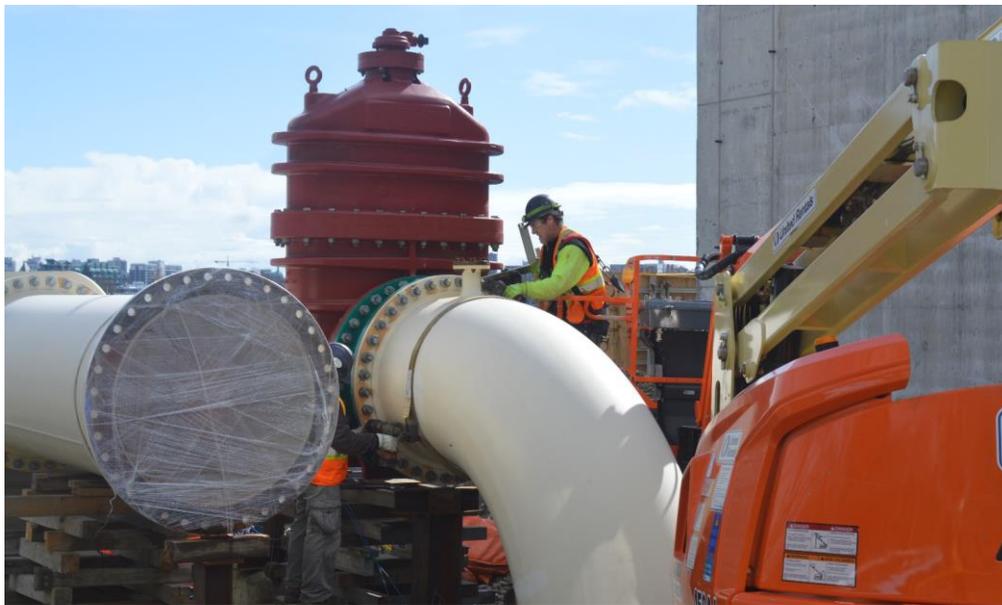
Figure 2– McLoughlin Point Wastewater Treatment Plant - Bolting up valve and fittings at pigging chamber preparing for pressure test.

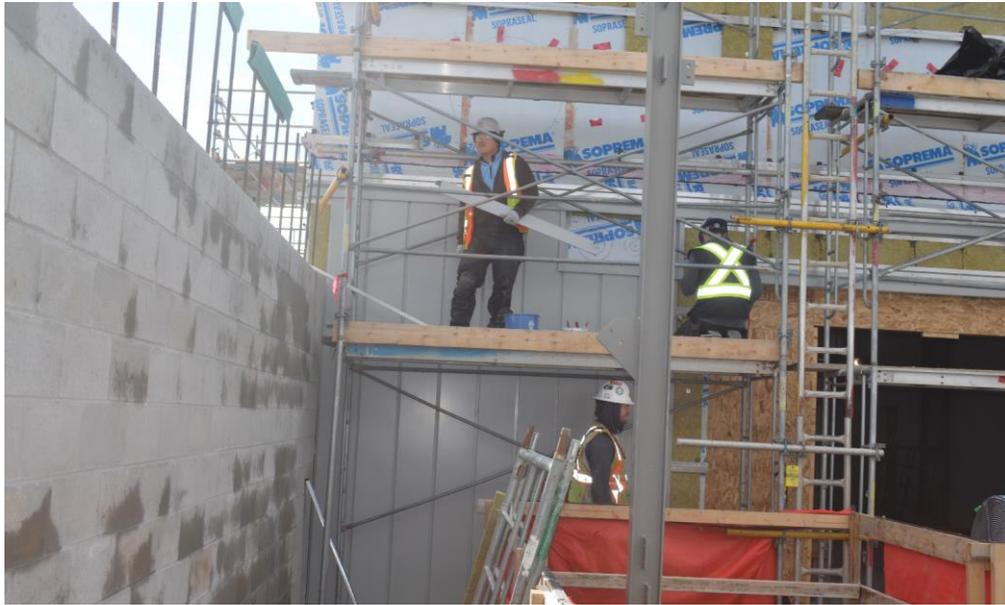
Figure 3- McLoughlin Point Wastewater Treatment Plant- Cladding installation on north end of heat recovery room.

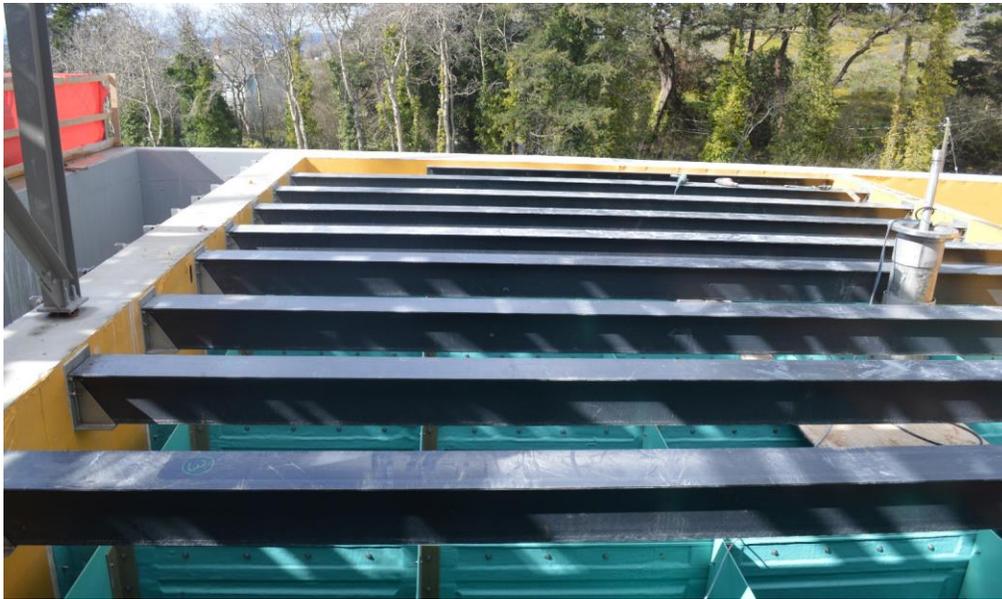
Figure 4- McLoughlin Point Wastewater Treatment Plant- Fibreglass reinforced plastic beams installed and ready for covers at DD3 final clarifier.

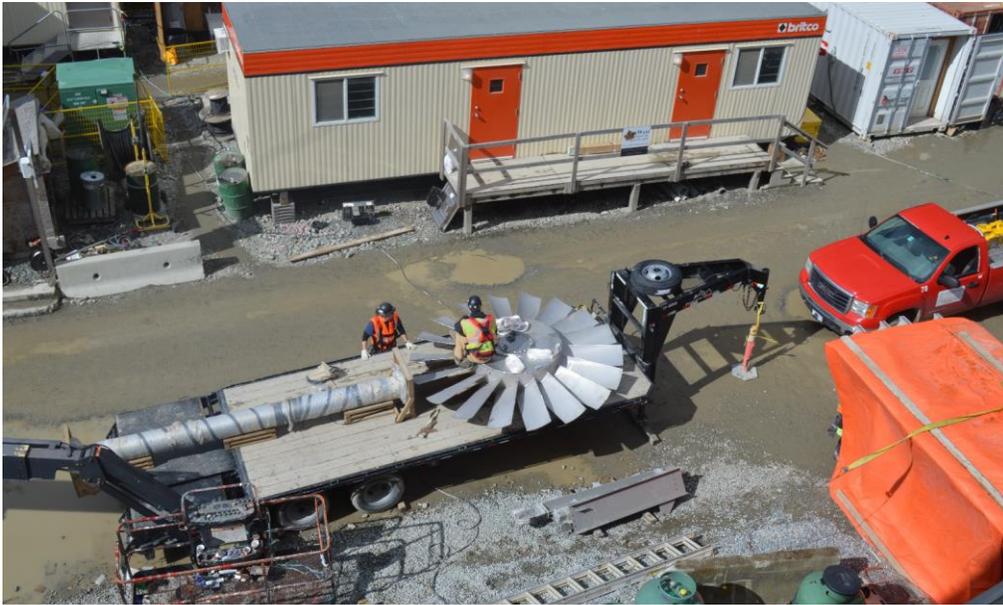
Figure 5- McLoughlin Point Wastewater Treatment Plant- delivery of turbine blade for Densadeg reactor.

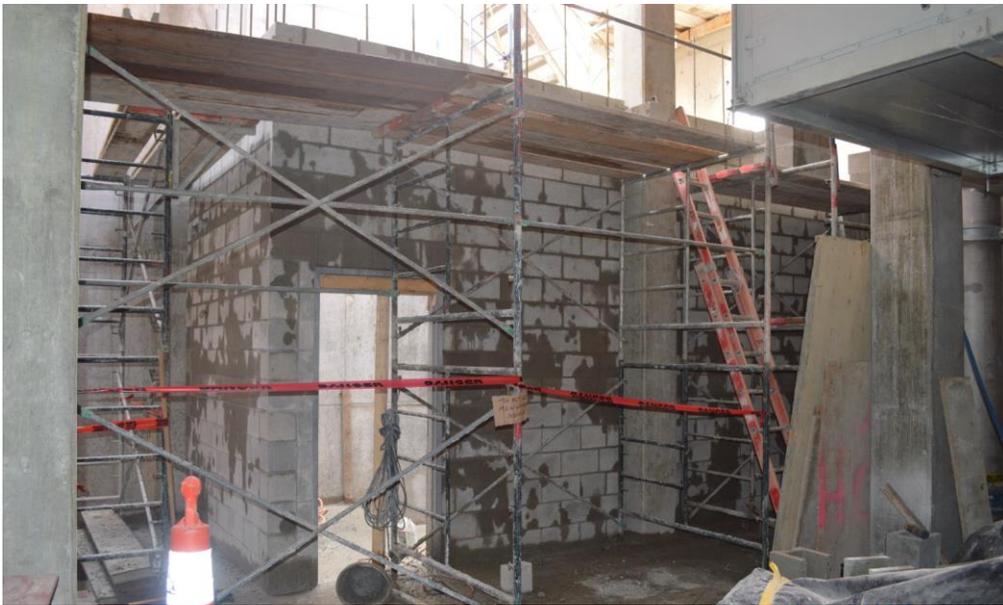
Figure 6- McLoughlin Point Wastewater Treatment Plant- Cinder block installation at northeast stairwell of tertiary treatment structure.

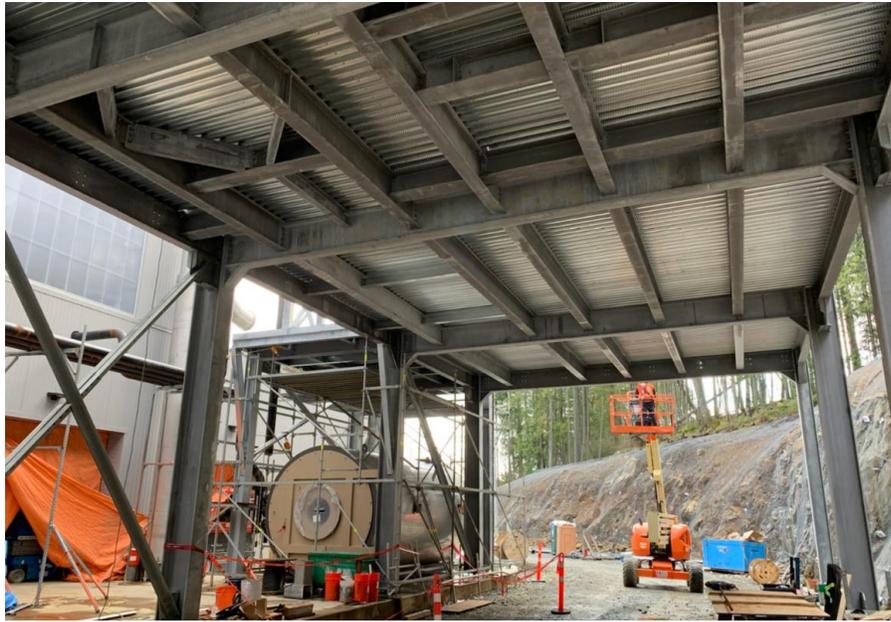
Figure 8– Residuals Treatment Facility- Installation of Q deck roofing system ongoing on product load out structure.

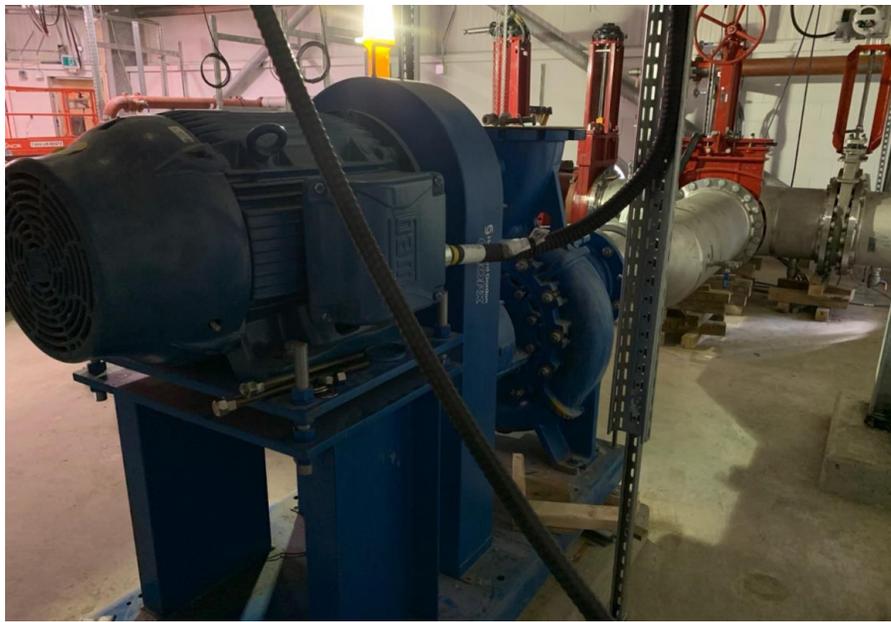
Figure 9– Residuals Treatment Facility- Chopper pumps wired in digester equipment building.

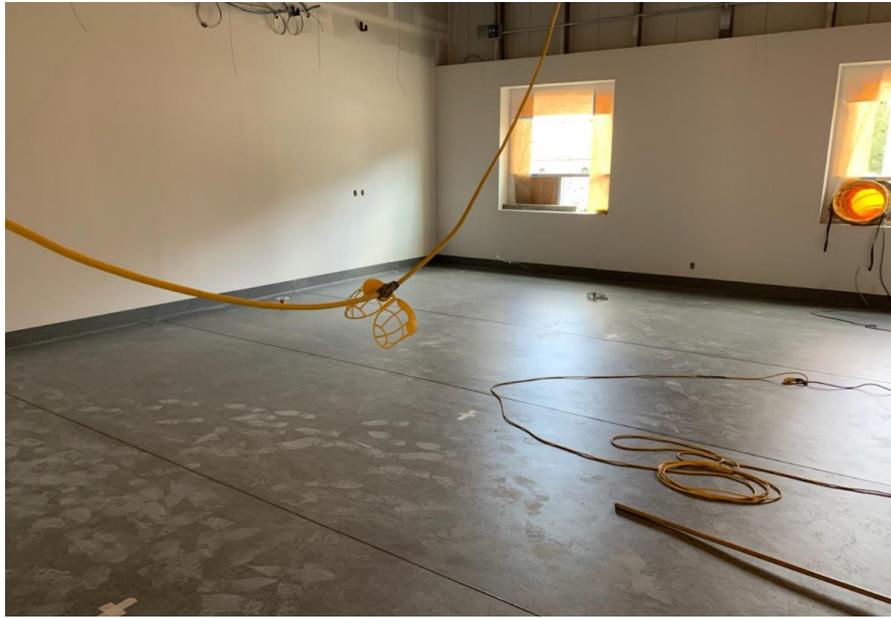
Figure 10- Residuals Treatment Facility – Interior painting and flooring installation ongoing in operations building

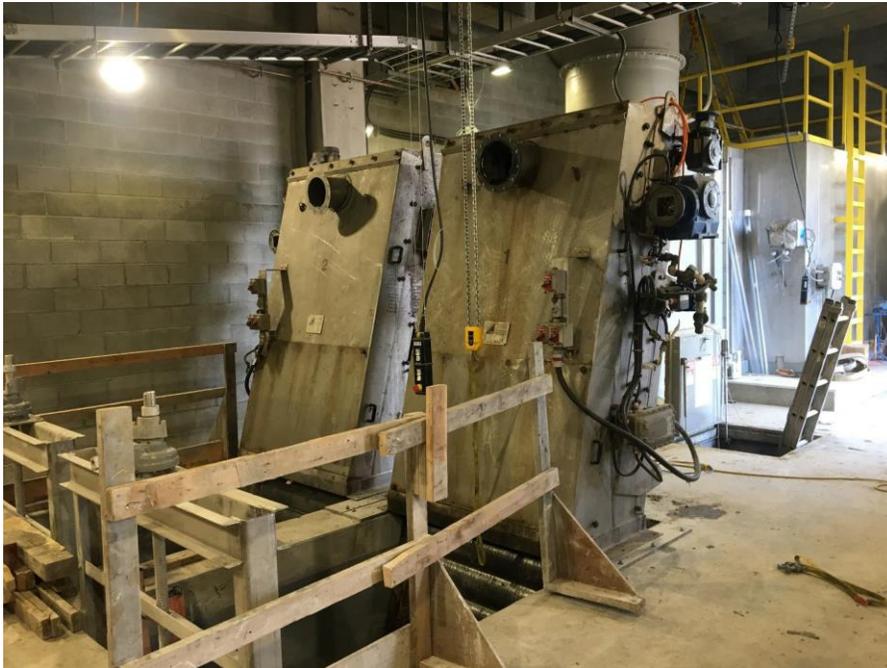
Figure 11–Clover Point Pump Station- Existing screen installation to new inlet channel.

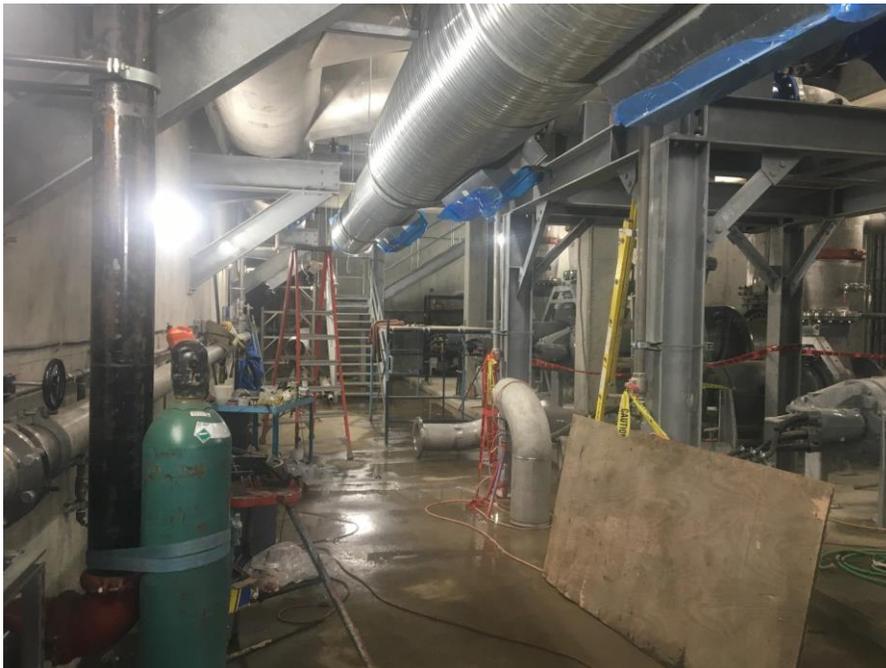
Figure 12–Clover Point Pump Station- Lower pump room

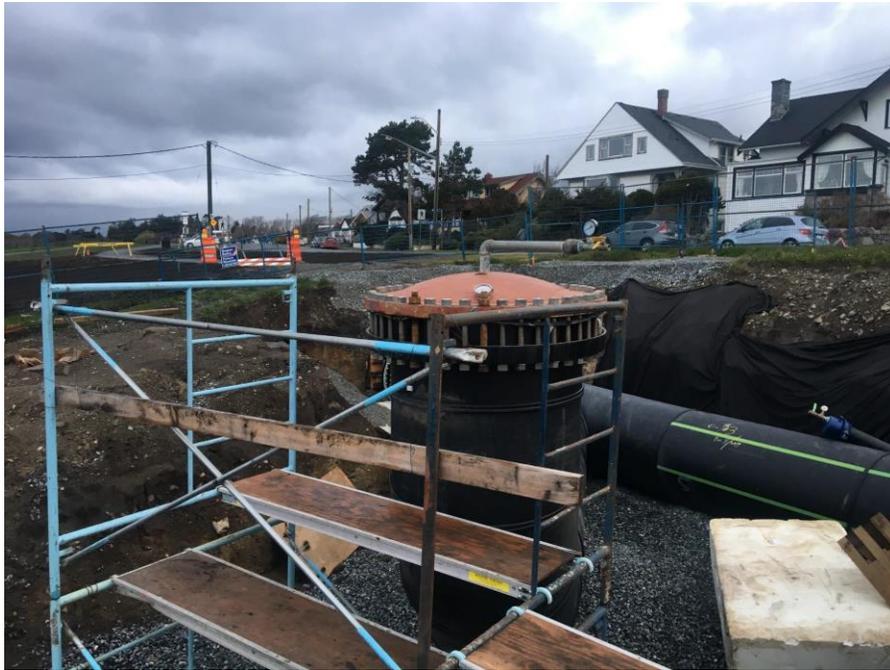
Figure 13- Clover Pump Station – Forcemain pressure test.

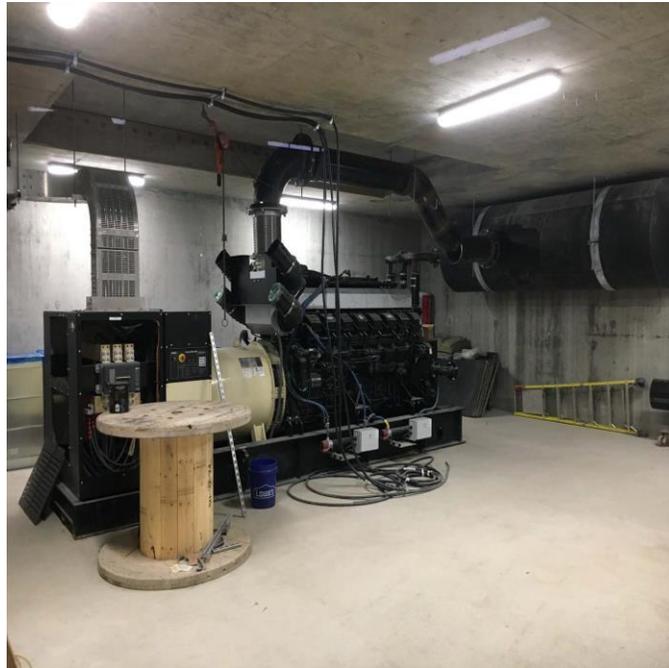
Figure 14-Macaulay Point Pump Station- Genset room progression.

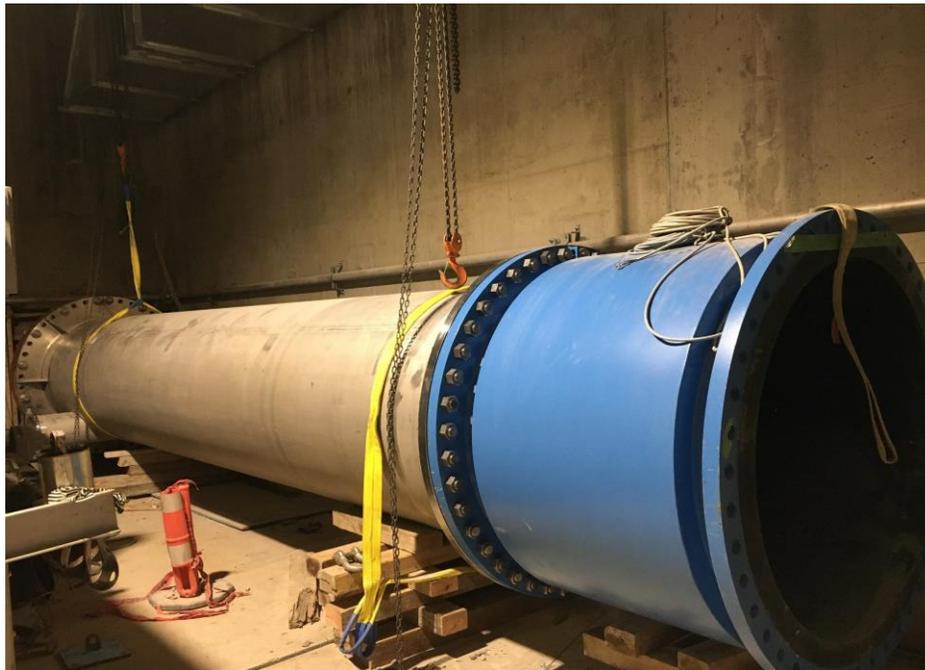
Figure 15-Macaulay Point Pump Station- Stainless steel pipe installation to Forcemain.

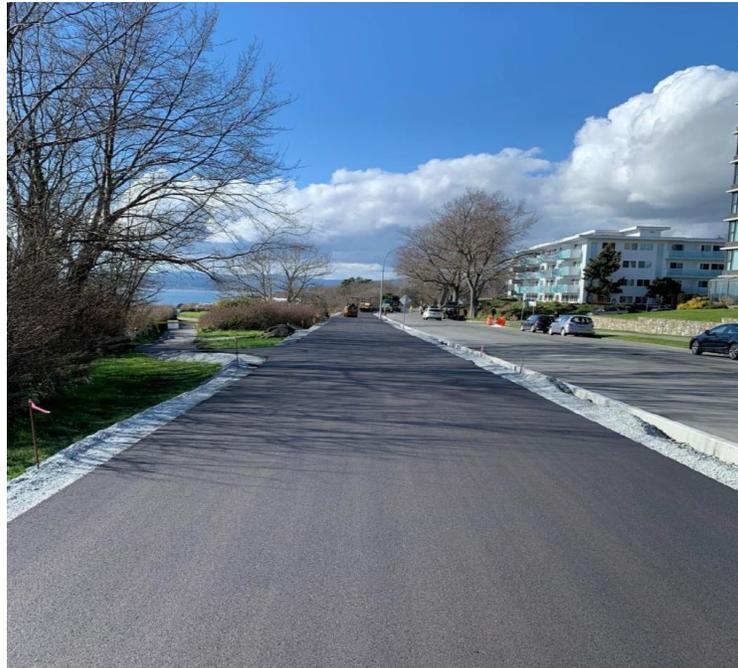
Figure 16–Clover Forcemain- Cycle track/road restoration from Government to Lewis Street.

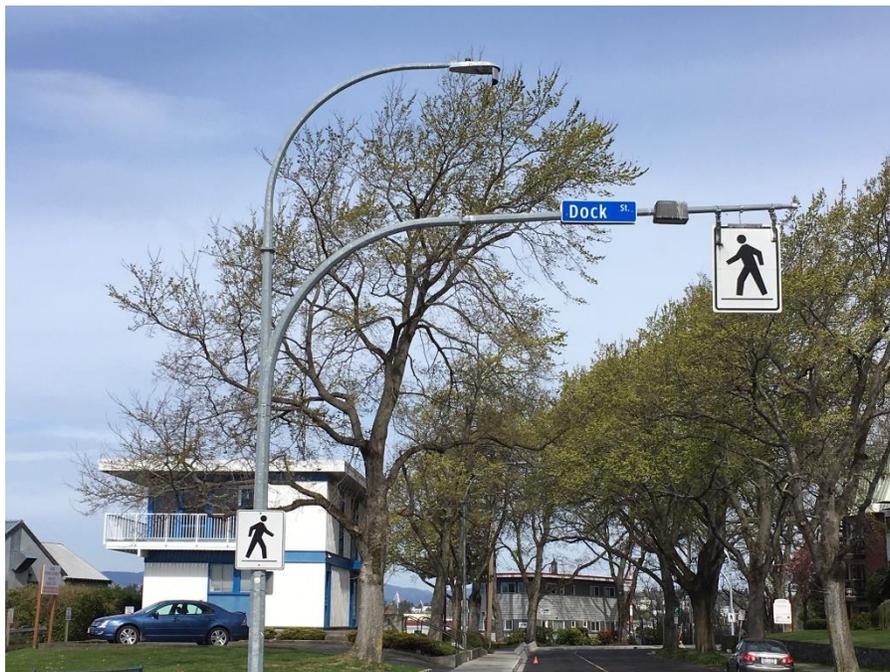
Figure 17–Clover Forcemain- Electrical lighting installation Montreal Street to Lewis Street

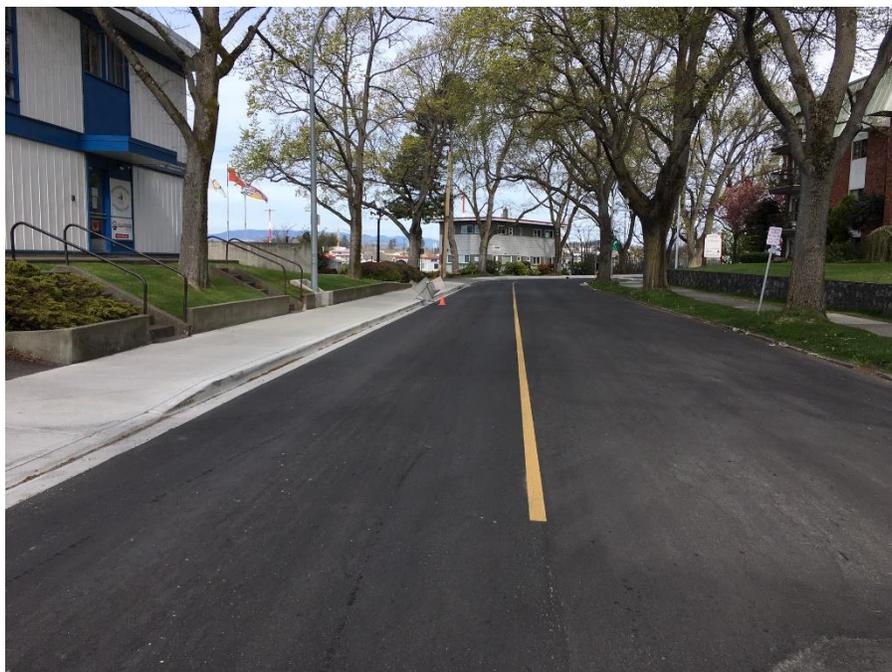
Figure 19–Clover Forcemain- Top lift of paving Niagara Street to Dock Street.

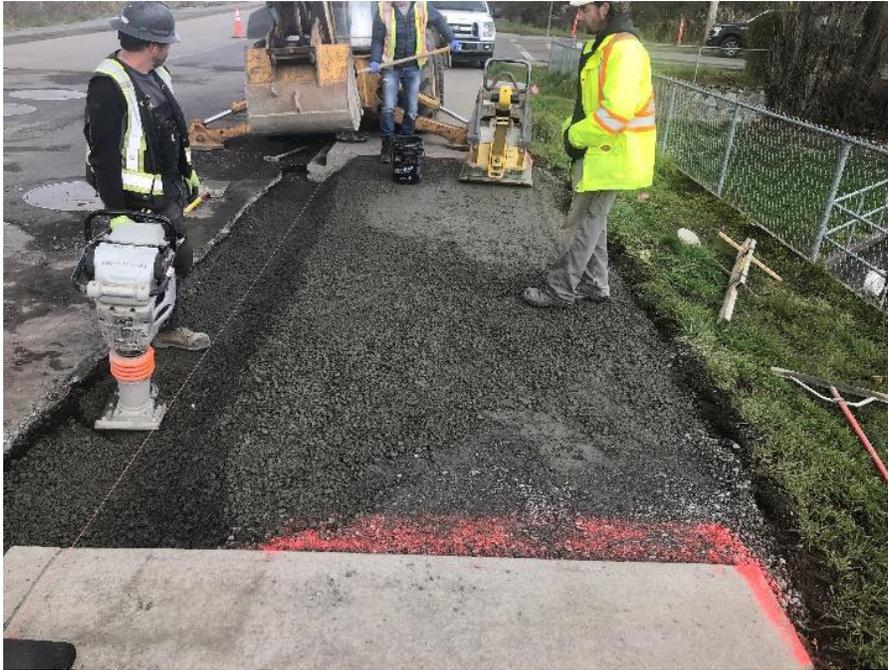
Figure 20– Residual Solids Pipes-Sidewalk, curb and gutter preparation on Interurban Road at Charlton Road

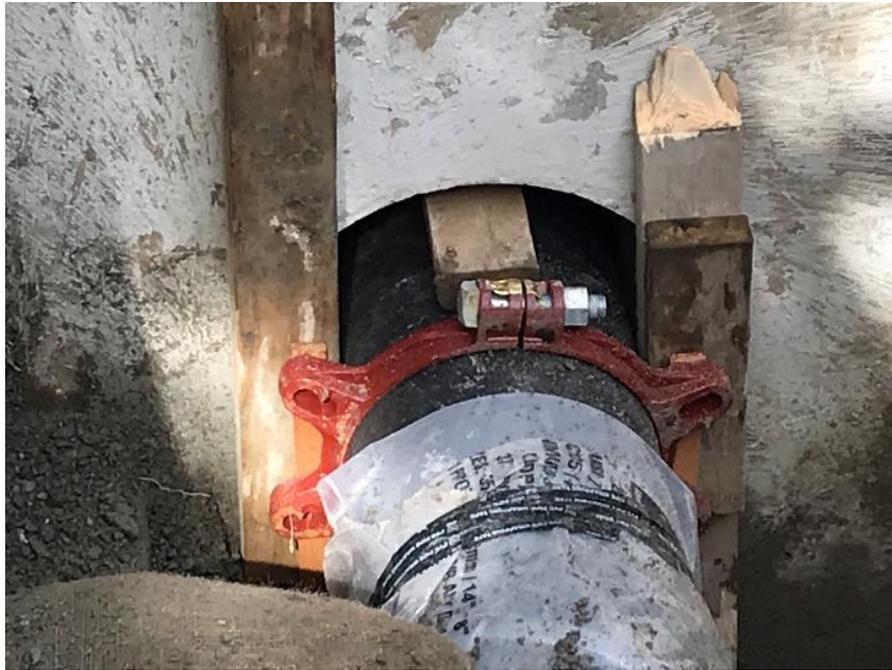
Figure 21-Residual Solids Pipes- Installation of pipe through Tillicum Bridge abutment.

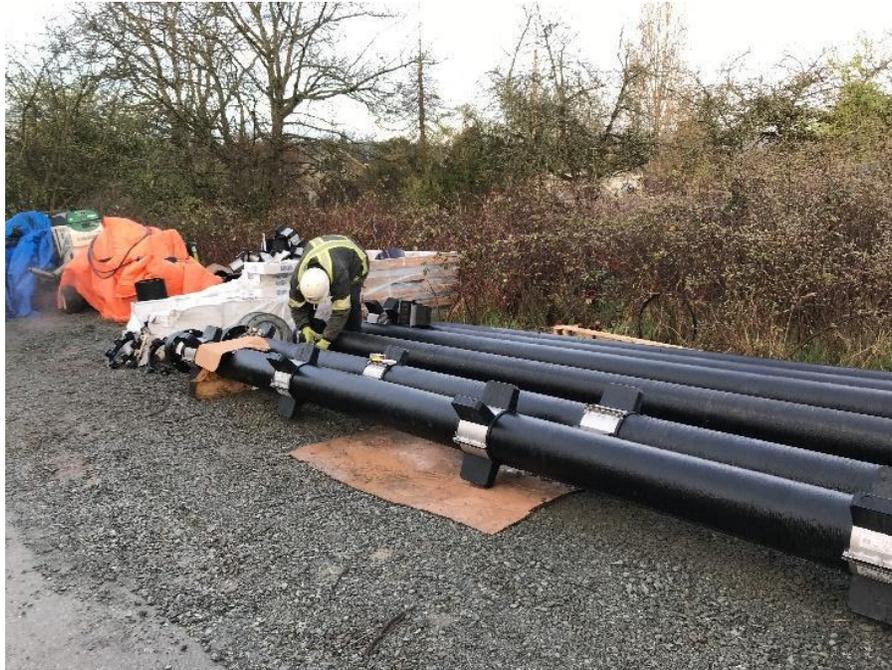
Figure 22-Residual Solids Pipes – Installing spacers on highway crossing pipe.

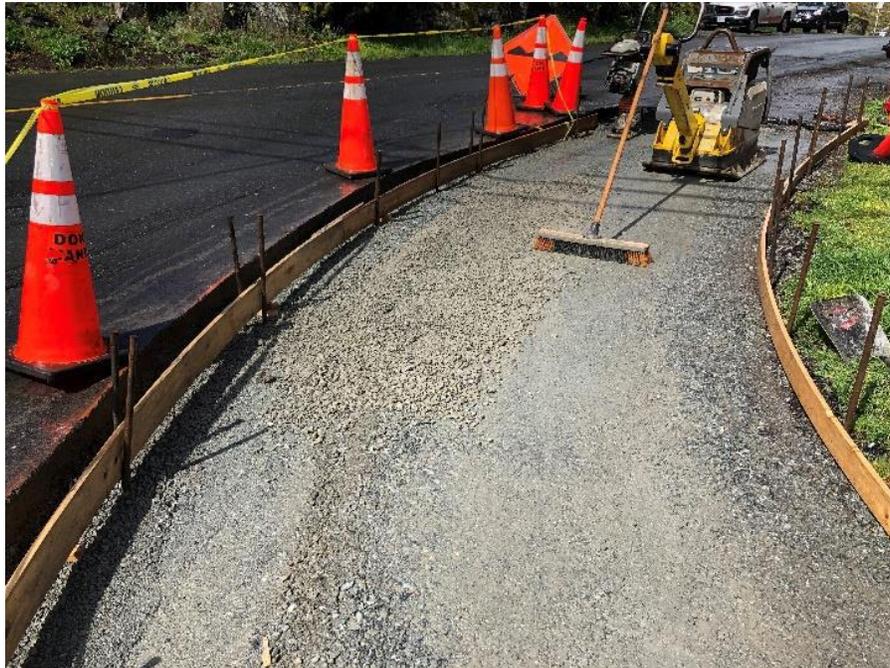
Figure 23–Residual Solids Pipes - Sidewalk, curb and gutter preparation on corner of Burnside Road and Grange Road.

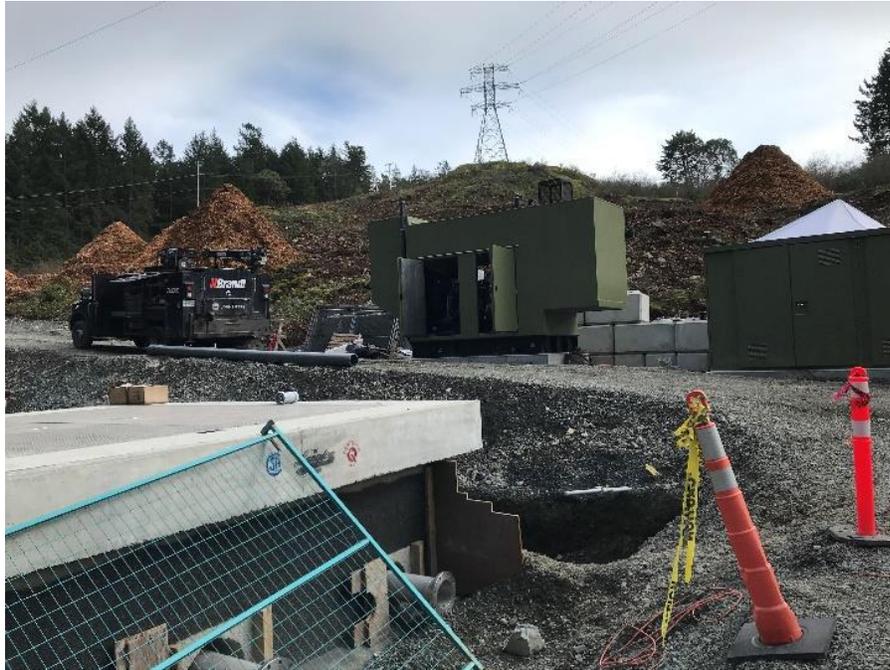
Figure 24–Residual Solids Pump Stations– Pump Station 3 – Emery Electric performing a 5– hour load test on the generator.

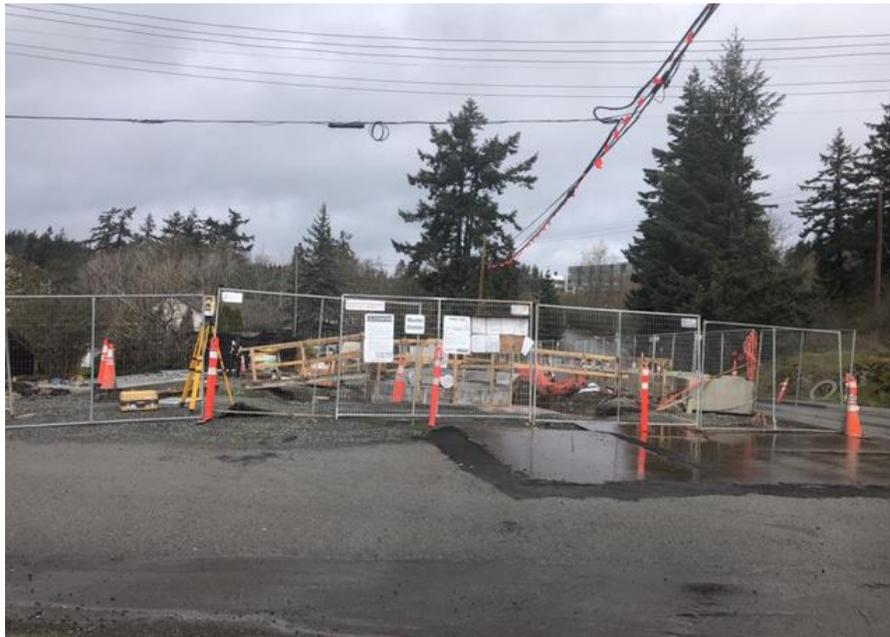
Figure 25 –Residual Solids Pump Stations – Pump Station1 Survey layout for generator and odour control unit pads.

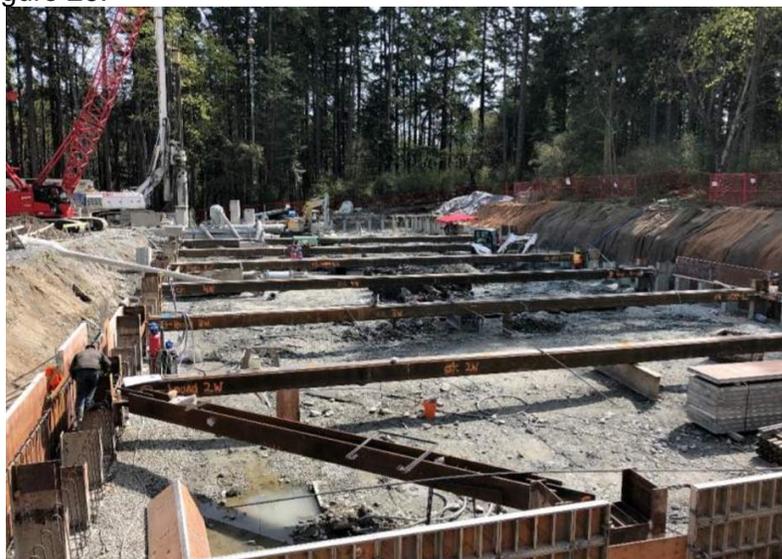
Figure 26–Arbutus Attenuation Tank–Installed diagonal and lateral struts atop the secant piles.

- removal of construction ramp into tank footprint to facilitate installation of the remainder of the secant piles; and
- installation of diagonal and lateral struts atop the secant piles.

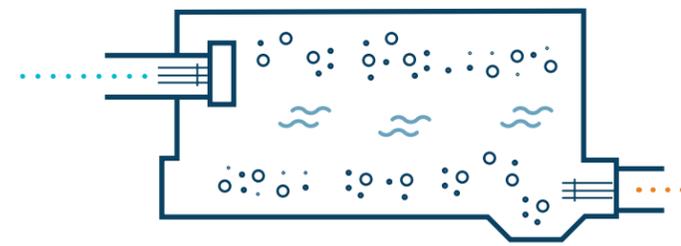
Grit Removal

A vortex system uses centrifugal force to keep the organic material suspended while grit settles and is removed.
