Core Area Stormwater Quality Program

2019 Report

Capital Regional District | Parks & Environmental Services, Environmental Protection

September 2020

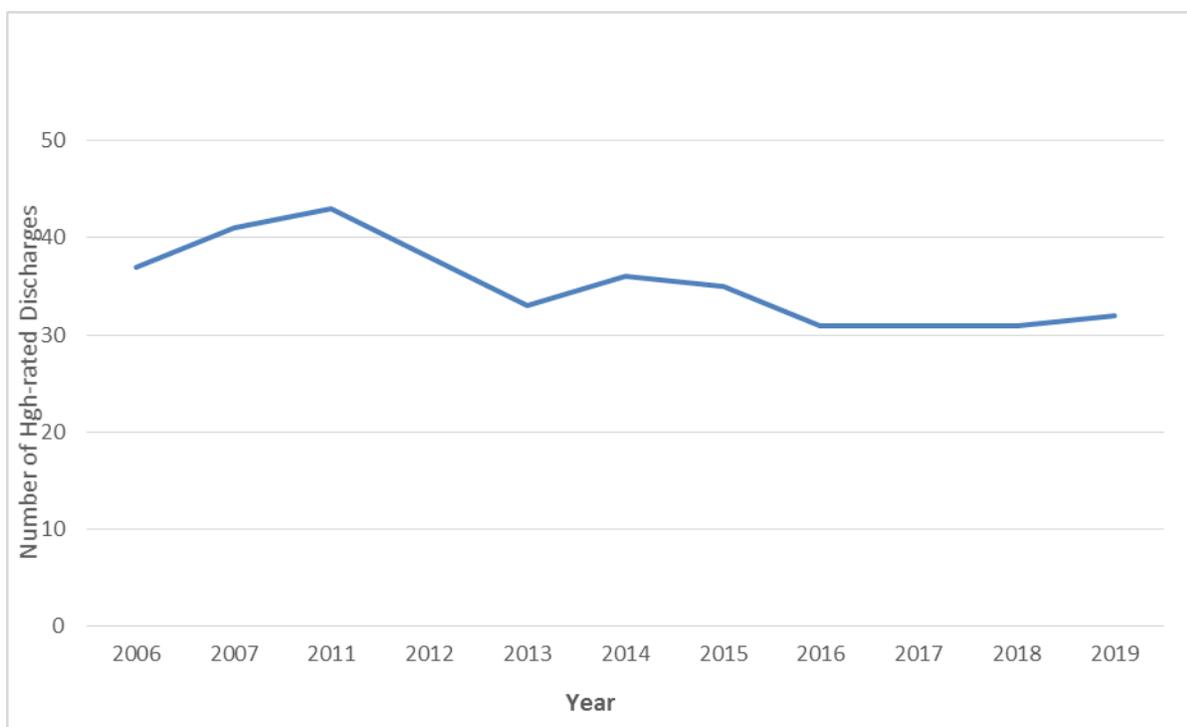
Figure A. Number of Discharges Assigned a High Public Health Concern Rating Over Time

The number of high-rated discharges has remained stable for the last four years (Figure A and Table A). However, while the total number has remained nearly the same, some of the discharges on this list have changed. In 2019, six of the previously high-rated discharges were assigned lower ratings, due to lower bacterial counts, while seven discharges were added to the list, due to newly-identified sources.

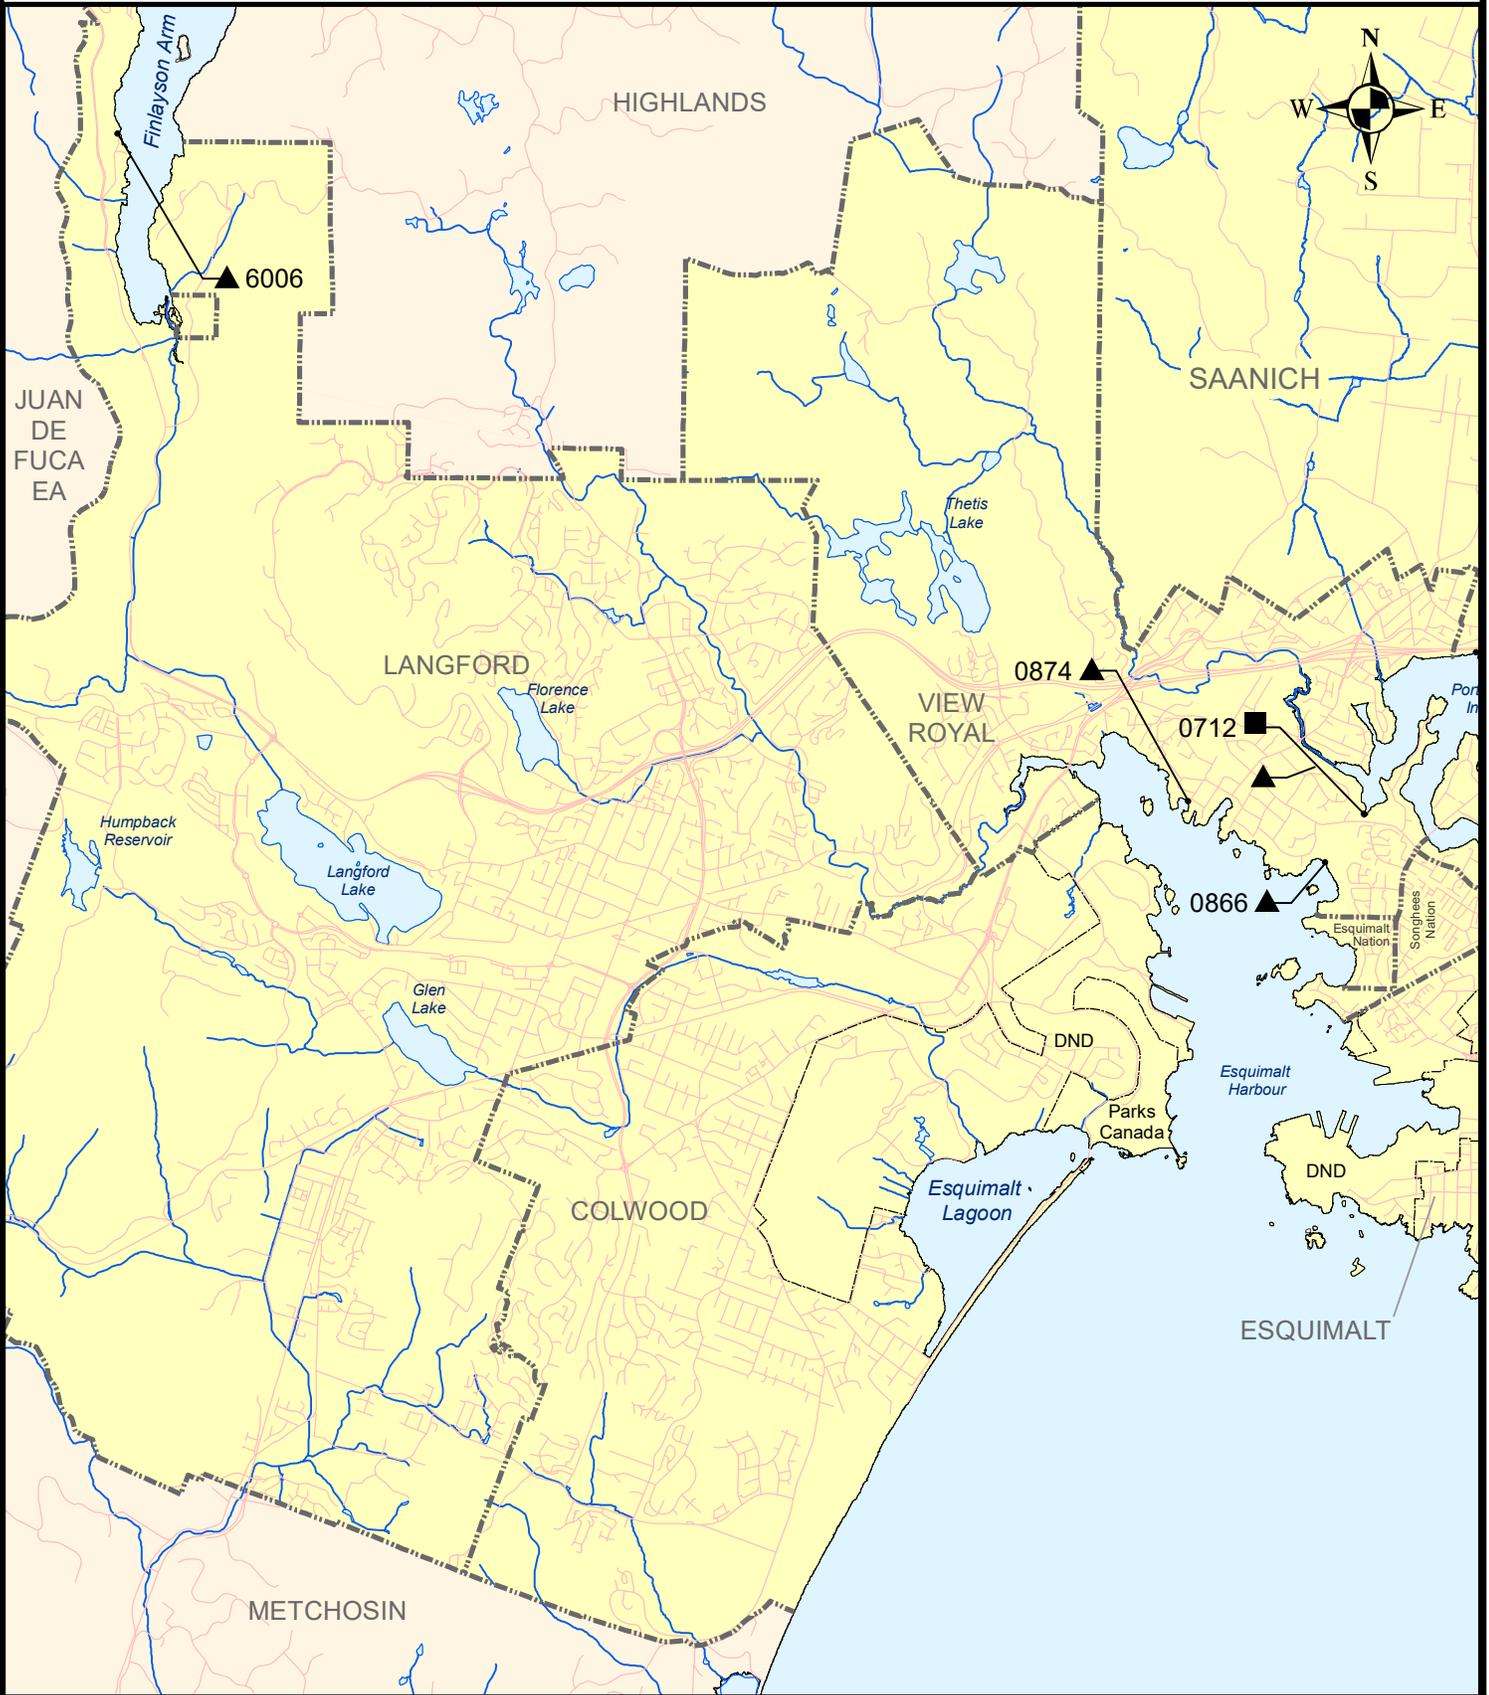
Figure B - Core Area 2019

- 63 low ratings
- 80 moderate ratings, and
- 31 high ratings (Table A, Figures B and C)

Staff make recommendations for corrective action to find and eliminate sources of chemical contamination when a rating remains high for two consecutive years and the parameter(s) of concern are determined. Based on data up to 2020, CRD recommends 21 discharges for corrective action in the core area (shown in Table C). Of the five discharges assigned a high rating in 2019 (307, 324, 505, 692 and 712) two of these are identified as needing corrective action (307 and 505). Locations of high-rated discharges in 2019, and those identified for corrective action, are shown on figures B and C.

Stormwater Discharges Requiring Action for Public Health and Environmental Concerns
(Metchosin to Esquimalt Border)

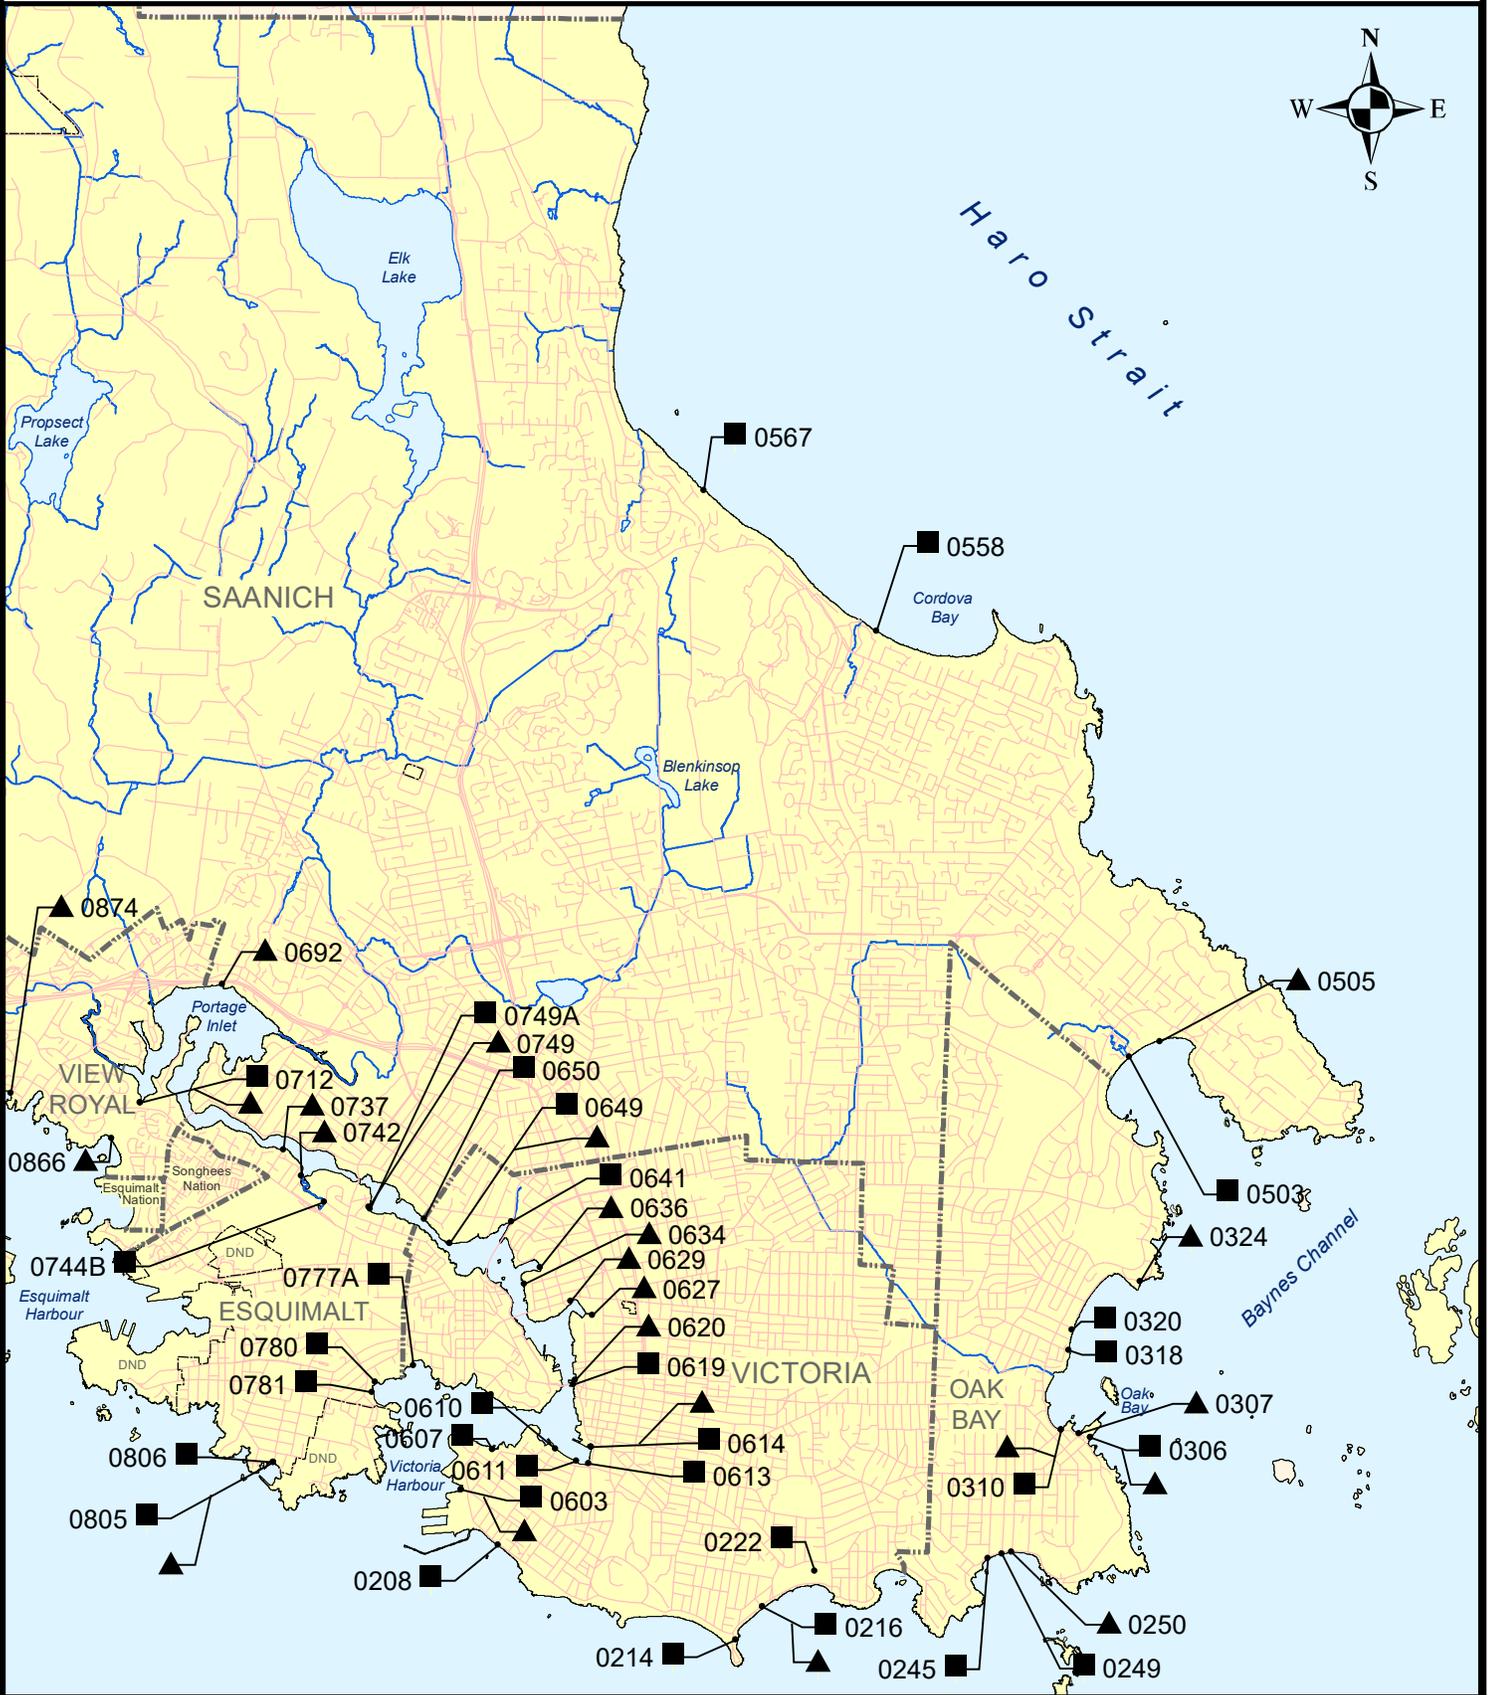
Figure C - Core Area 2019

Stormwater Discharges Requiring Action for Public Health and Environmental Concerns
(Esquimalt to Central Saanich Border)
