APPENDIX C

APPENDIX C—BOWKER CREEK CHANNEL RESTORATION NEEDS AND PRESCRIPTIONS

By Tanis Gower, RPBio

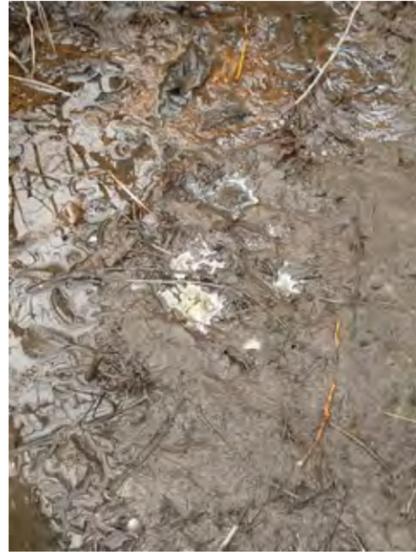
Plate 25: Runoff from the hospital includes hydrocarbons. There is an opportunity to improve VIHA's Royal Jubilee stormwater runoff facilities next to Bowker Creek.

VIHA engineered the Royal Jubilee drainage so that no pipes drain directly from the property into the creek. However, their infiltration channel/area is not treating water quality sufficiently, and does not allow for significant infiltration. The original design of these features should be compared to their current functioning.

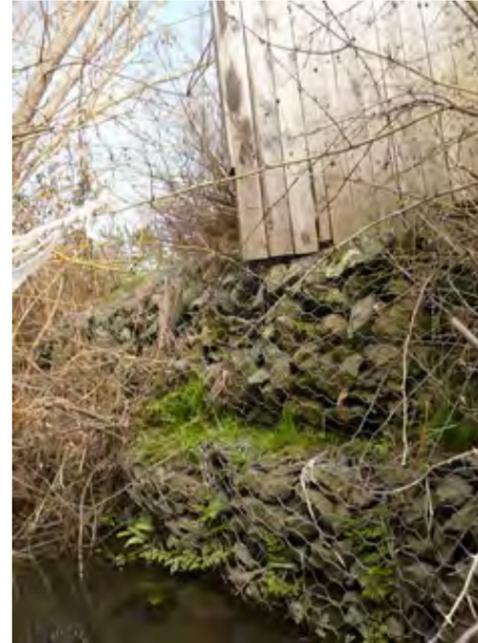
Plate 29: The property at 1875 Haultain comes to a point at the edge of Bowker Creek and is stabilized by gabions.

Short term riparian restoration potential and techniques Remove invasives on the west bank, and plant with a diversity of native trees and shrubs. Monitor the areas with dead bioengineering wattles to determine whether problems with erosion will develop over time. Plant native shrubs and trees on the upper reach east bank where no riparian vegetation currently exists (on triangle south of Haultain and on Bishop/Adanac ROW property). Improve the water quality running off the hospital property, by improving their stormwater infiltration/channel design (see Plate 25).
Short term channel restoration potential and techniques The following could be done in the short term or combined with longer term/larger scale actions: Use the triangle of land immediately south of Haultain, and the informal path on the west bank, to widen the creek corridor (Plate 27). This effort can result in a 15 meter wide corridor, even at the most narrow point. With the exception of the location where a fenceline comes directly to the streambank (see Plate 28), this would allow an opportunity to remove the gabions and create a terraced creek bank with native vegetation. This may require a retaining wall on the west bank and at the corner of the lot at 1875 Haultain—a detailed design would be required.

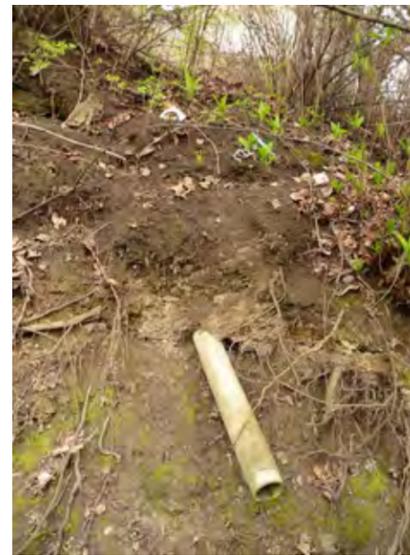
Plate 43: Discrete areas on both banks, particularly the west bank, have erosion problems.

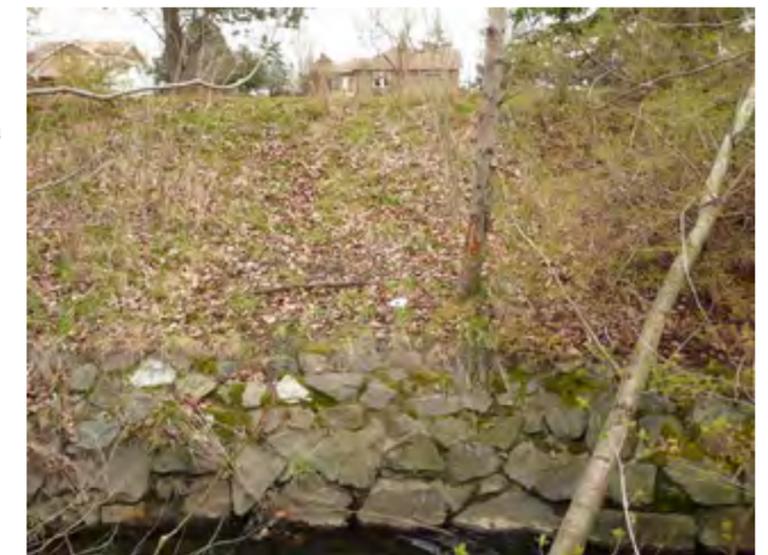
Plate 50: looking across to the east bank where homes have been removed to expand the park. Even if the creek is not moved further east to accommodate a wider riparian buffer on the west bank, the east bank can be re-graded and have riparian buffer on the west bank, the east bank can be re-graded and have riparian vegetation planted, and the rock wall removed.

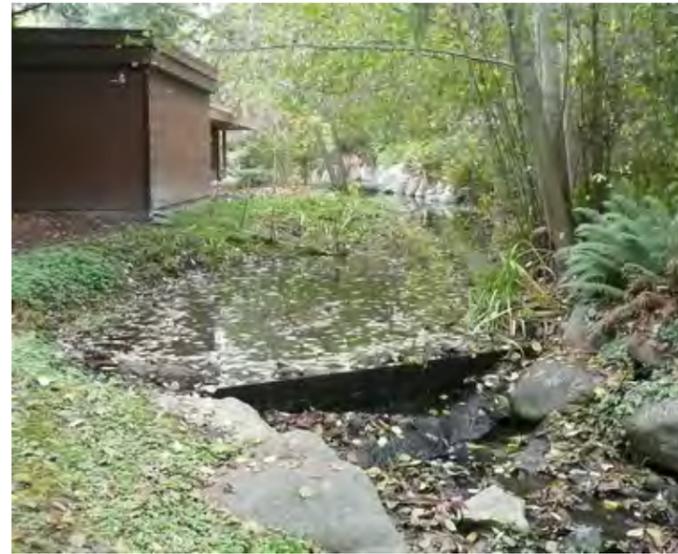
Plate 53: Pond outlet channel

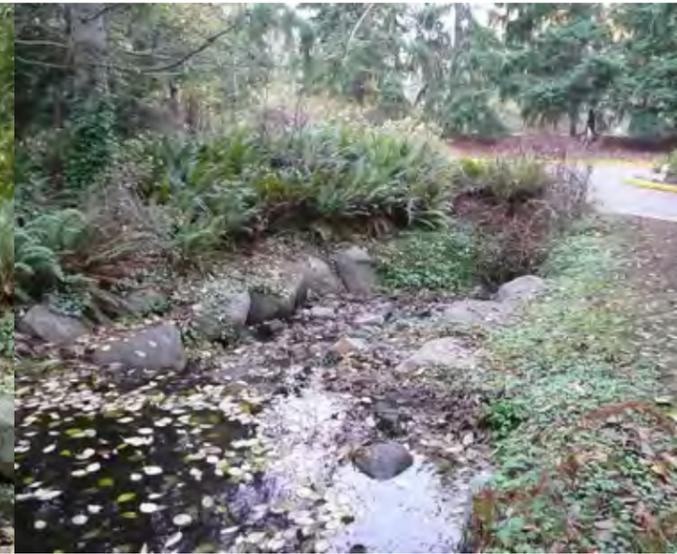
Plate 54: Pond outlet channel as it goes into a culvert below parking and access roads

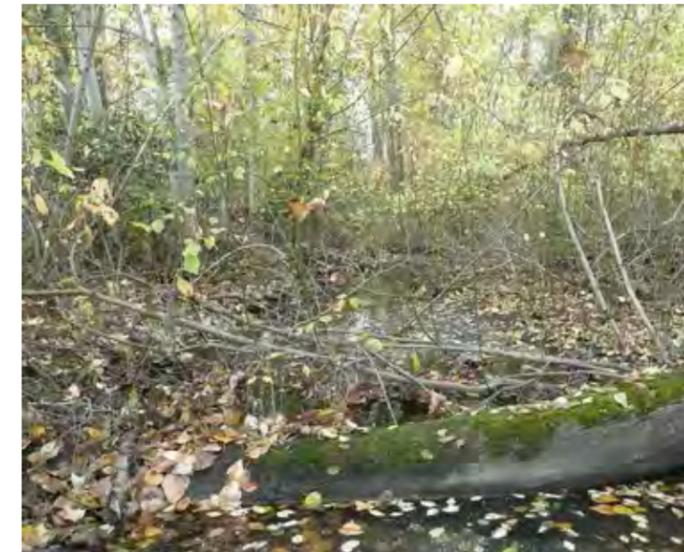
Plate 55: Creek channel behind Faculty Club parking lot

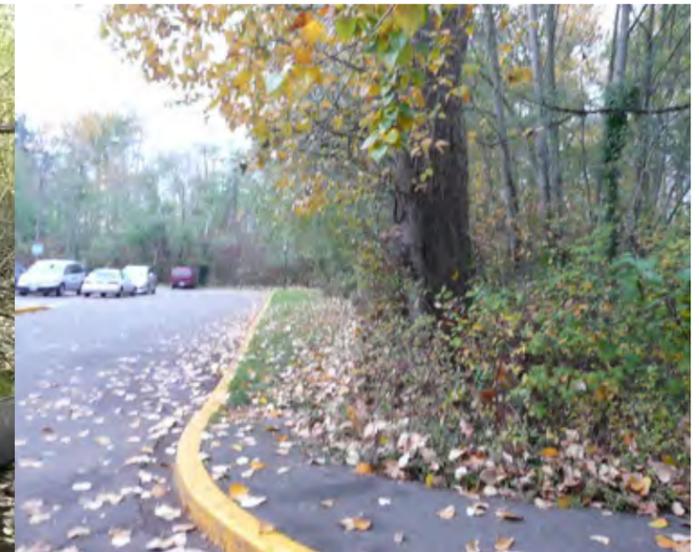
Plate 56: Location of creek channel beside Faculty Club parking lot. The riparian buffer could be extended into the grass ROW.

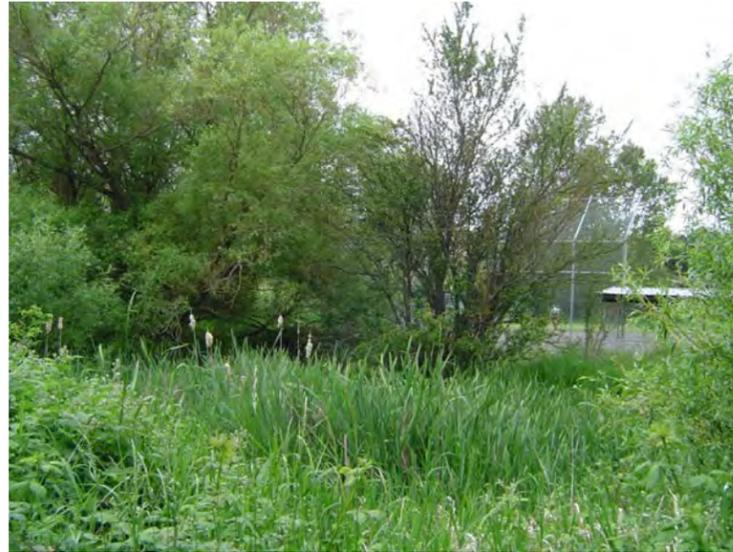
Plate 70: Cattail marsh looking north to baseball diamond

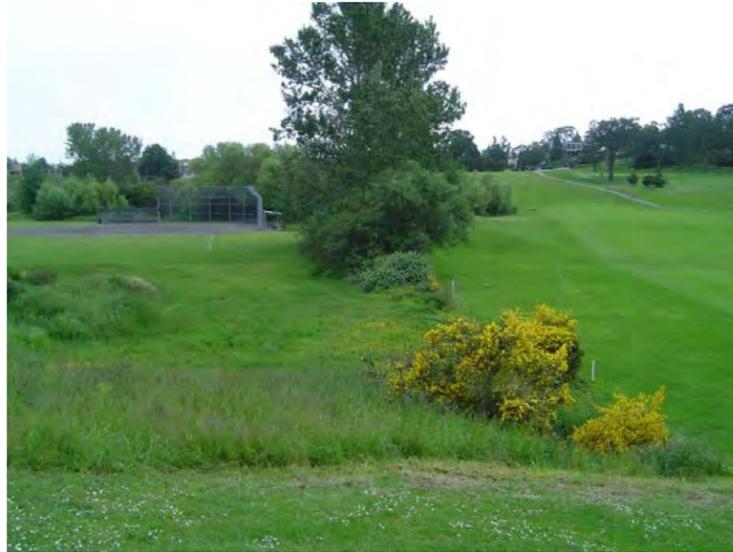
Plate 71: Top of Reach 17B linear section, looking south

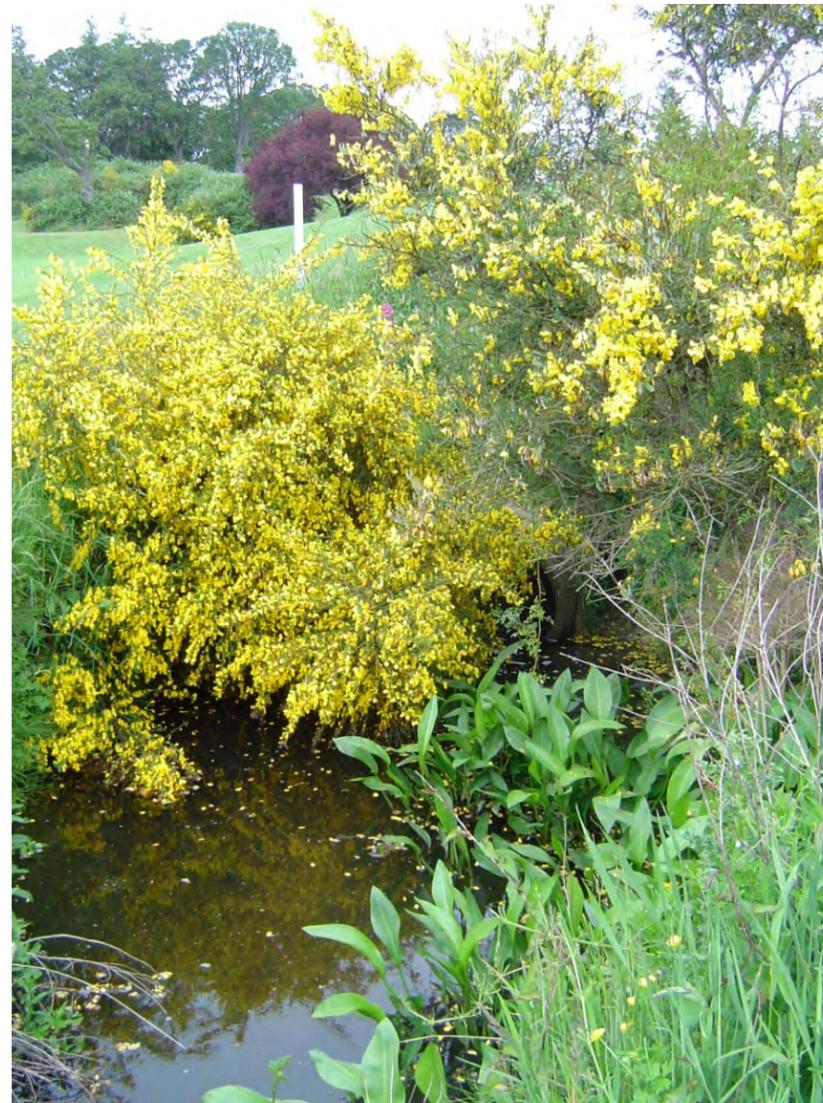
Plate 72: Pool at head of 600 mm culvert

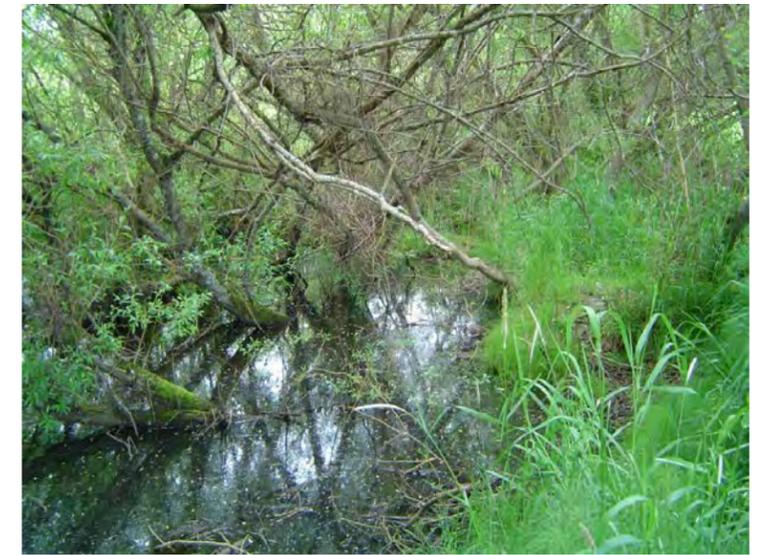
Plate 73: Willow marsh at top of Reach 17B

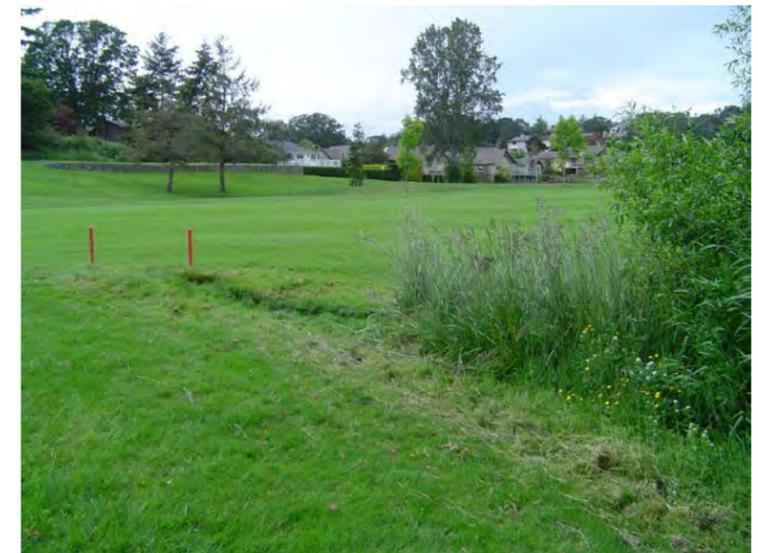
Plate 74: Source flow from west tributary into cattail marsh
