MINERS BAY DOCK FACILITY

CONDITION ASSESSMENT REPORT

Capital Regional District

M&N Project No. 8985 VC15

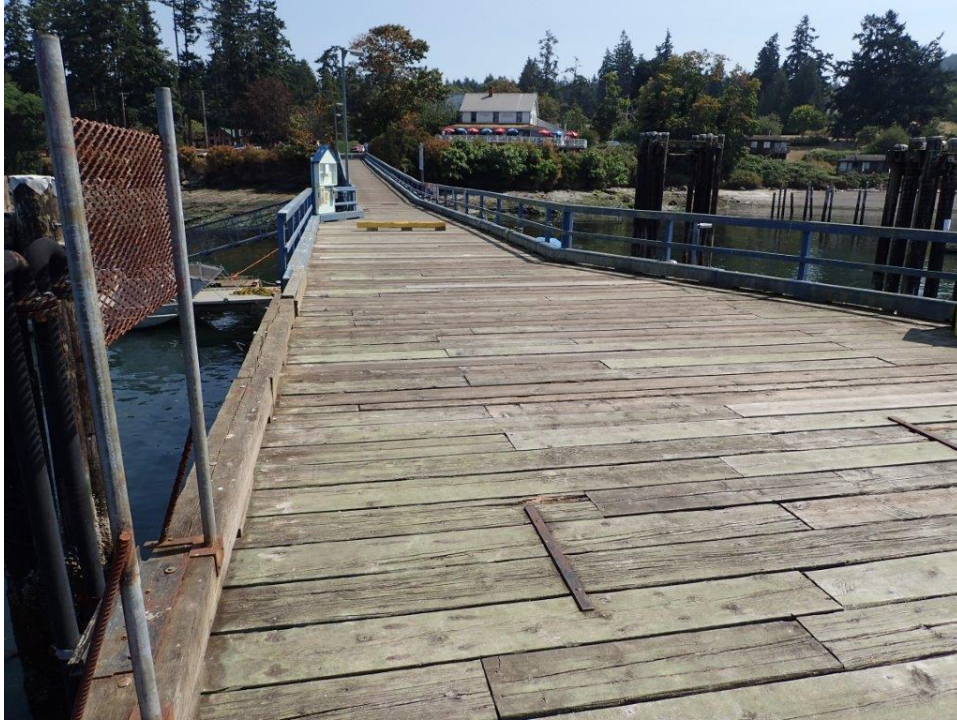
The timber topsides are in poor condition. The approach and wharfhead have multiple boards that are weathered and starting to rot.

Photograph 3: General Condition of Approach

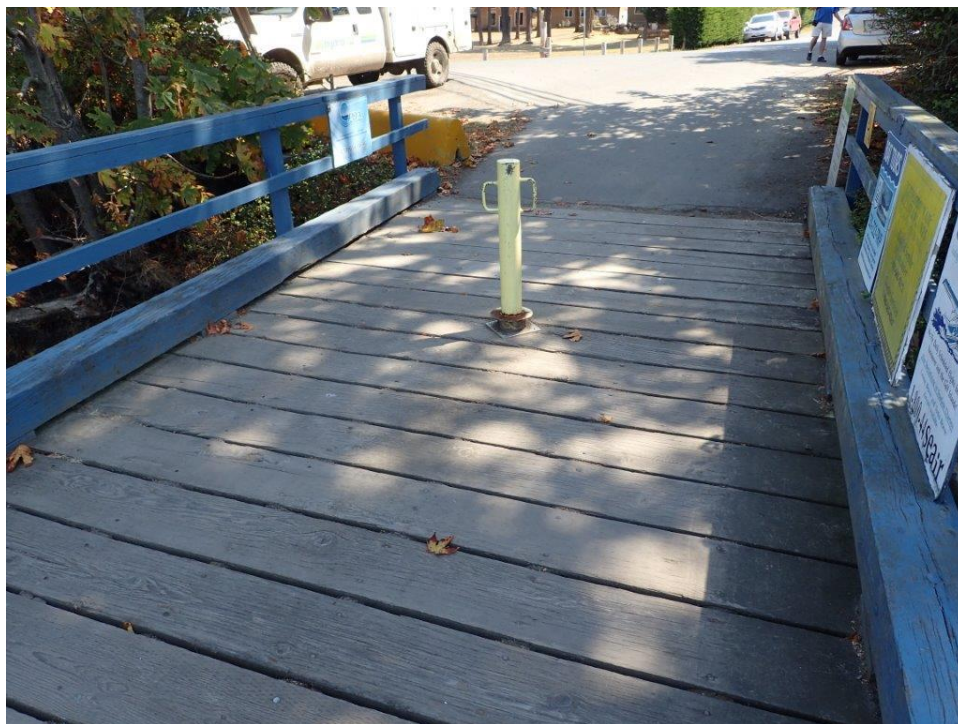
The abutment is in good condition with no notable defects.

Photograph 23: Abutment

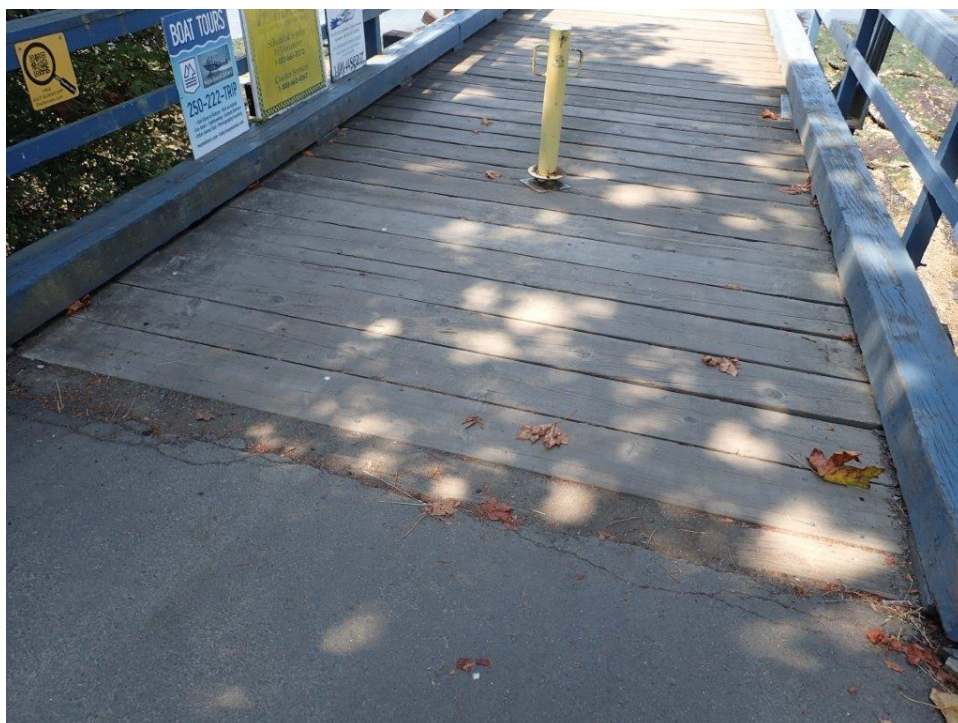
Photograph 24: Abutment

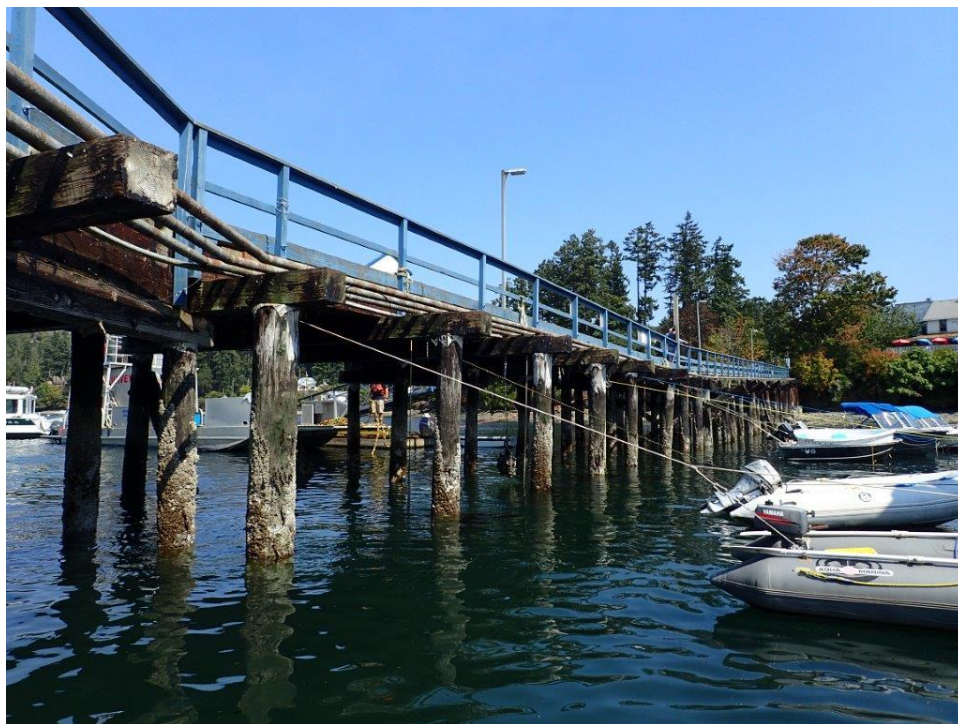
The pile caps are in good condition.

Photograph 25: Pile Caps

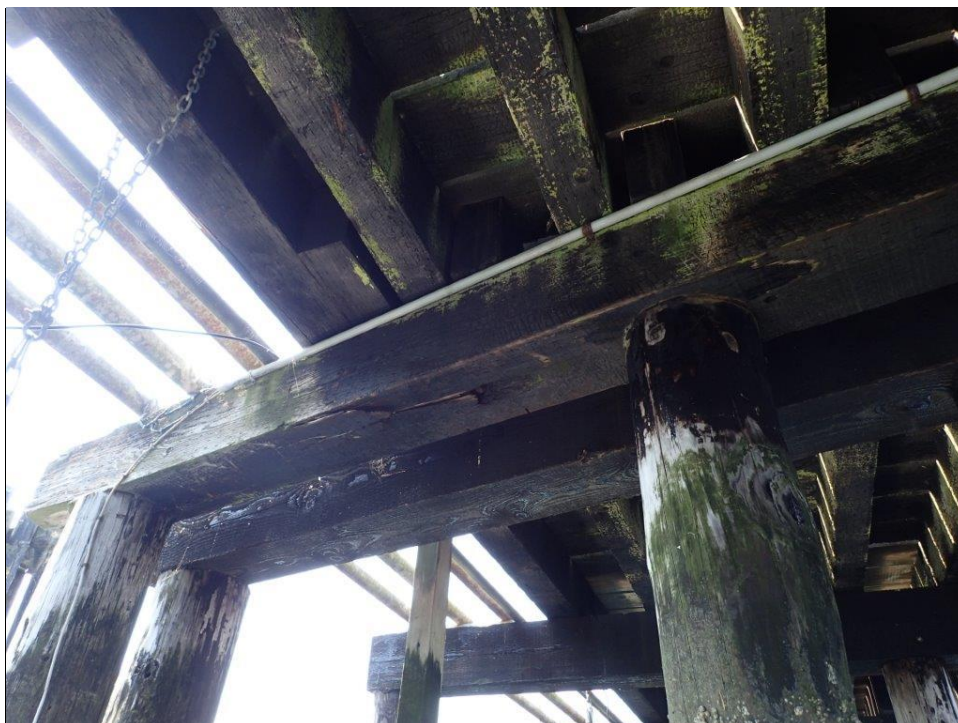
Location	Damage/Condition	Comments	Recommendations
Bent 25	Split Pile Cap	Photograph 26	Monitor

Photograph 26: Pile Cap Split at Bent 25

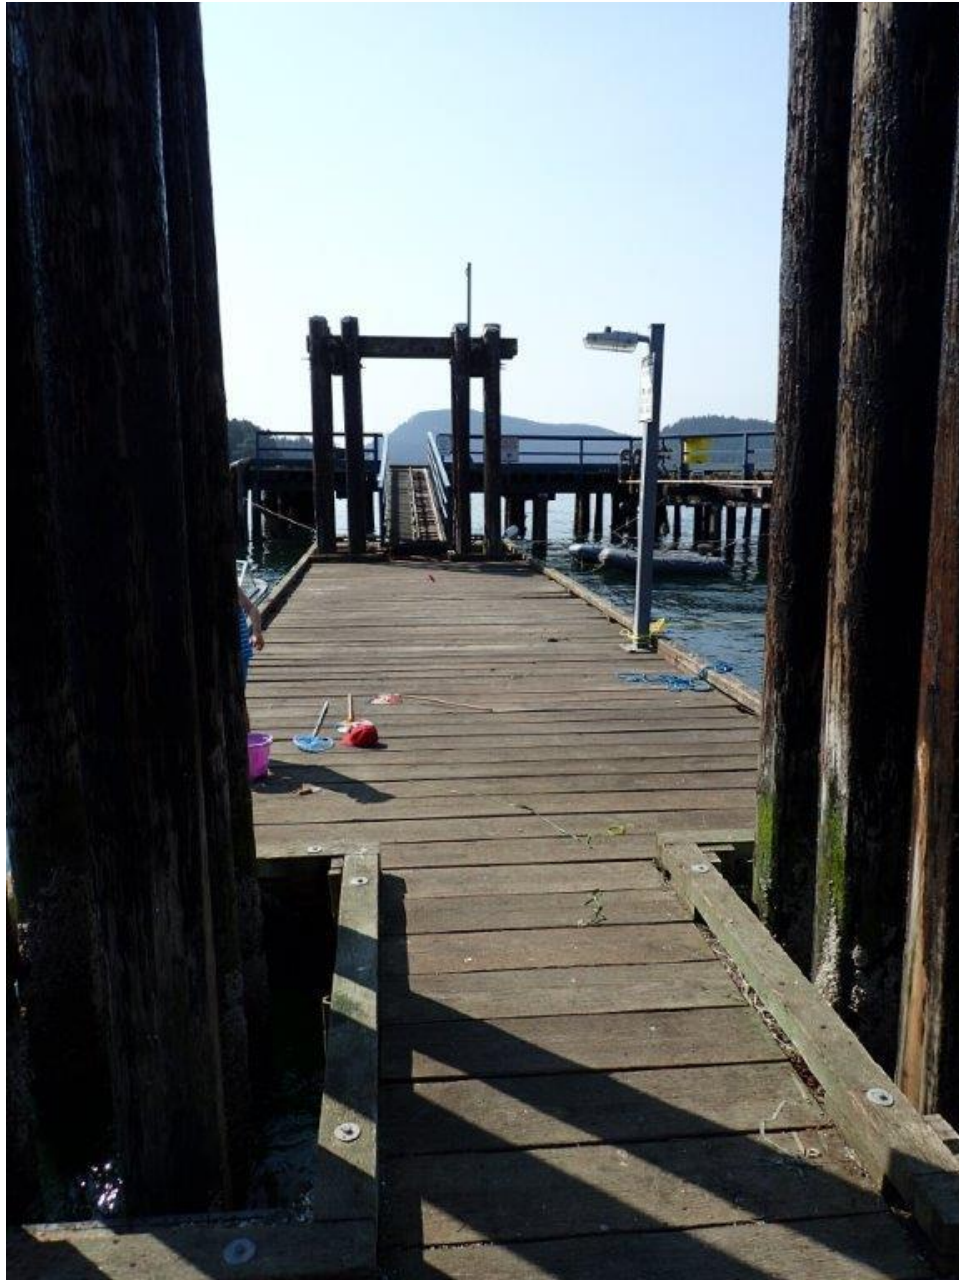
Location	Damage/Condition	Comments	Recommendations
Typical condition of floats photographs 47 to 48			
Bull Rails			
South East Side	Worn bull rails		Monitor
Decking			
Typical	10+ boards are loose, split, or warped		Repair
Rub Boards			
South and West Side	Worn rub rails		Monitor
Floats			
All	Foam billets are exposed foam with scattered areas of 20% section loss		Replace
All	Fasteners are corroded with 10% section loss		Replace
Guide Piles

Photograph 47: Float A General Condition

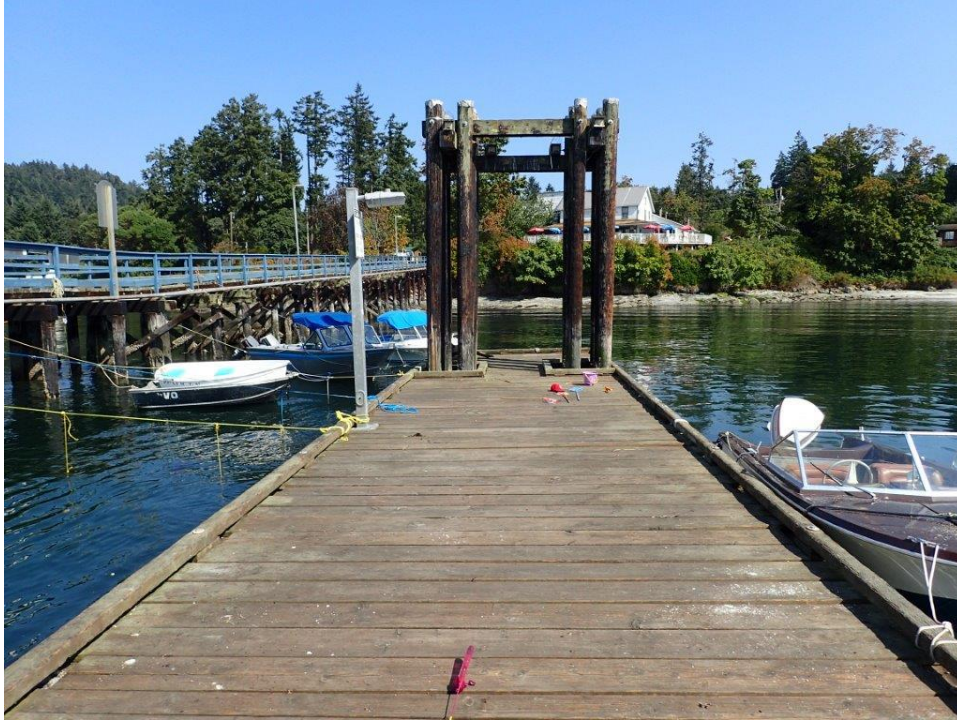
Photograph 48: Float A General Condition

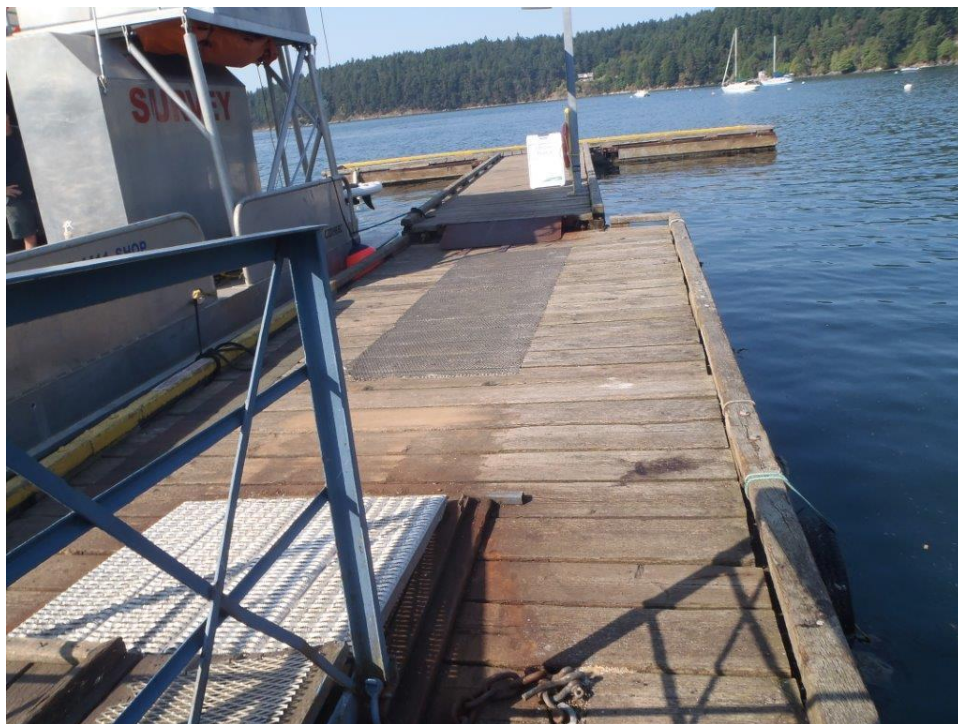
Location	Damage/Condition	Comments	Recommendations
Typical condition of floats photograph 54 to 55			
Bull Rails			
Typical	Fair condition	Photograph 56	Monitor
South Side	Missing bull rail	Photograph 59	Repair
Decking

Photograph 54: Float B Condition

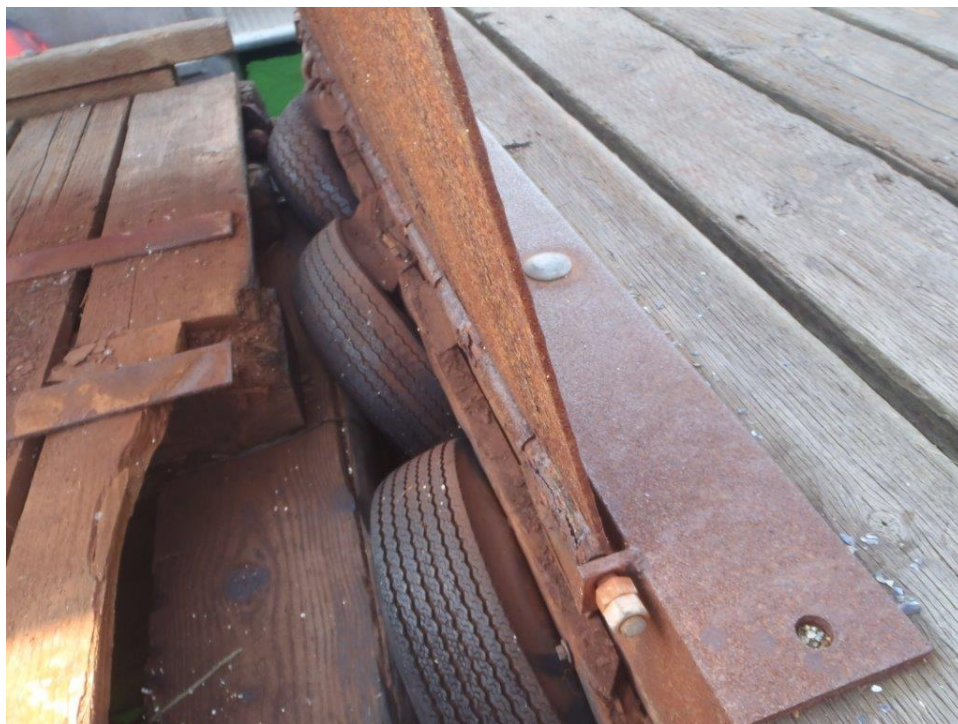
Typical	Grating on deck is disconnecting from the timber boards.	Photograph 55	Remove grating and install a lower gauge of grating
South Side	Missing board	Photograph 59	Replace
Middle	Heavy abrasion from gangway landing	Photograph 57	Repair gangway landing to prevent abrasion
Rub Boards			
Typical	Worn boards		Monitor
Anchor Chains			
Typical	Chains have 15% loss, Fair Condition		Monitor
Floats			
Typical	Foam billets are encapsulated, good condition		Monitor
Connection			
Between Float B and C	Poor Condition	Photographs 60 and 61	Repair
Transition Plate	Rusted		Replace
Decking and rub rails	Significant abrasion		Replace

Photograph 60: Connection between Float B and C

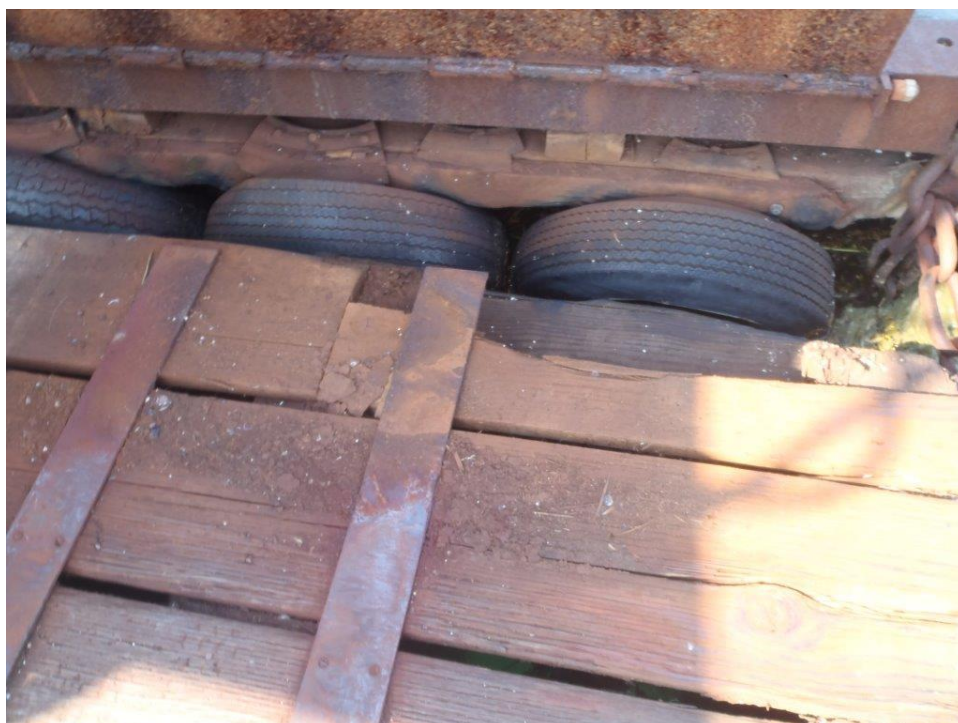
Photograph 61: Connection between Float B and C

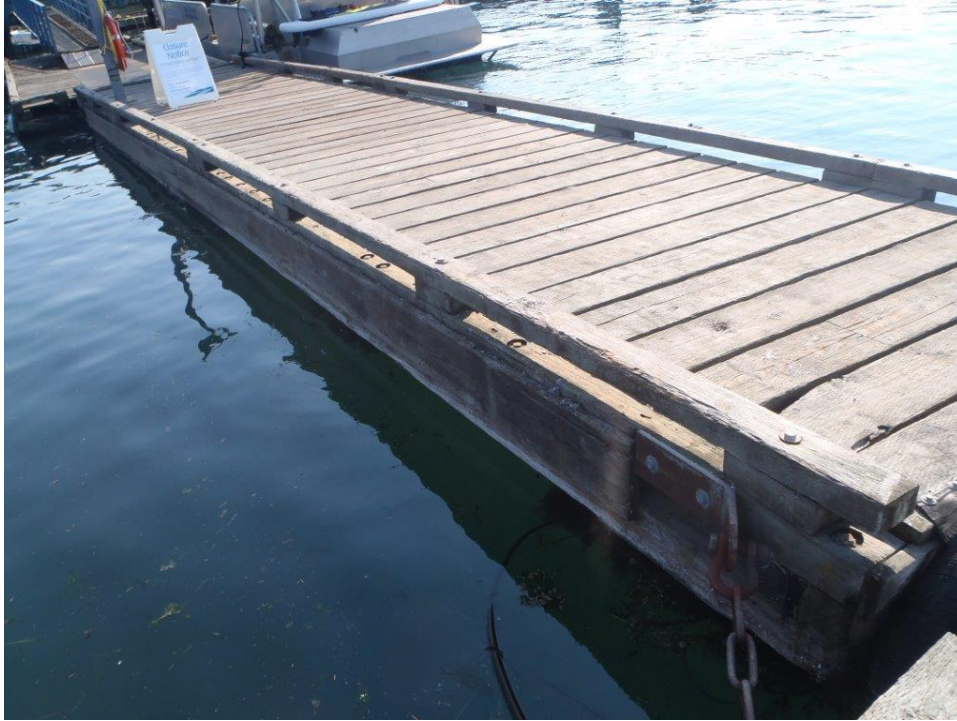
Location	Damage/Condition	Comments	Recommendations
Typical condition of floats photograph 62 to 63			
Bull Rails			
Typical	Fair condition		Monitor
Decking			
Near North End	Cracked boards	Photographs 64 to 65	Monitor
Rub Boards			
Typical	Fair condition		Monitor
Anchor Chains			
Typical	East anchor chain have 80% loss, West anchor chain has 50% loss Poor condition		Replace
Floats			
Typical	Foam billets are encapsulated, good condition		Monitor
Typical	Fasteners corroding		Replace
Connection			
Between Float C and D	Fair Condition	Photographs 66 and 67	Monitor
Transition Plate	No transition plate	Photograph 67	Add
West side	Missing tire	Photograph 68	Replace

Photograph 62: Float C

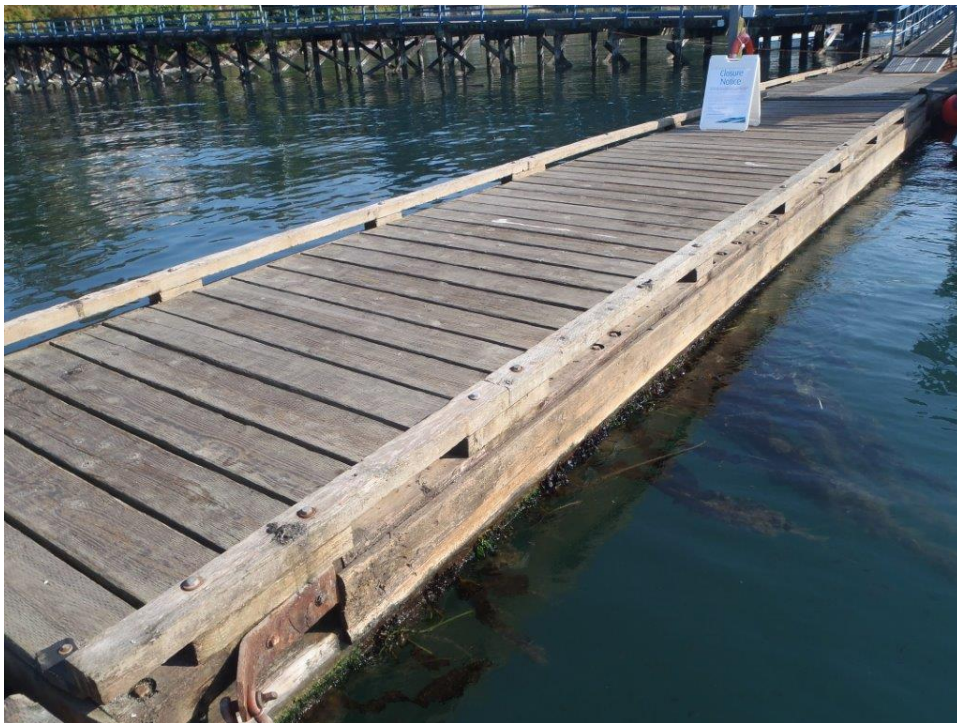
Photograph 63: Float C

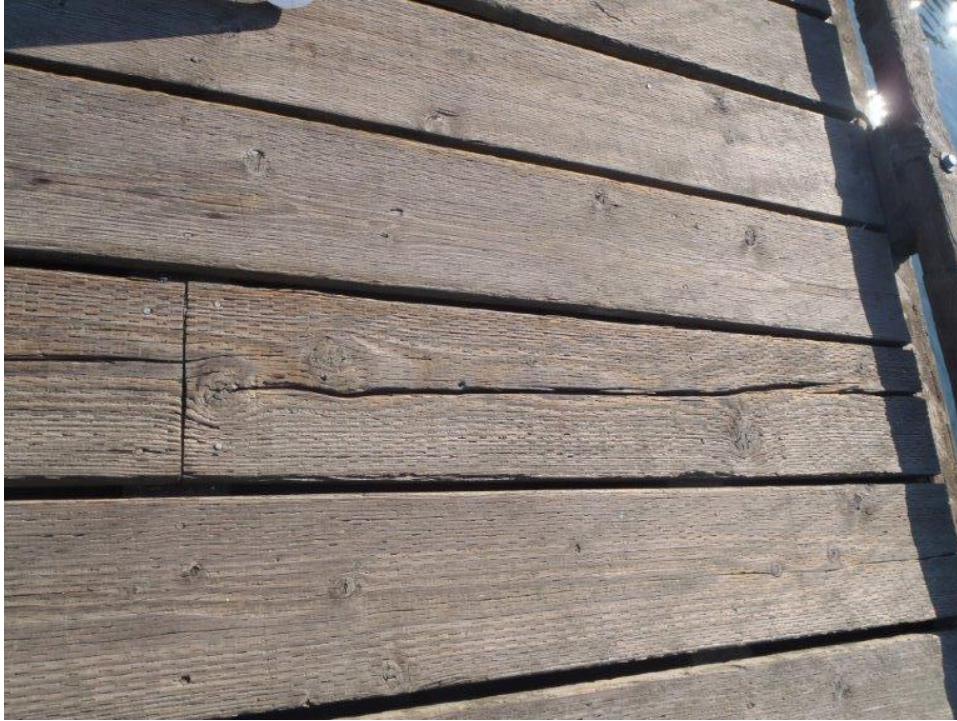
Photograph 64: Float C Deck

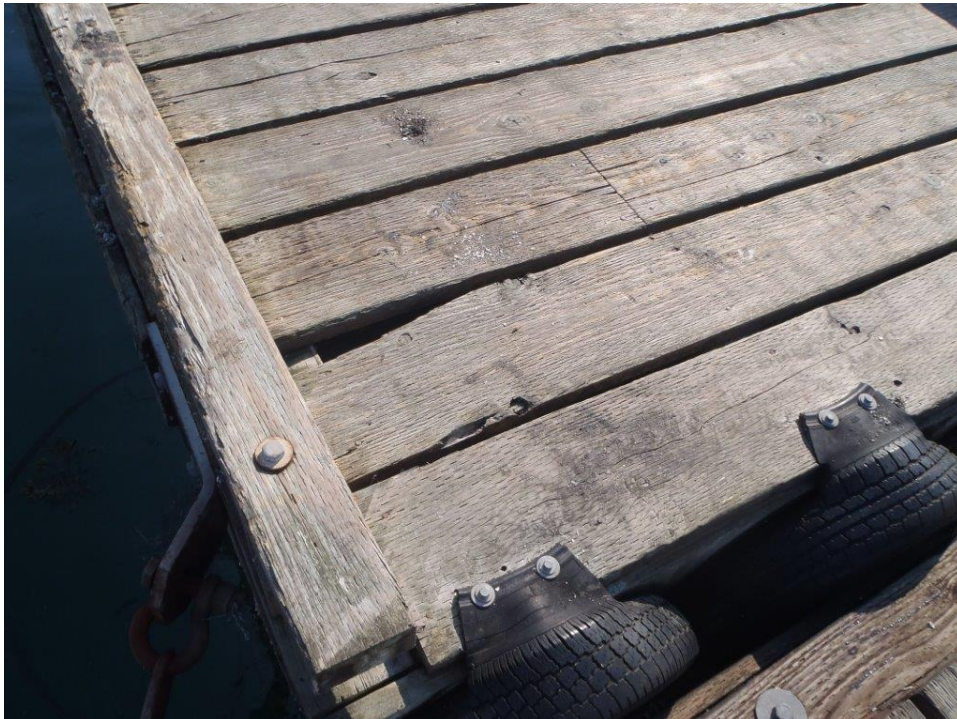
Photograph 65: Float C Deck

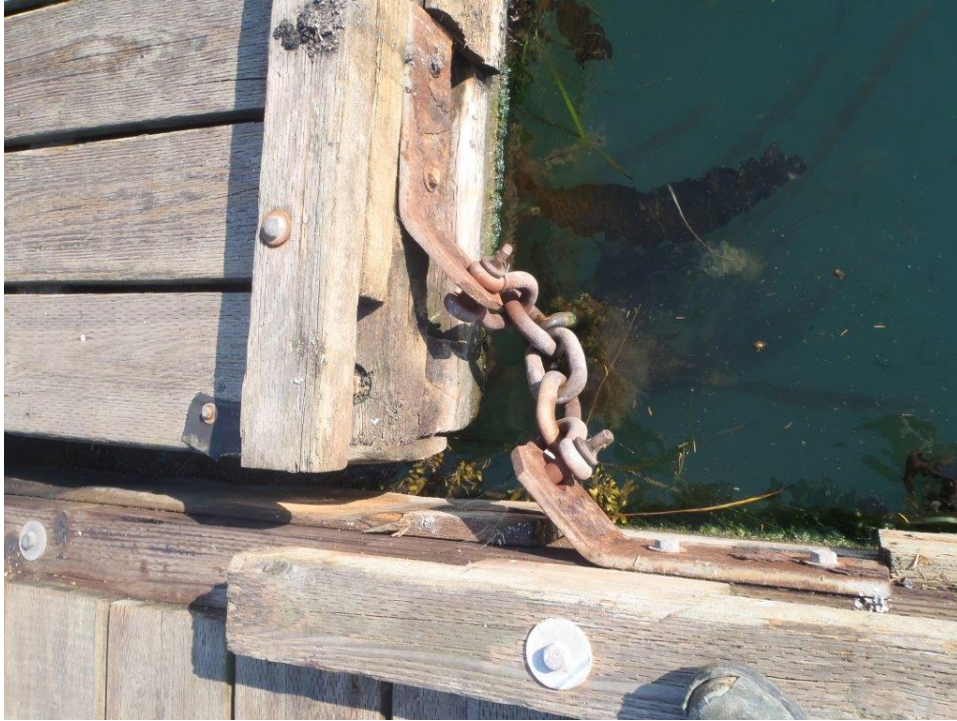
Photograph 68: Connection between Float C and D

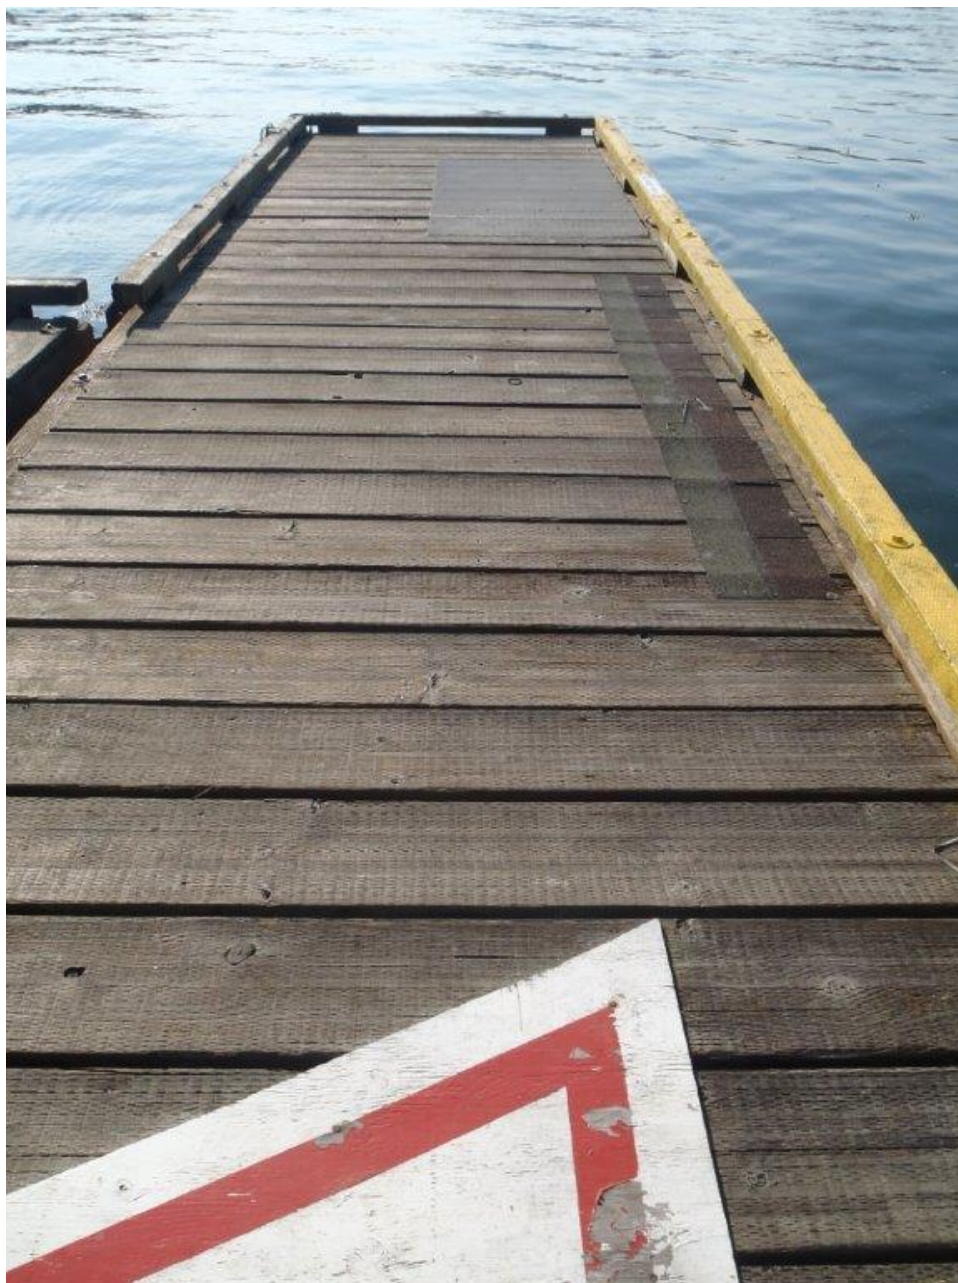
Location	Damage/Condition	Comments	Recommendations
Typical condition of floats photograph 69 to 70			
Decking			
Typical	Fair condition, boards are starting to warp		Monitor
Anchor Chains			
Typical	Chains have 15% loss, Fair Condition		Monitor
Floats			
Typical	Foam billets are encapsulated, good condition		Monitor

Photograph 69: Float D

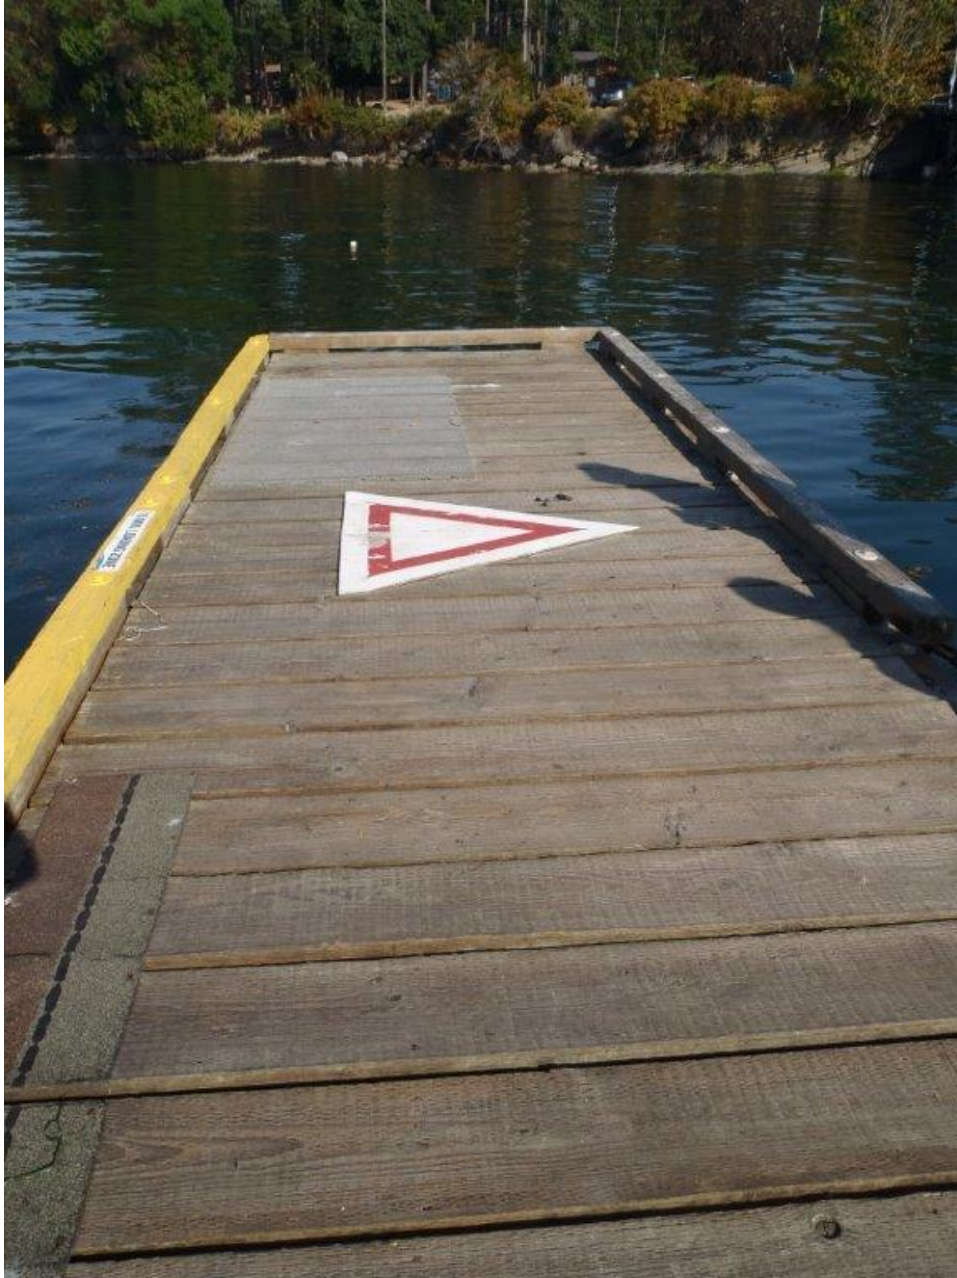
Photograph 70: Float D

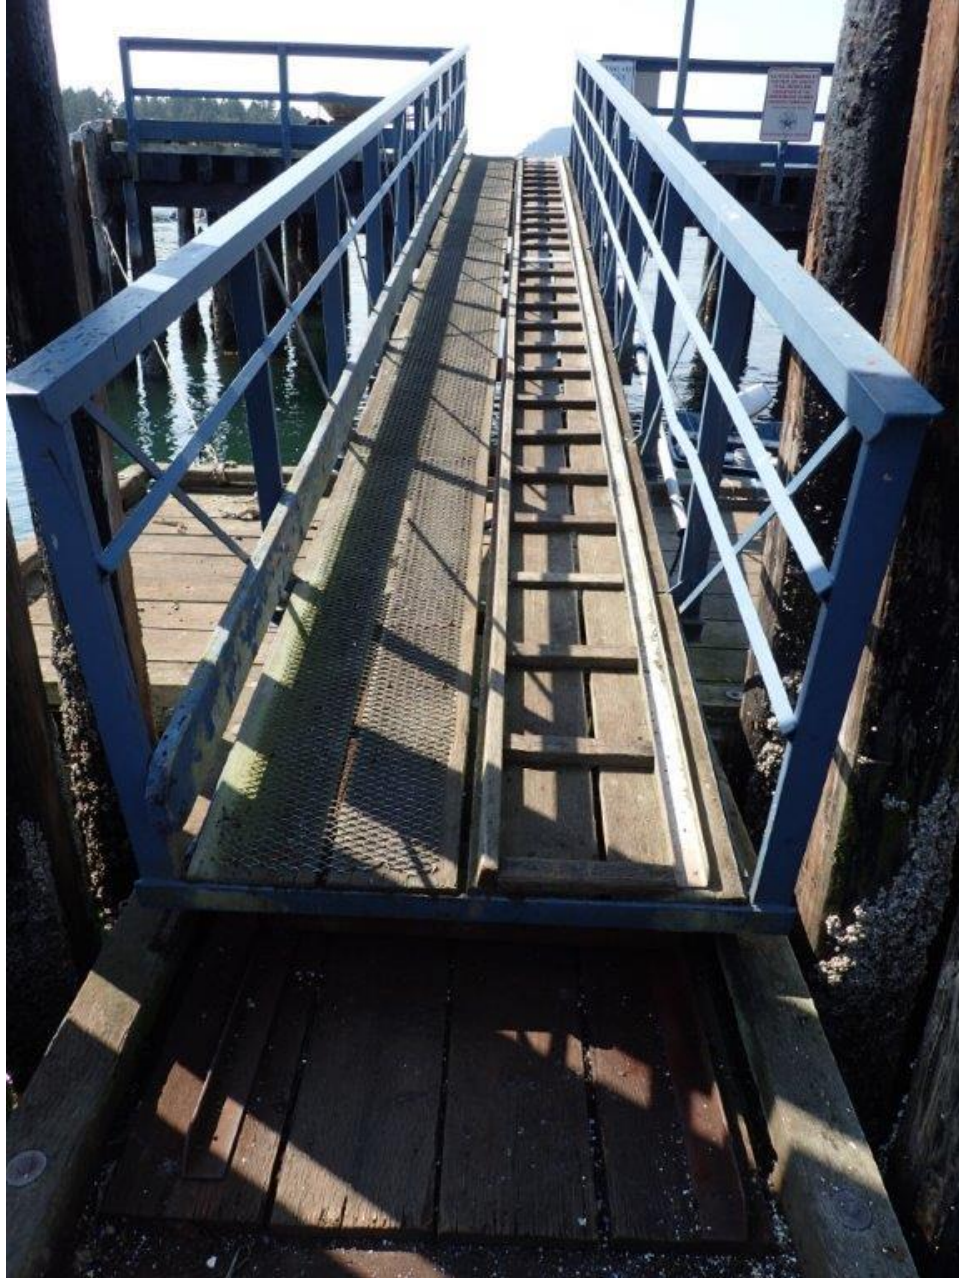
Location	Damage/Condition	Comments	Recommendations
Frame	Some loss of paint and rust	Photographs 73 to 76	Clean and repaint
Roller	Clearance between pile wells is too small for the gangway roller	Photograph 77	Repair
Roller	Broken roller	Photograph 78	Replace
Guide Rail	Out of alignment and worn out	Photograph 79	Replace

Photograph 74: Gangway A

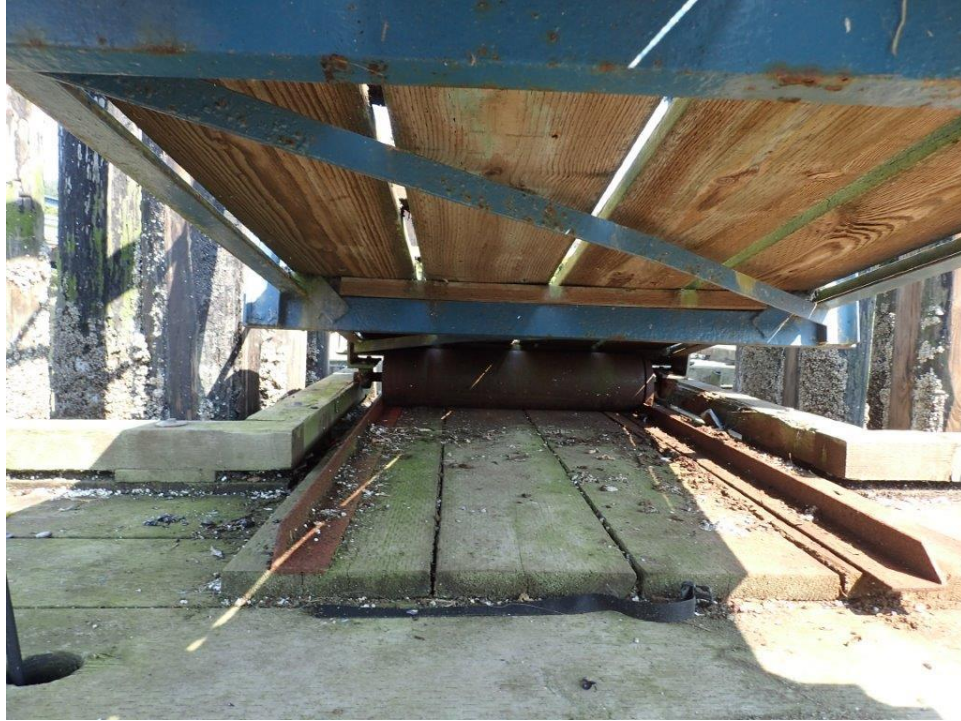
Photograph 75: Float A

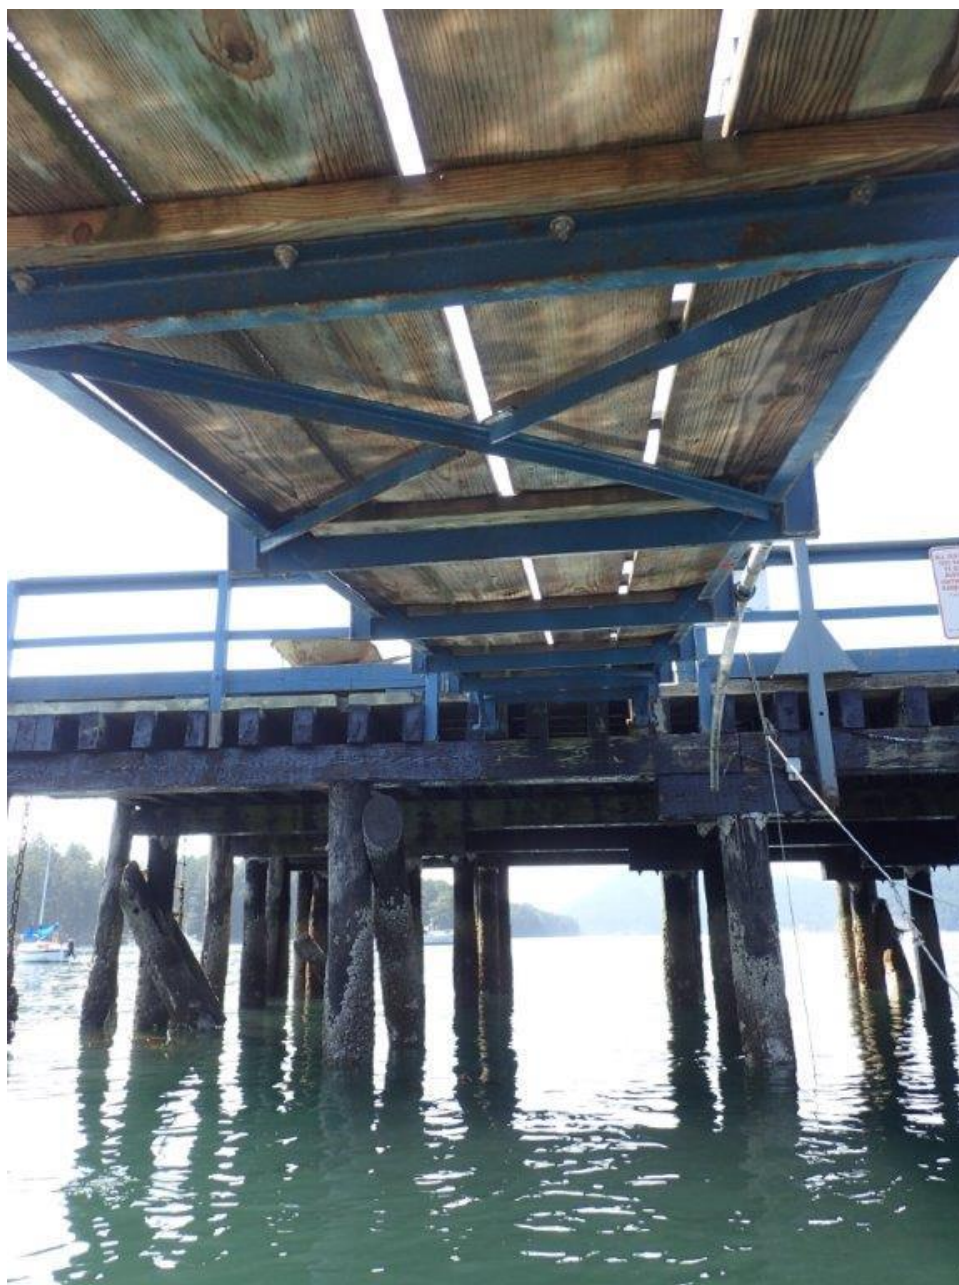
Photograph 76: Gangway A

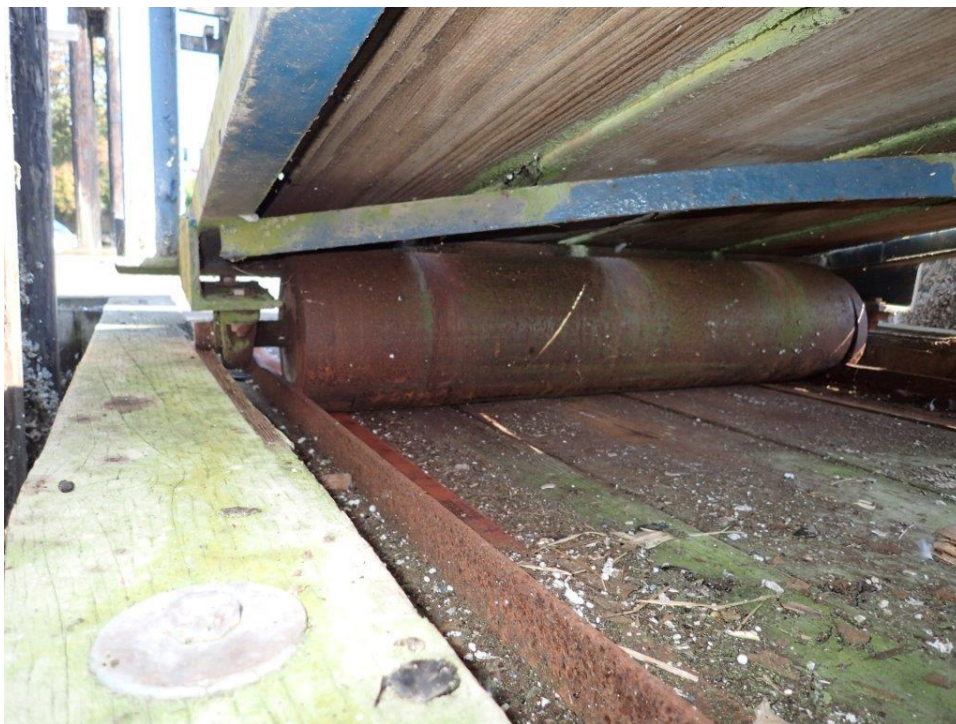
Photograph 77: Gangway A Guide Rails and Roller

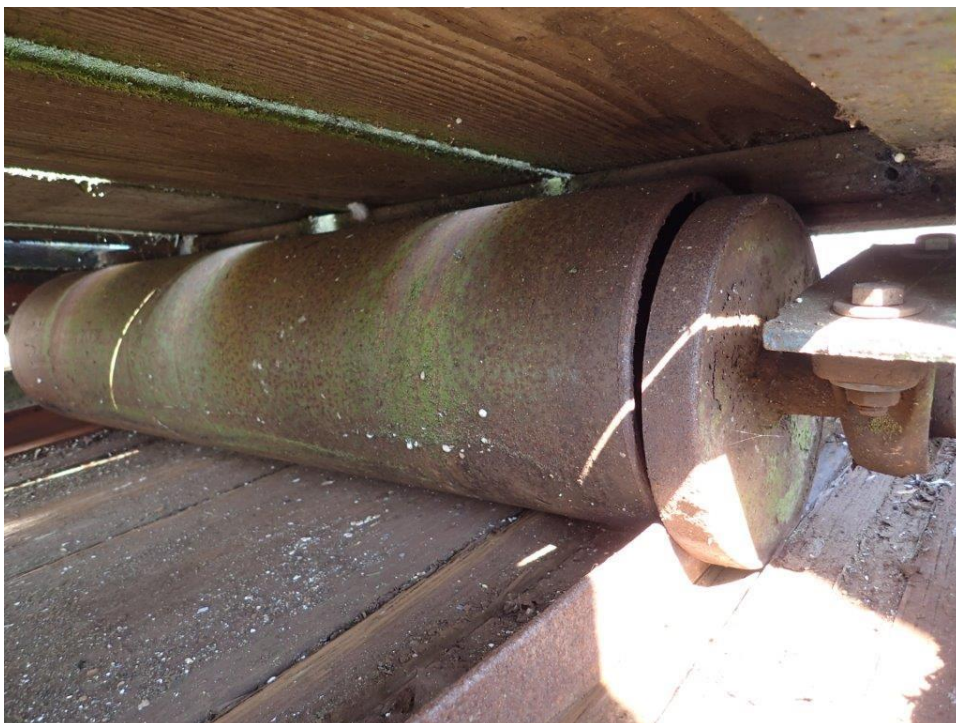
Photograph 78: Gangway A Roller

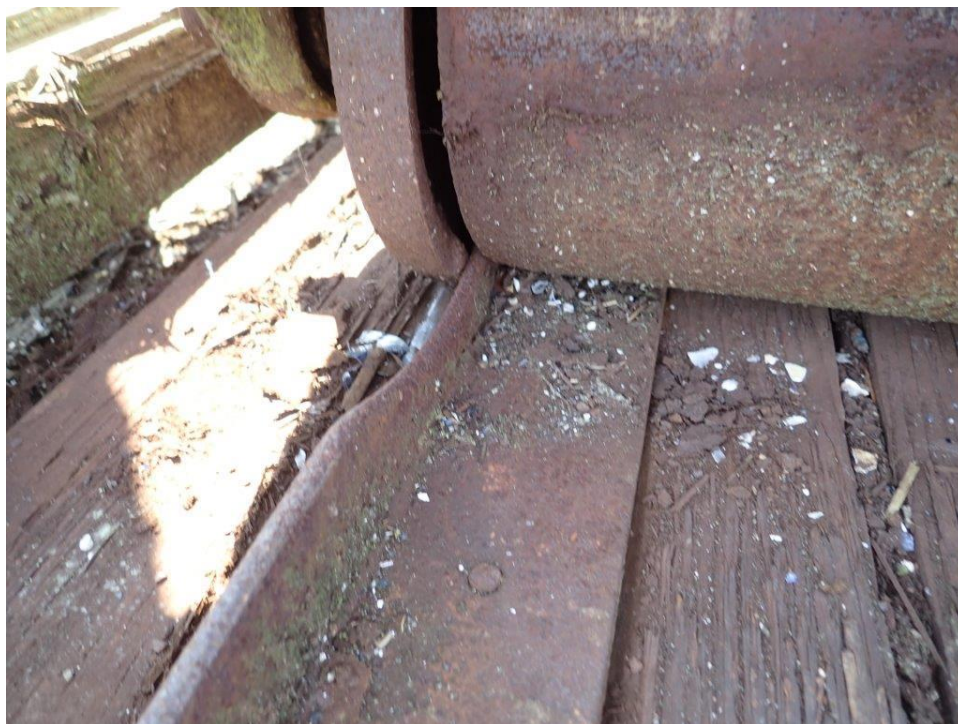
Photograph 79: Gangway A Roller

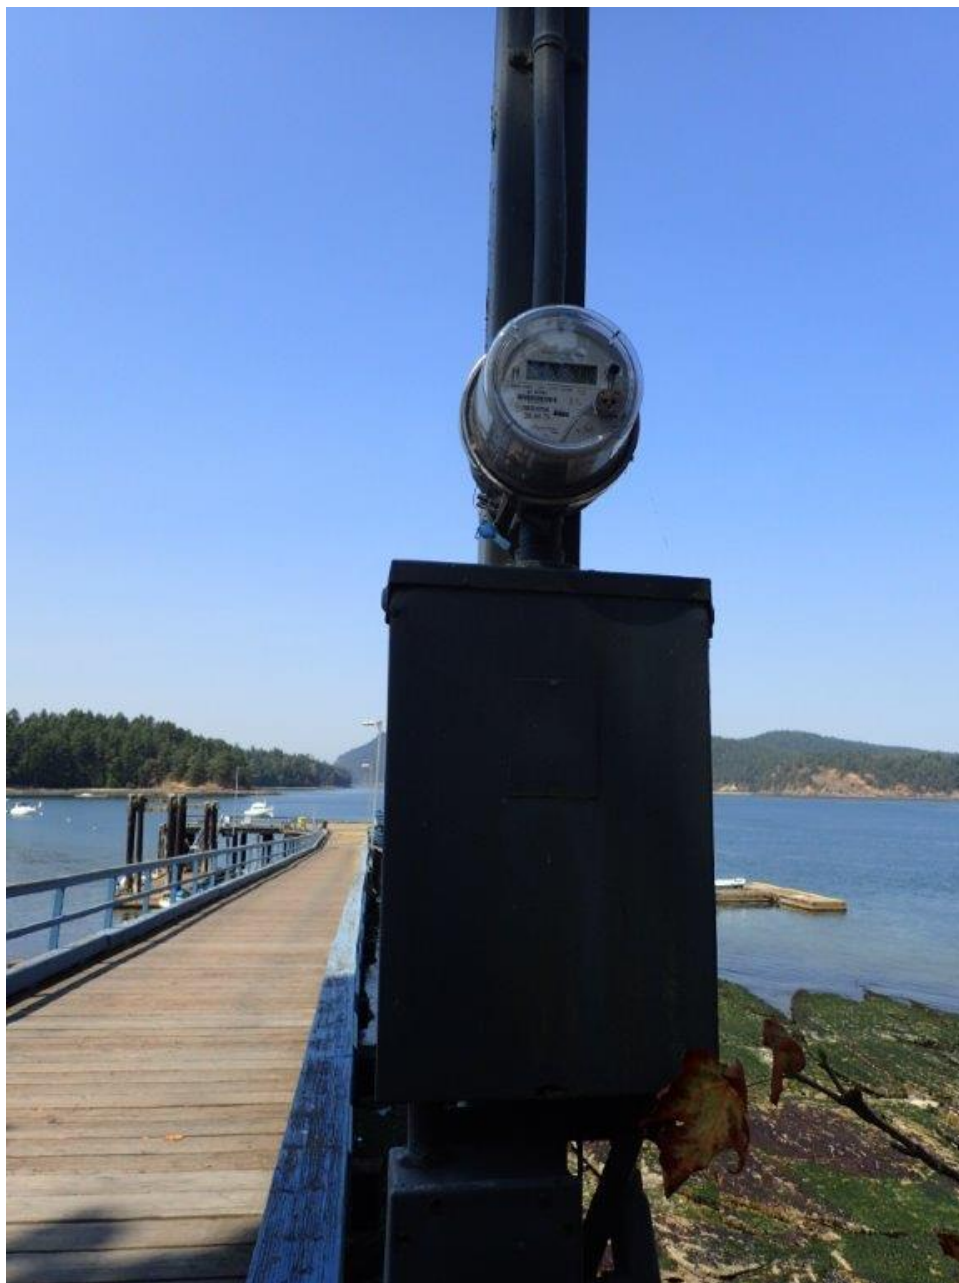
Photograph 88: Electrical Services

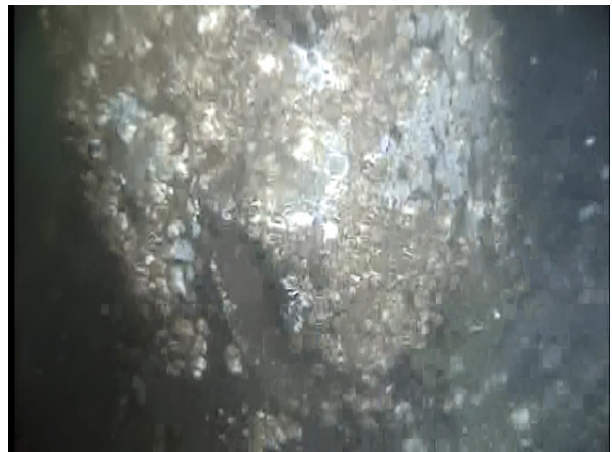
B) Southwest 4 pile cluster, piling on the NE corner; two cavities sighted approx 50mm deep x 130mmL x 30mmW near mud line.

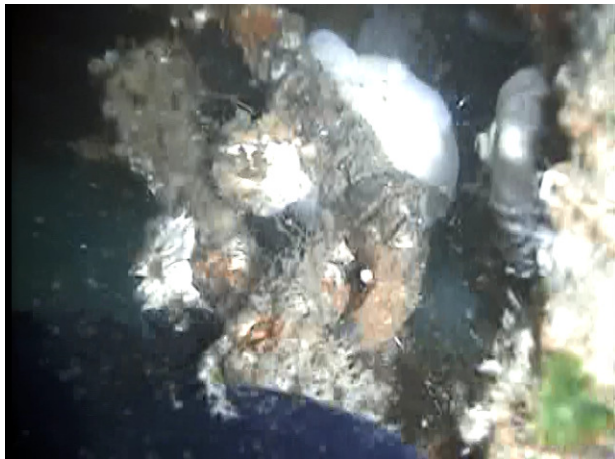
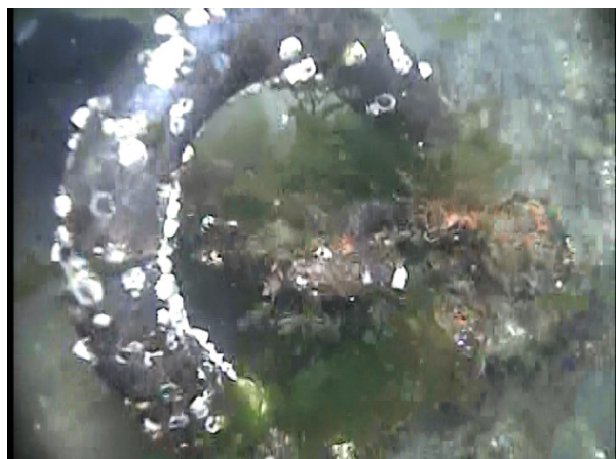
C) Anchor chains from N end of triangular float, 3 connections, up to 50% wastage on links in the tidal zone. Anchor connections secure approx 20% wastage on shackle

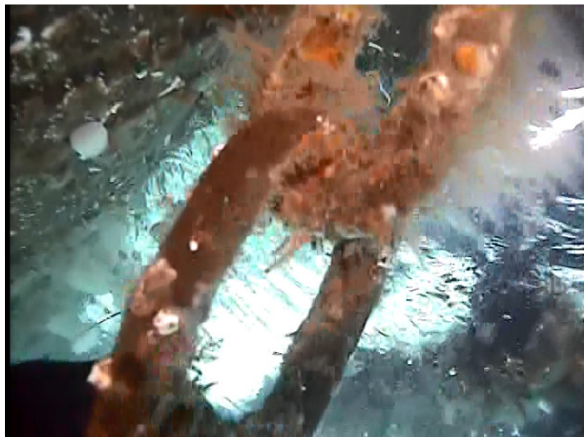
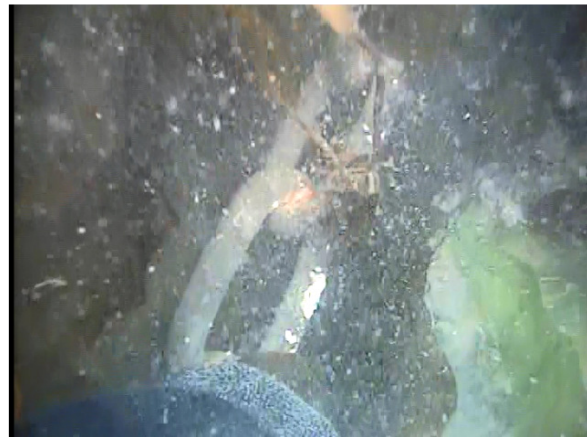
A) Anchor chain in tidal zones from dock connection has approx 10-20% wastage at the links. Chain along bottom up to 10% wastage.

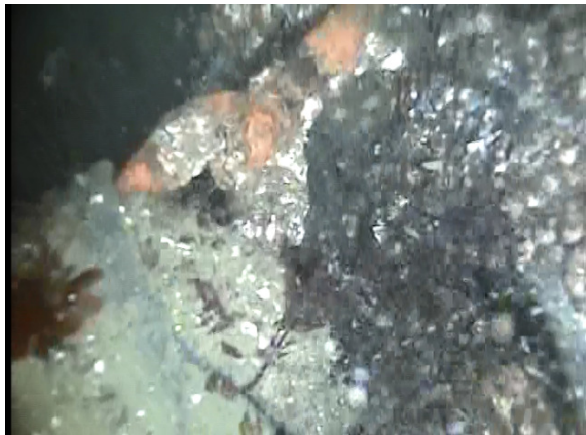
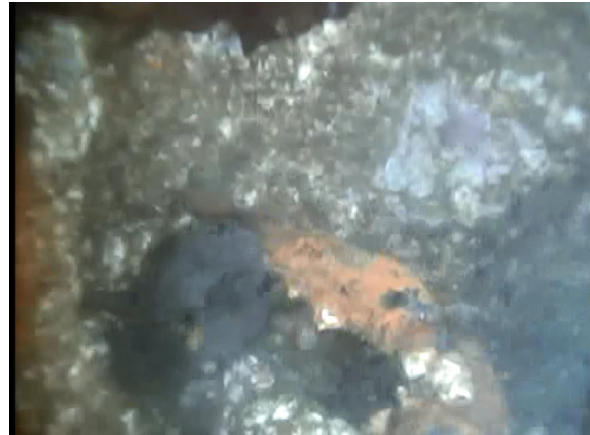
B) Float A, East anchor chain at block connection, chain link has up to 30% wastage.
