MINERS BAY DOCK FACILITY

CONDITION ASSESSMENT REPORT

Capital Regional District

M&N Project No. 8985 VC15

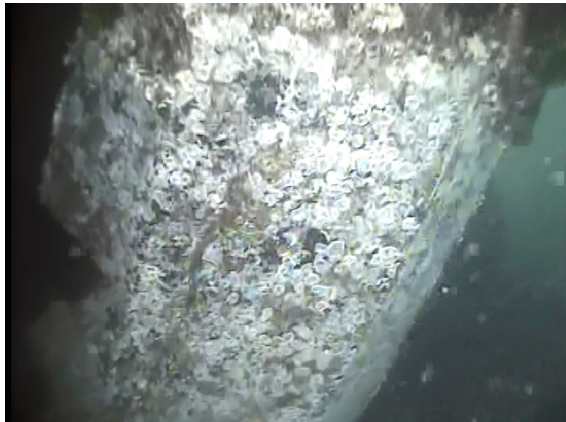
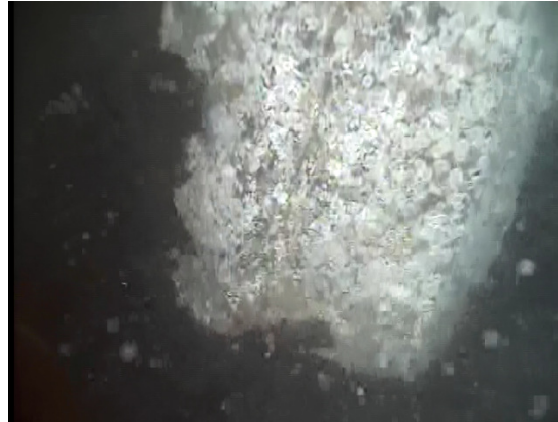
E) Concrete pilings #5 and #6: vertical fractures sighted up from mud line approx 400mmL.

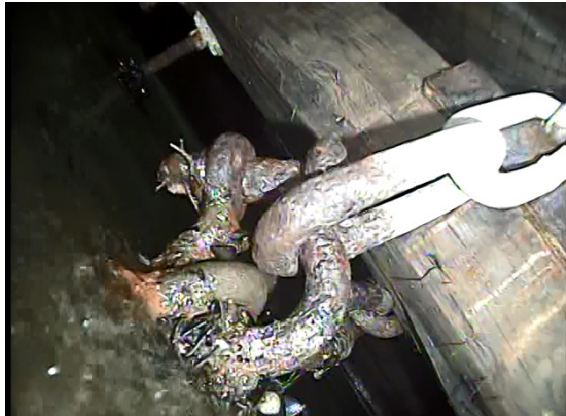
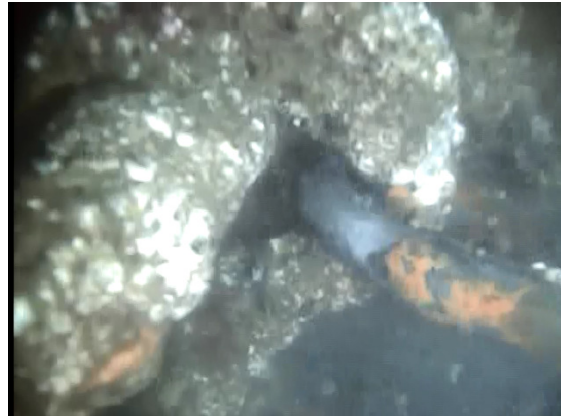
A) Anchor chain connections at North float running east, chain wastage up to 15%

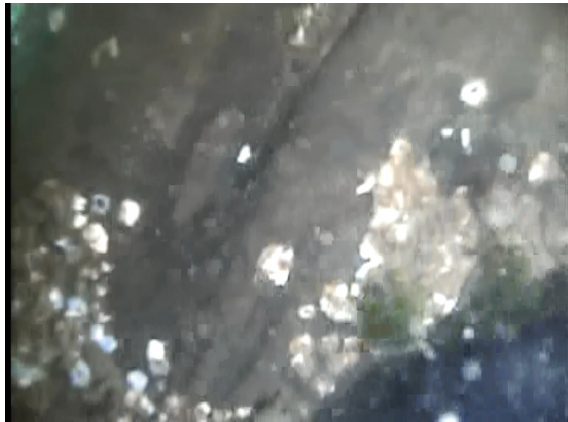
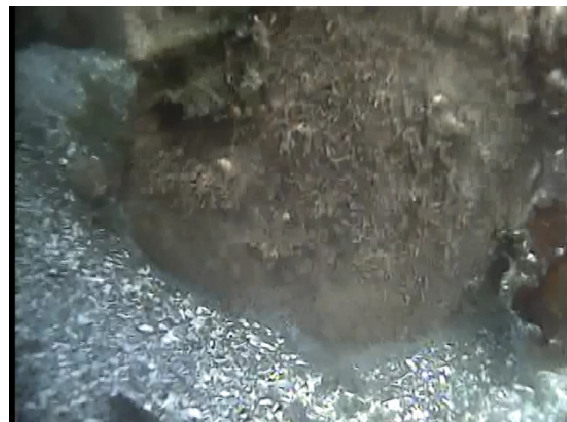
B) Gangway pilings exhibit few small cavities to 20mm depth, very scattered.

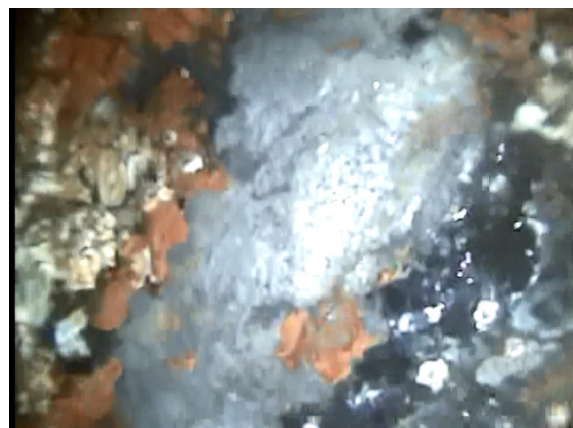
A) Approach steel pilings exhibiting surface corrosion and pitting in way of scattered areas void of coatings. Second row from shoreline pilings are pitted to 2mm depths. Remaining steels piles to the North reveal pitting to 1mm depths. No anodes were fitted to the piling.

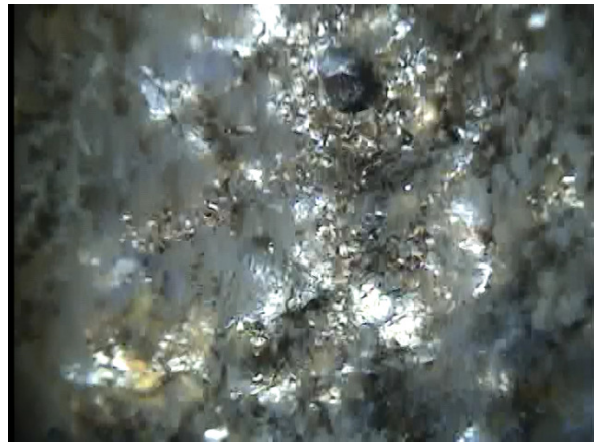
B) Non encapsulated foam billets under floats are deteriorated 10-20%

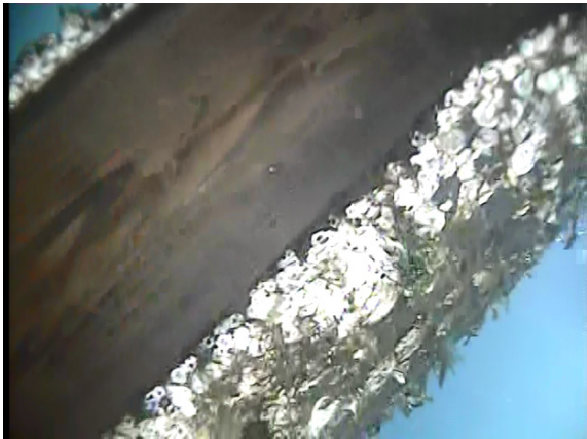
108:52 Wood pile

C) Float contact on wooden pile, wear approx 12mm. Steel pile wear from float approx 2mm, weld seam flush with pile surface. Scattered areas on steel pile, exposed corrosion to 1mm depths.

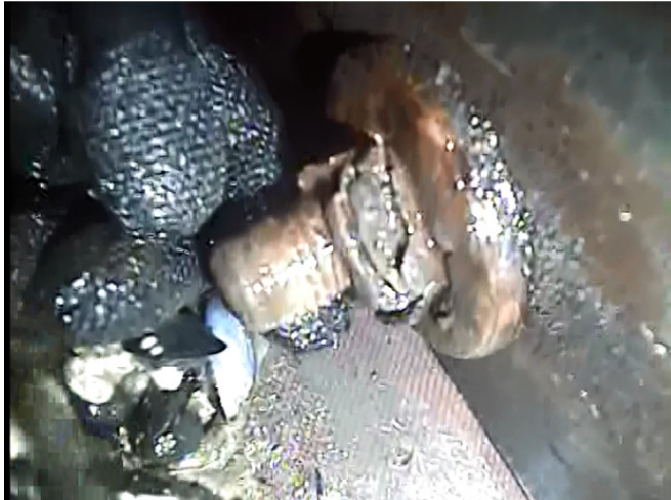
Ch.2; 17:56

E) Float fasteners exhibit moderate corrosion.

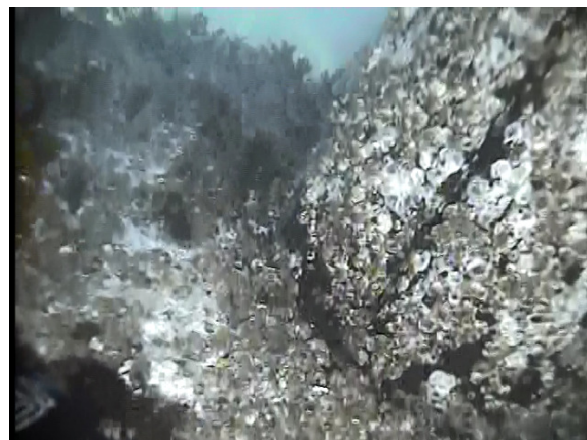
01:57

- A) Pile row #6 angle cross timber, hollowed out at end in way of piling C
- B) Crack lines evident in pile 6B at concrete pile foot

Split line at pile foot

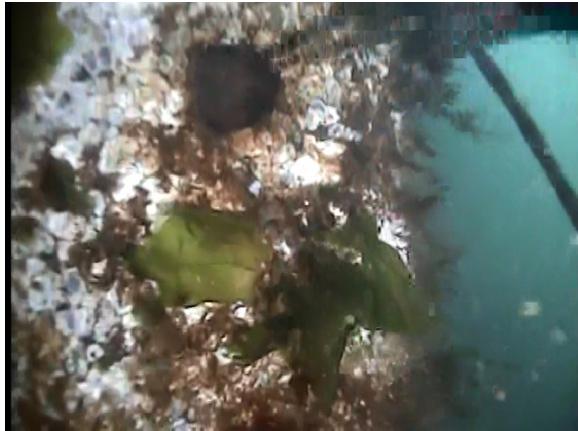
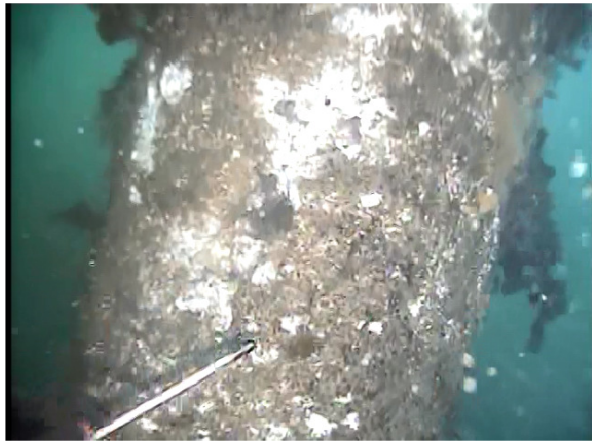
C) Scattered areas of small hole amongst the Wharf head and approach pilings to depths of 90mm opening to inner cavities. Each pile exhibits a certain degree of holes.

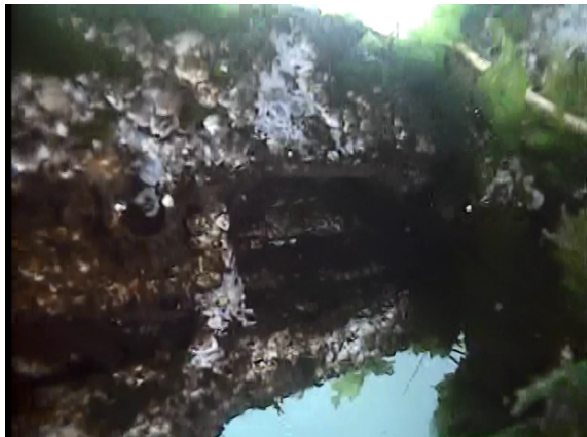
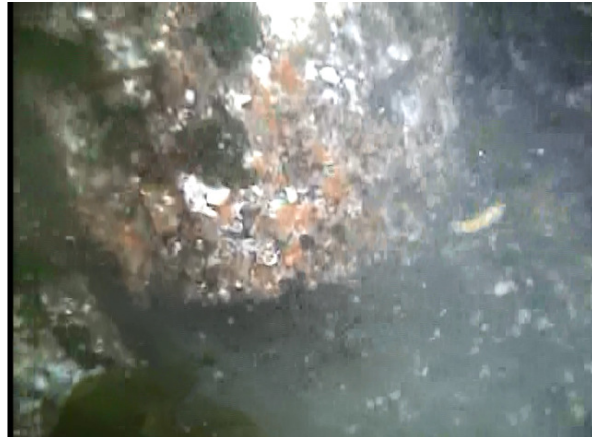
E) Row 8 Pile D, Cross timber hollowed out at low end. Pile bottom contact on rocks approx 20%.

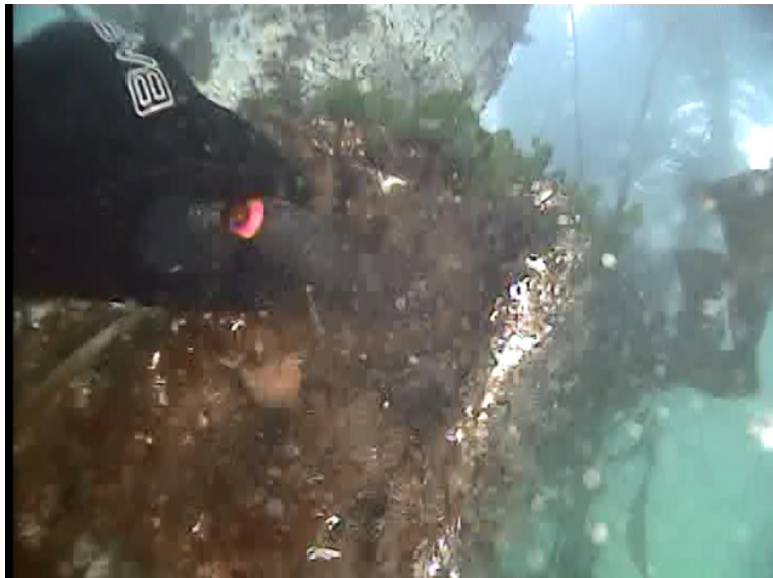
25:39

F) Row 10 Pile C, lower end of cross timber eroded out to a depth of 200mm

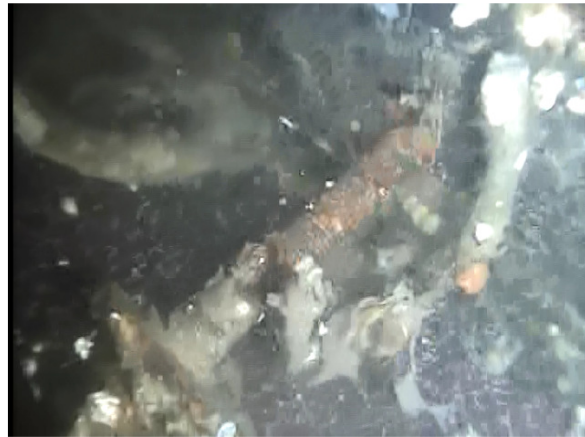
G) Float A, south side, east of gangway horizontal board dropped due to timber fasteners failing

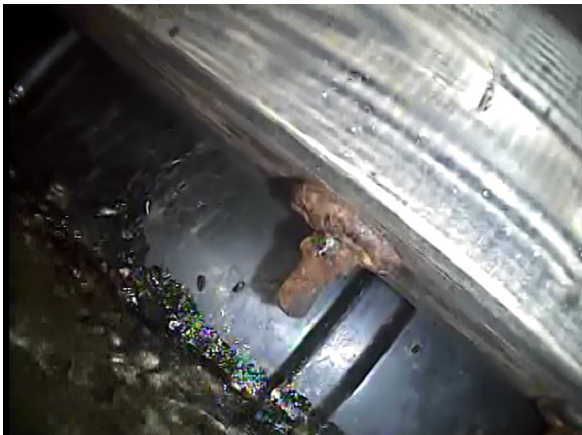
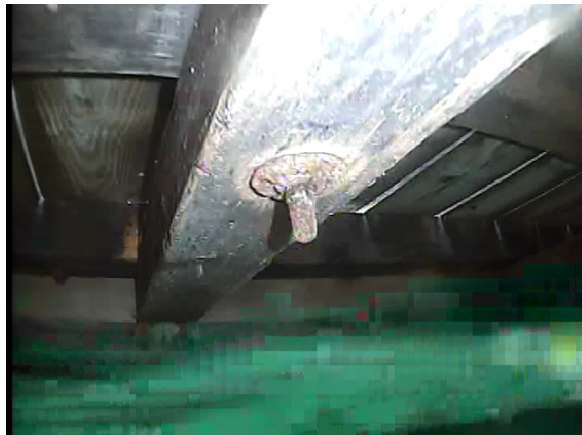
H) Float A & C timber fasteners, scattered areas of wasted nuts.

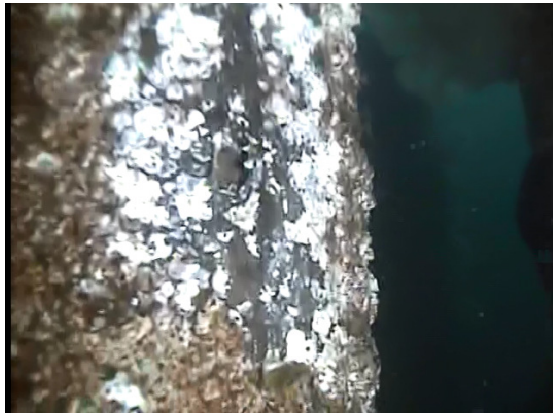
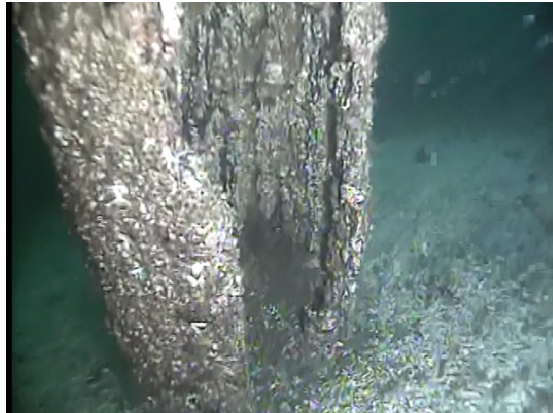
A) 3 pile cluster fender piles at west end of the approach. Multiple holes and outermost pile hollowed out at the bottom.

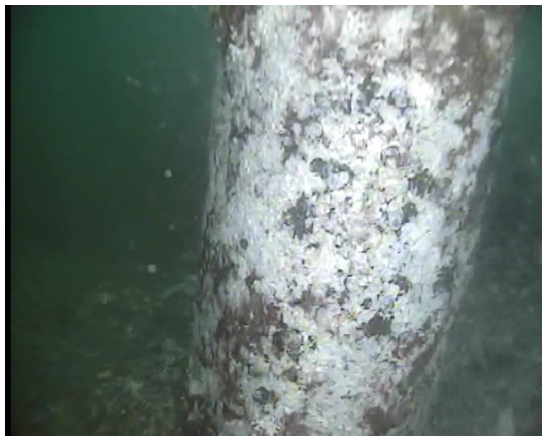
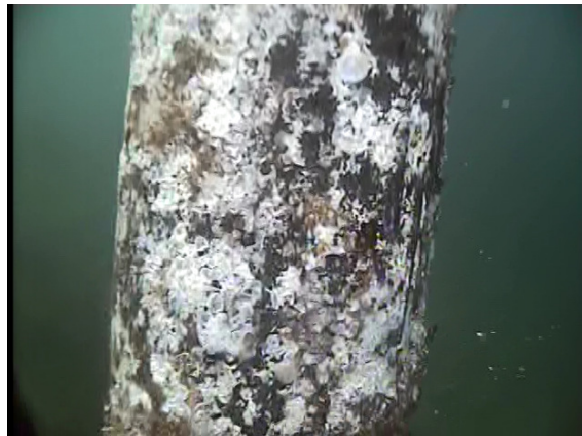
B) 3 bands scraped bottom, mid way and below water line, no abnormalities found

13:04 Row 9, Pile C (bottom)

24:53 Row 7 Pile B (mid way)

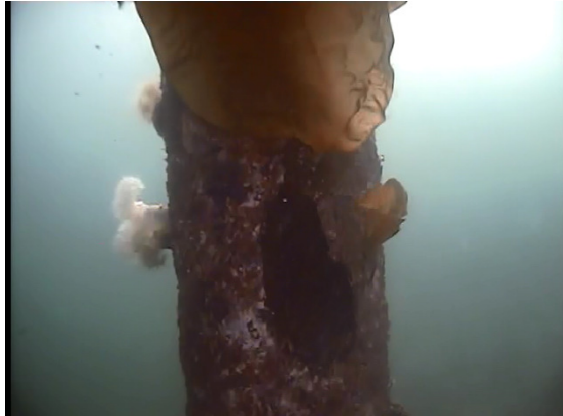
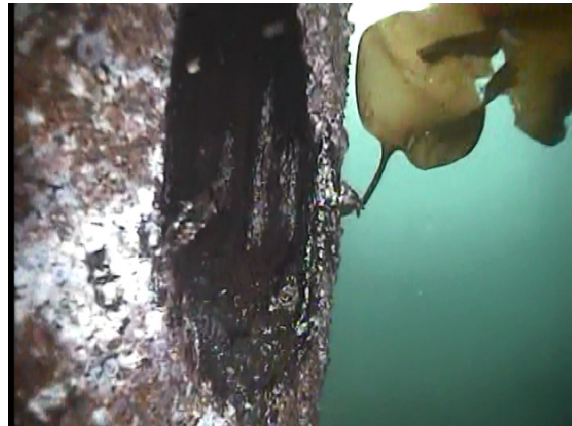
C) Row 8 Pile B has a large cavity approx 1.5M from bottom, measures 180mmDeep x 130mmw x 250mmH

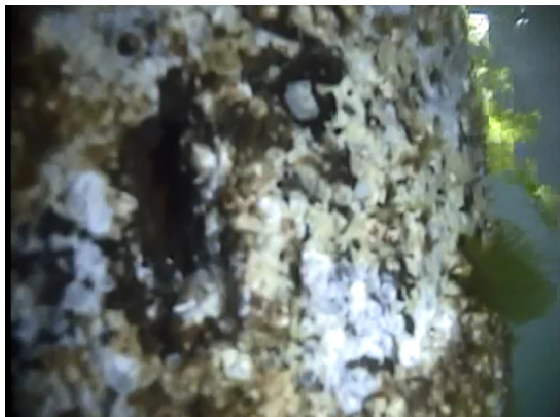
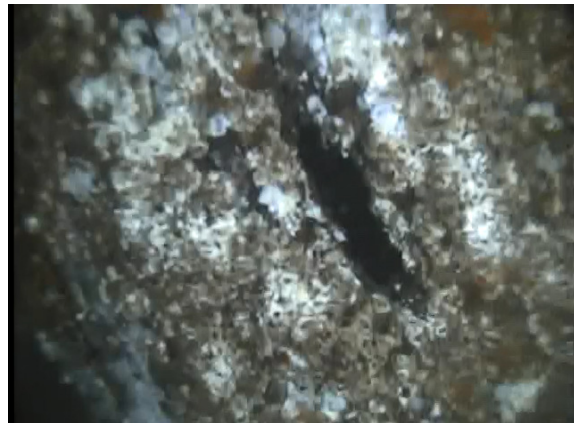
D) Scattered areas of small holes in pilings from Rows 6, 5 and 4, lines A and B. Depths up to 100mm.

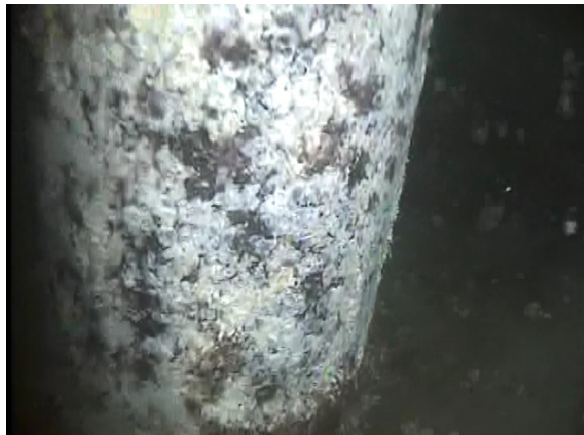
E) Scraped pile located at west cluster of three on pontoon float near gangway, north most pile. No abnormalities sighted.

43:28 Scraped pile

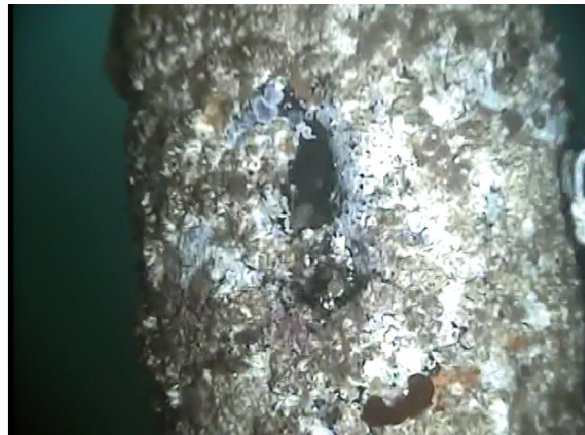
F) Very scattered shallow cavities found on the float piles, max depth 20mm.

46:40 Cavities

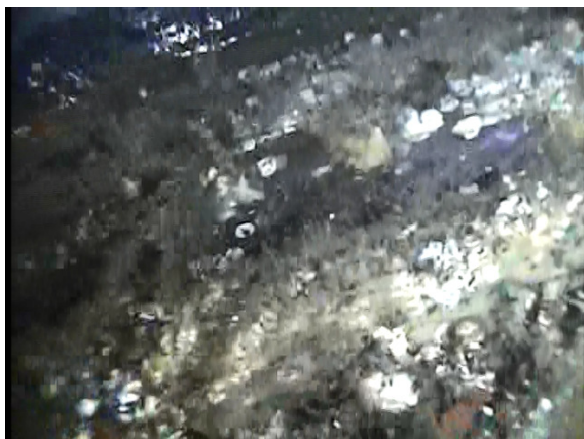
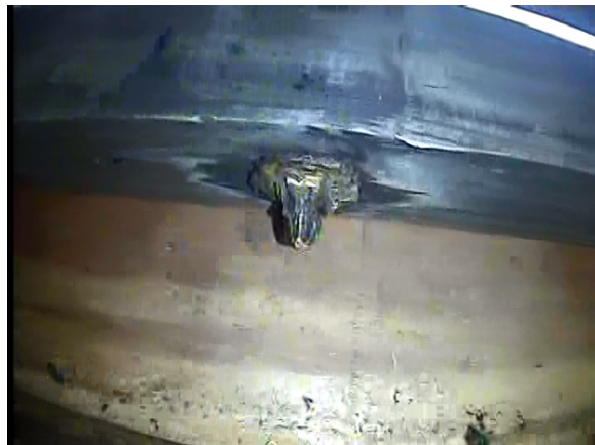
G) Side boards on pontoon float show signs of erosion at scattered areas, timber bolts are at varying degrees of metal wastage, still remains secure, bolts at max are 70% wasted

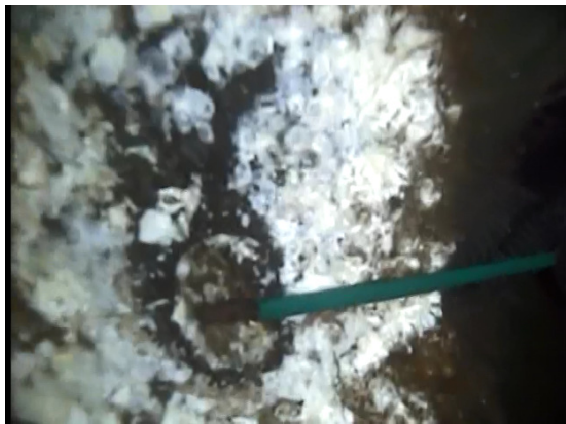
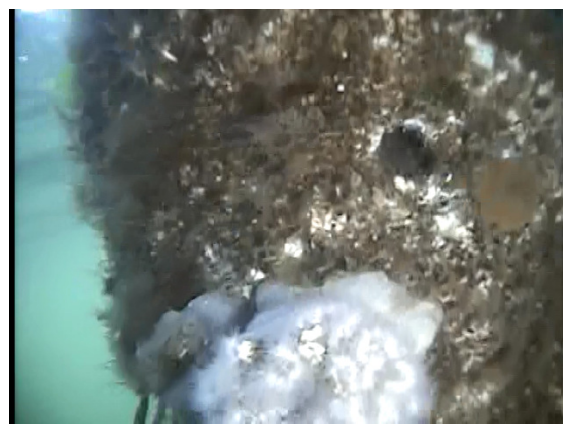
A) Piling condition generally good with very few scattered small cavities to depths of 40mm max and widths of 40mm. Diver u/w inspected the approach piles to row 22

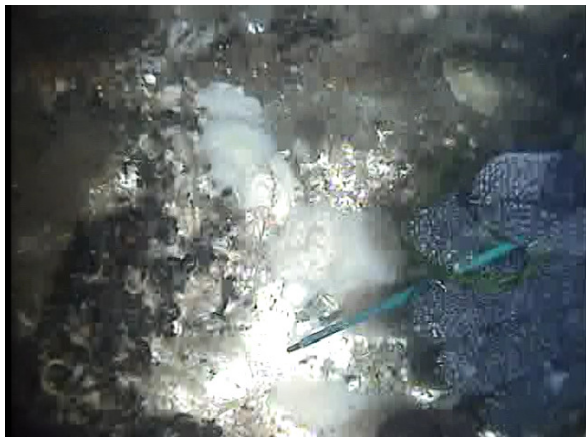
B) Older exposed foam billets show deterioration to approx 10%. Newer billets fiberglass coated are in good shape.

Exposed foam

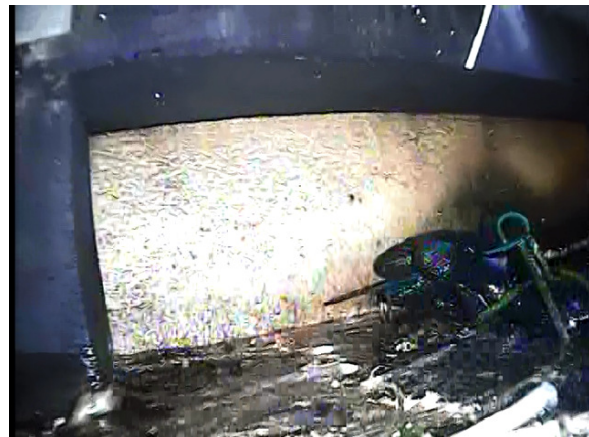
Encapsulated foam

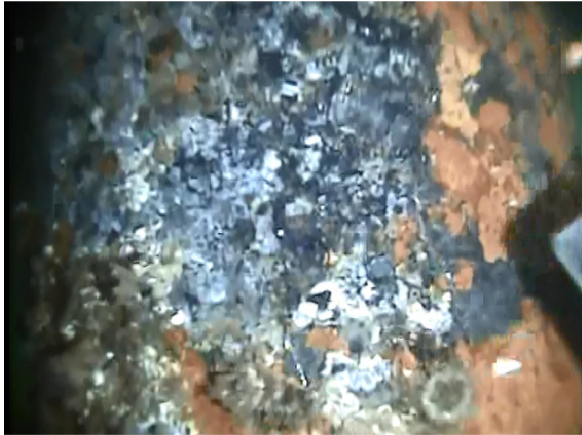
A) Steel pilings total of 4 exhibited corrosion spots to 2mm depths. Fitted anode brackets were 100% depleted of anodes.

17:45 Pitting to 2mm depths

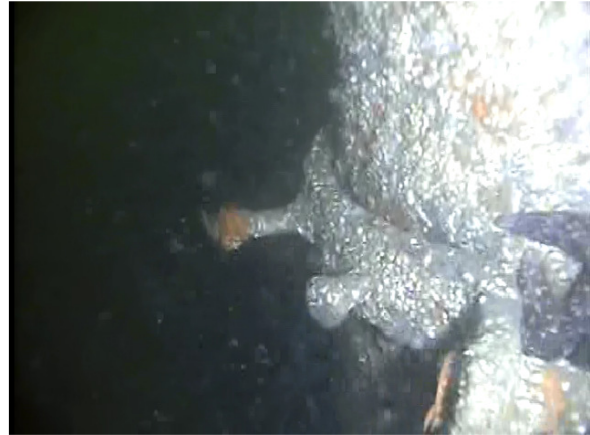
18:38 Anode brackets

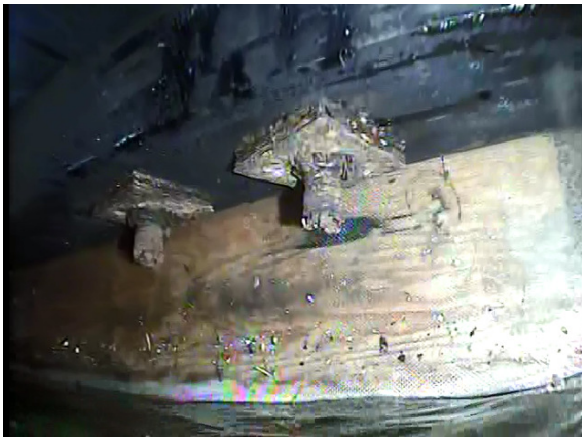
B) Float fasteners found to be corroded, scattered areas up to 80% of bolt wasted.

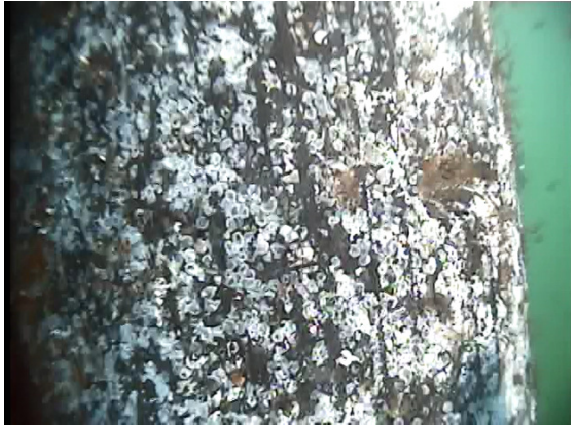
B) Break water piles are numbered 1 -93 beginning from north end. Piles 15, 40, 60 and 80 were scraped below water line, mid way and mud line, no defects sighted on those piles.

32:06 Pile 15 scraped band (Mid)

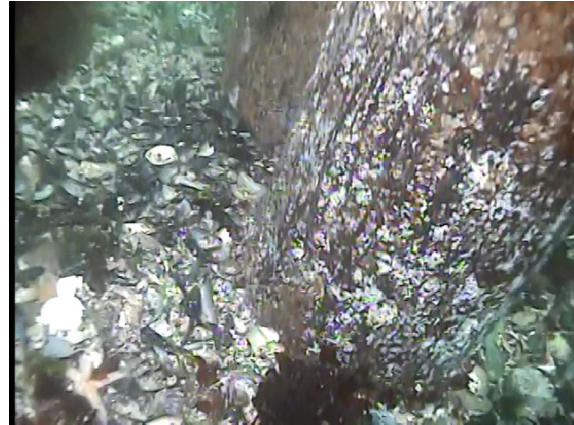
43:50 Pile 40 scraped band (lower)

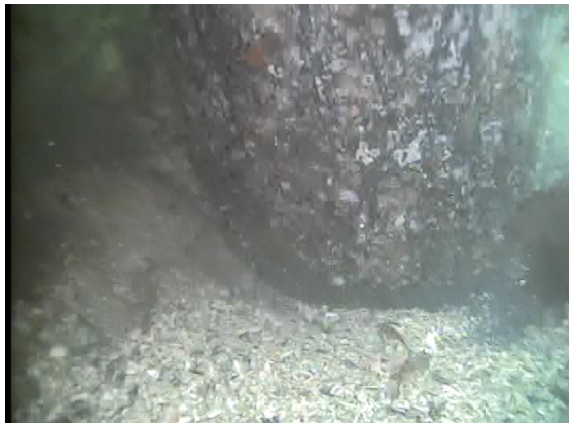
52:32 Pile 60 scraped (lower)

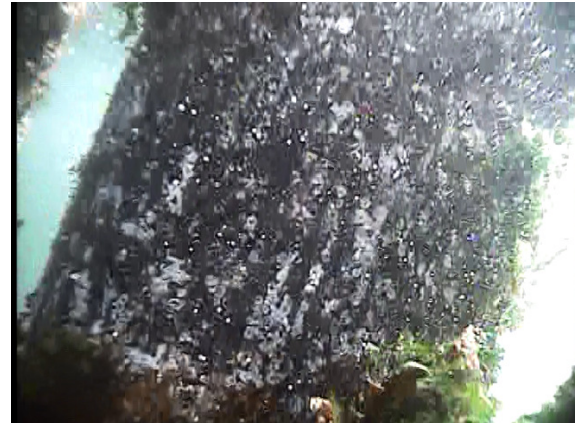
1:10:19 Pile 80 scraped (upper)

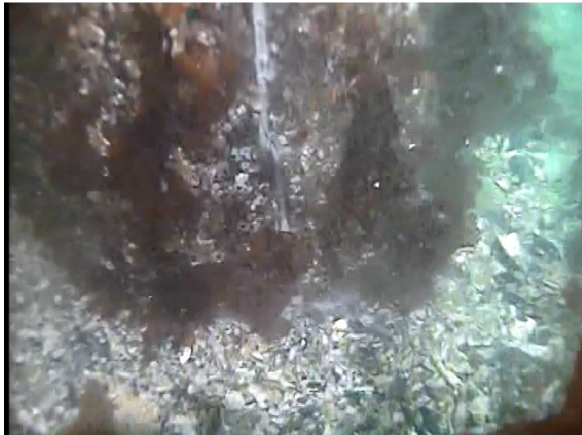
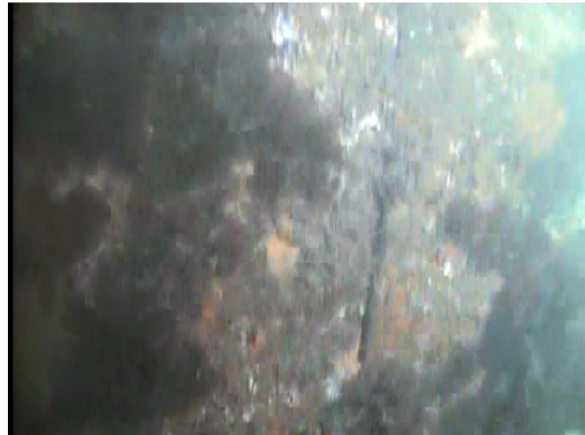
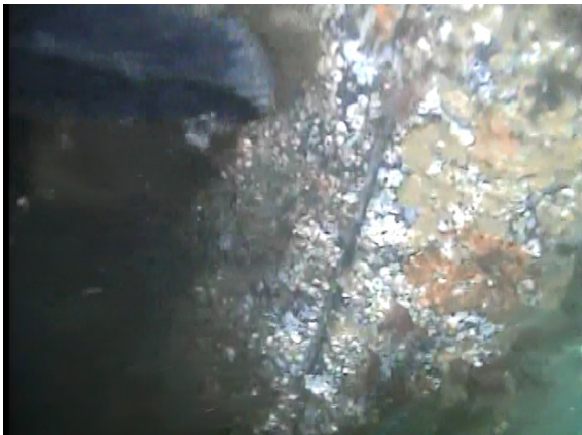
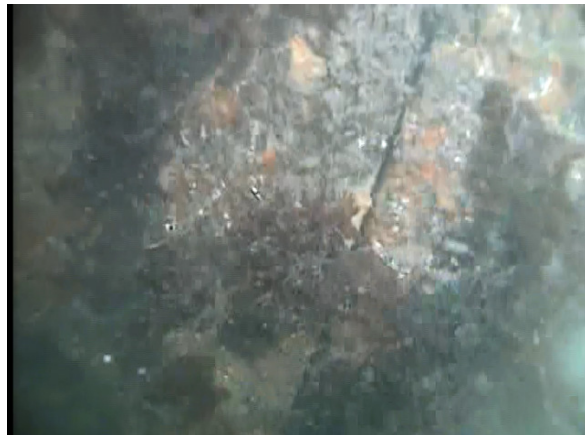
B) Piling 63, west face of break water, crack running up from mud line for approx 1.2M then a second crack alongside starting and running approx 2M up the pile.

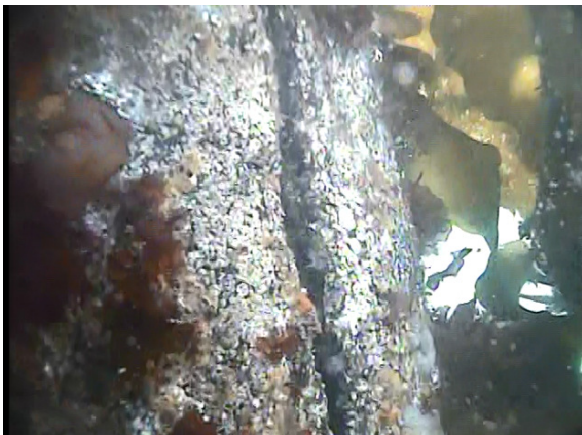
1:19:39

C) Pile 93 west face, approx 1.5M from bottom; cavity 75mmD x 400mmH x 25mmW

Cavity

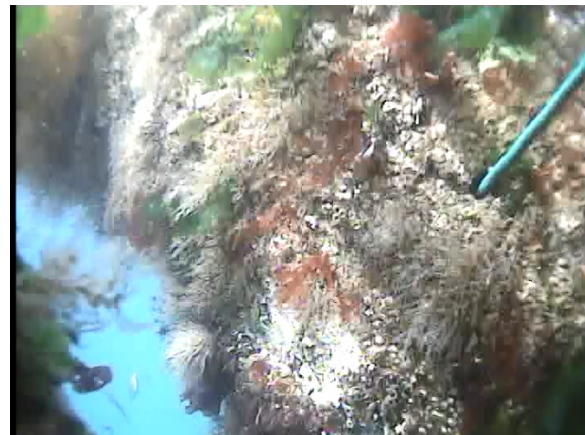
D) Pile 52 east face, small hole 25mm deep x 20mmW

Ch.2; 10:46 Small Hole

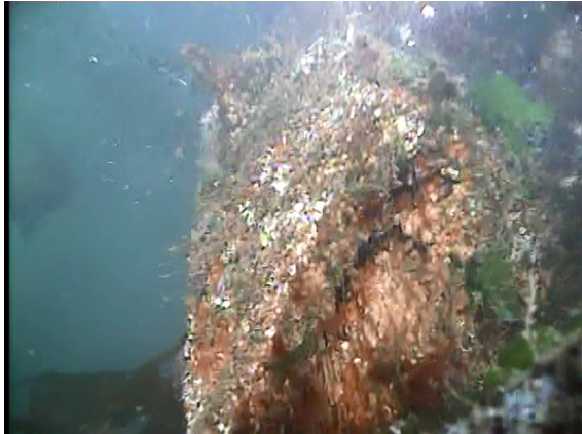
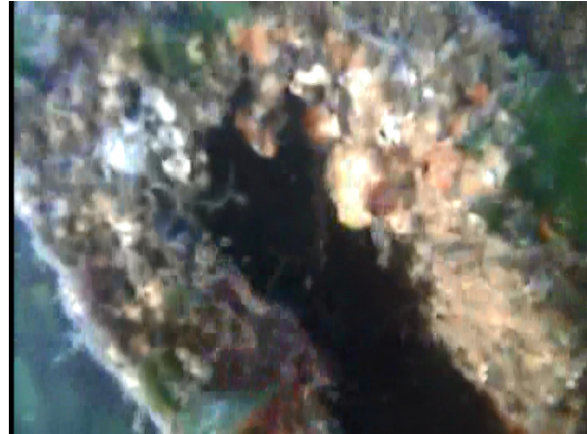
E) Row 14 pile F cross timber hollowed out at lower end approx 100mm deep

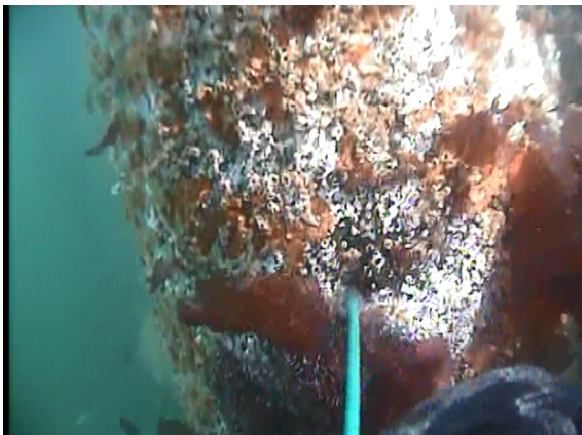
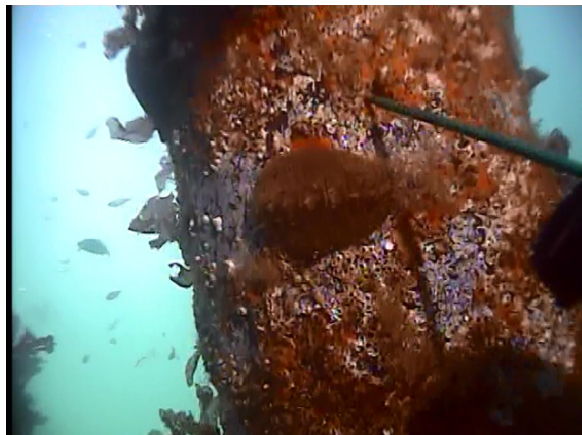
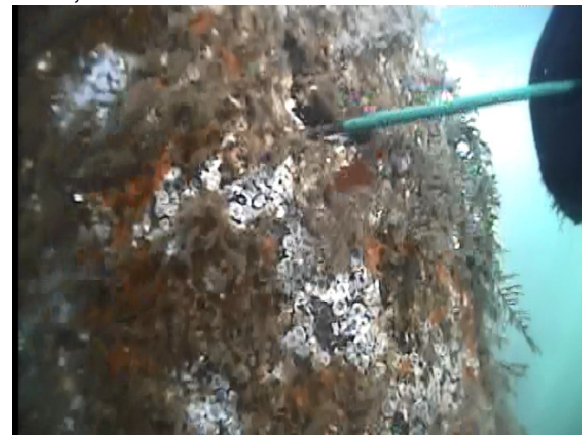
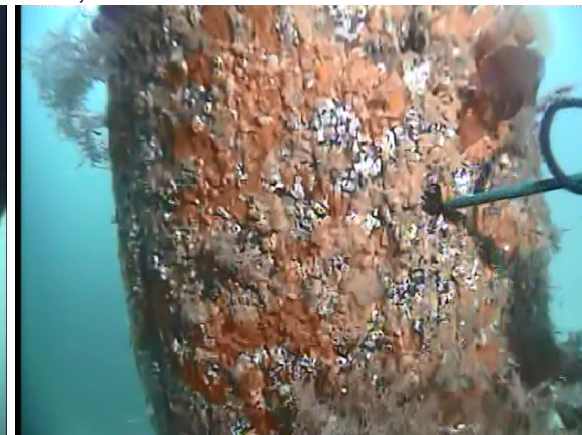
F) Scattered holes found on approx 7 of the 23 piles on the main approach. Max depths 60mm x 25mm wide.

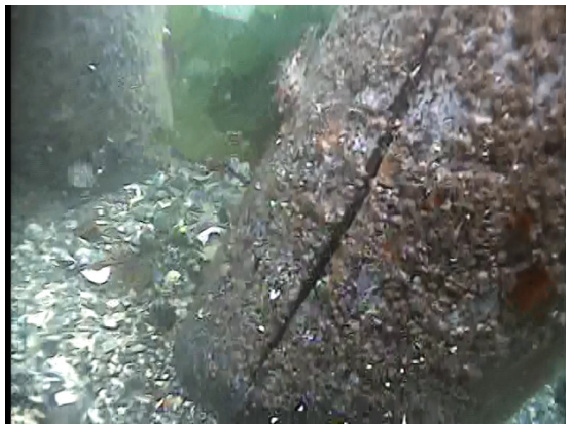
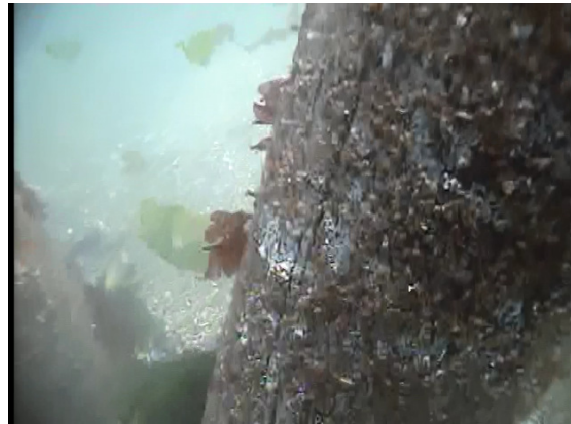
G) Row 9 Pile H, east pile of the pair; 1 meter crack from mud line up and approx 12mm wide at max.

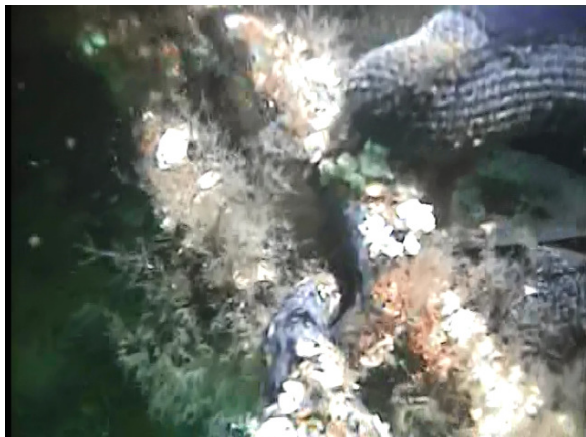
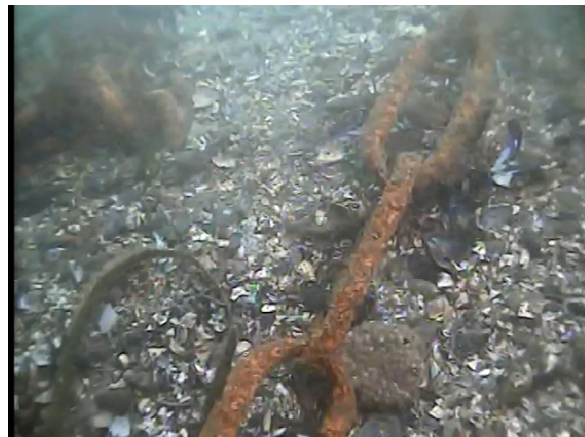
A) Float C east anchor chain, wear near connection 40%. Run of chain to anchor approx 80% wastage.

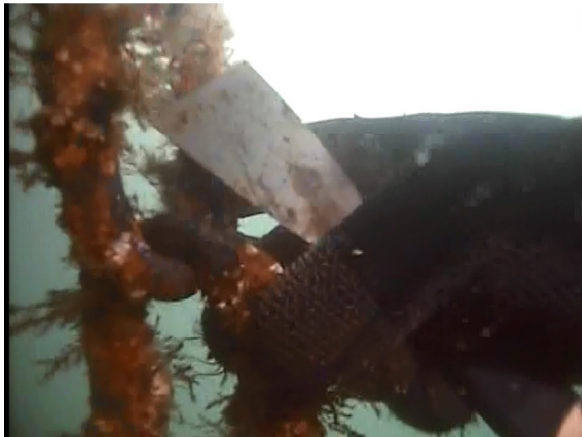
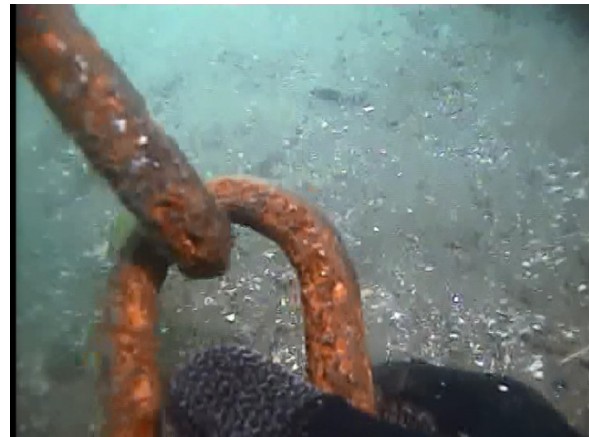
B) Float C west anchor chain, wear near connection 30%. Run of chain to anchor approx 50% wastage.

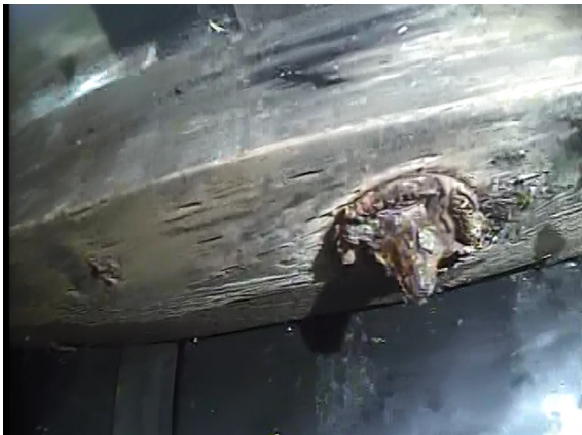
D) Float timber fasteners have varying degrees of corrosion. No loose boards were sighted.

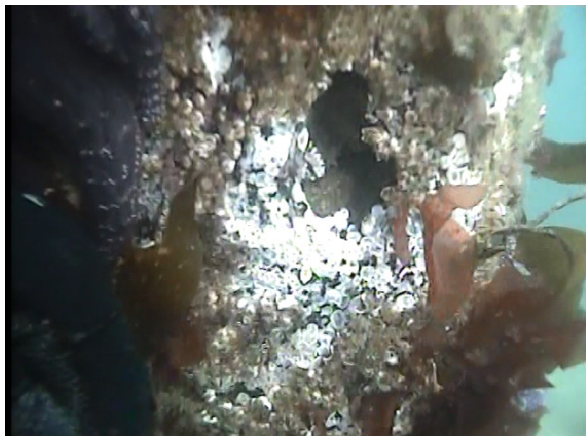
Ch2; 42:35 Row 21, pile B cavity 50mmD

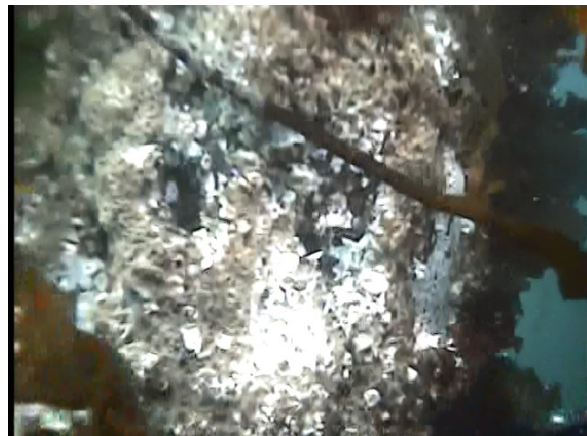
Ch2; 47:01 Row 21, pile C cavity 30mmD

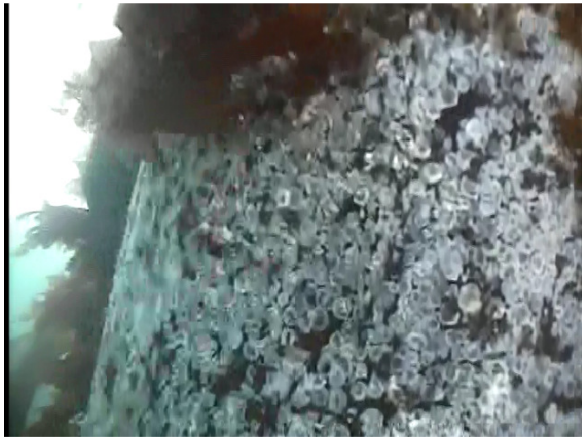
B) Row 26 Pile C scraped, 3 bands; Mud line ,mid way and below water line

Ch2; 14:45 Mid way

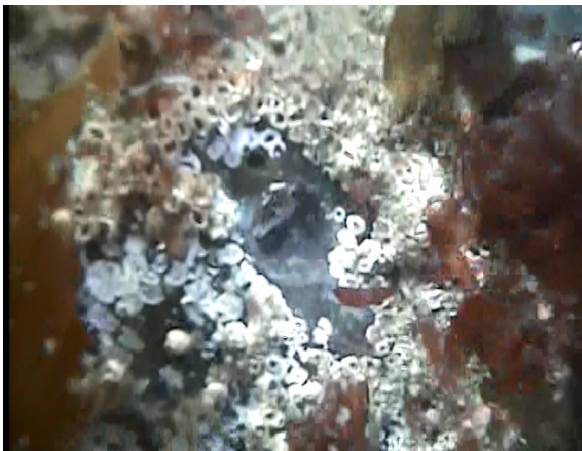
C) Row 30, pile B cavity approx 25mmD mid way up pile.

Ch2 108:08 Row 30 pile B (cavity)

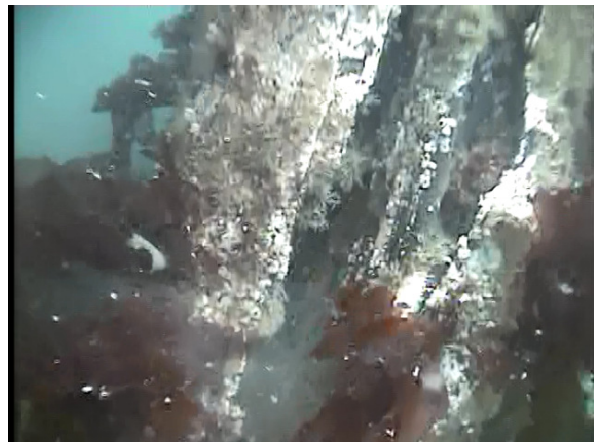
D) Row 32 Pile C cavity split at mud line approx 200mmD x 600mmH x 150mmW

Ch3; 06:57 Row 32 Pile C Large cavity split

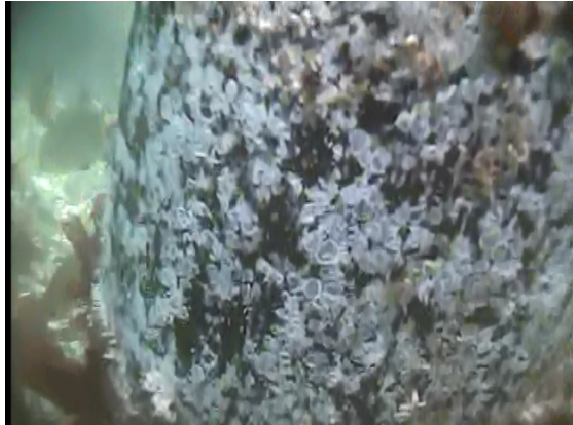
E) Row 33 Pile B 3 bands scraped at waterline, mid way and mud line, No abnormalities sighted.

Ch3; 09:47 Row 33 Pile B Scraped

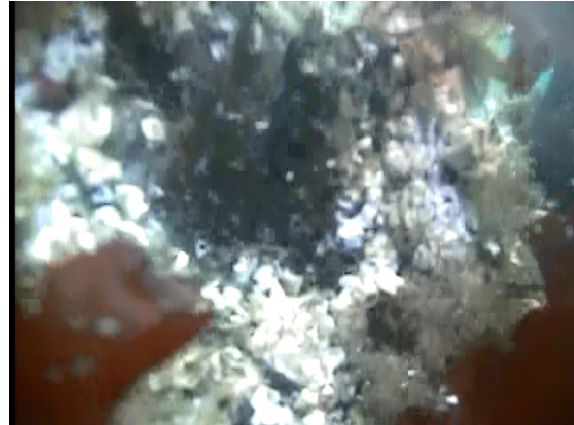
F) Row 34, batter pile, 75mmDeep x 25mmW cavity approx 1M from mud line.

Ch3; 17:53 Row 34 Batter Pile cavity

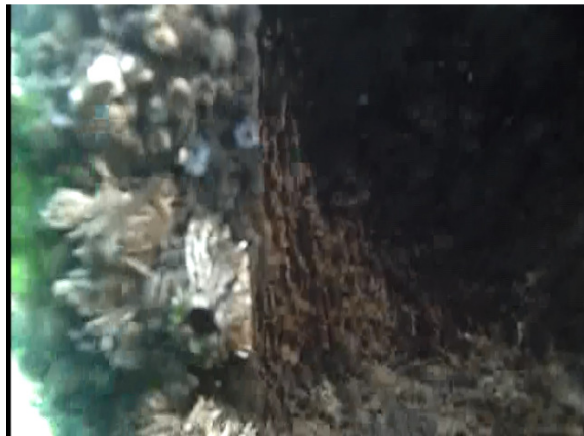
G) Fender pile clusters at North face of the wharf, to sets in way of Rows 39 and 37, piles exhibit large cavities, splits and small holes. Outer piles are cladded with a steel plate half sleeve. Piles are deteriorating, but appear to be moderately sound. They are not part of the wharf structure.

Ch3 29:58 large cavity approx 200mmD

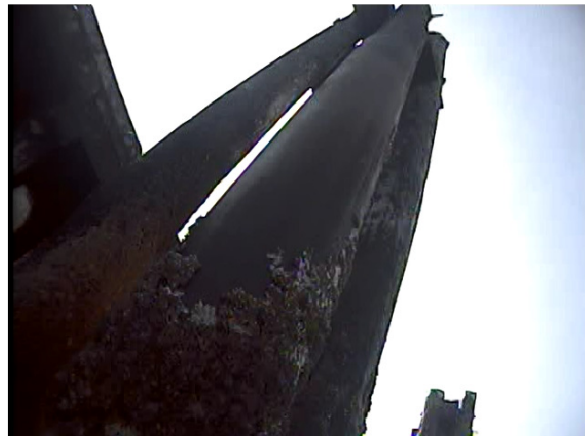
Ch3; 29:24 fender cluster

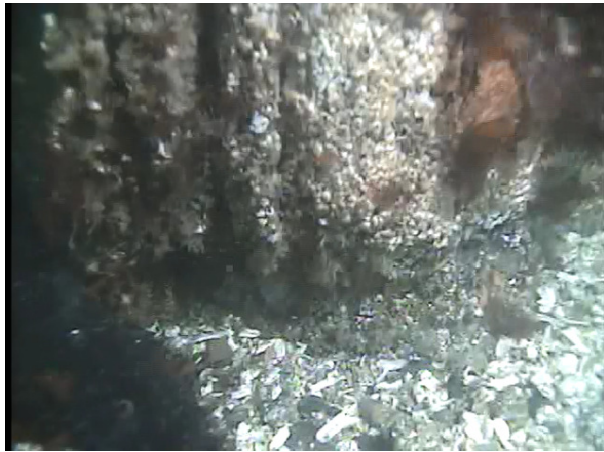
Ch3;47:17

H) Row 38 Pile B line, At mud line eroded approx 80mm deep x 200mmW approx 30% around pile.

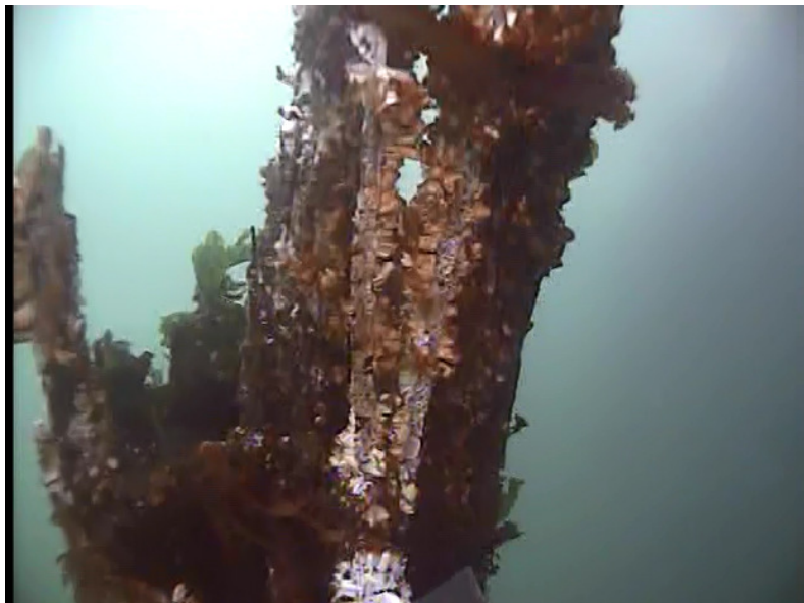
Ch4: 00:29

G) Row 39 Pile A below water line pile is rotted out almost completely.

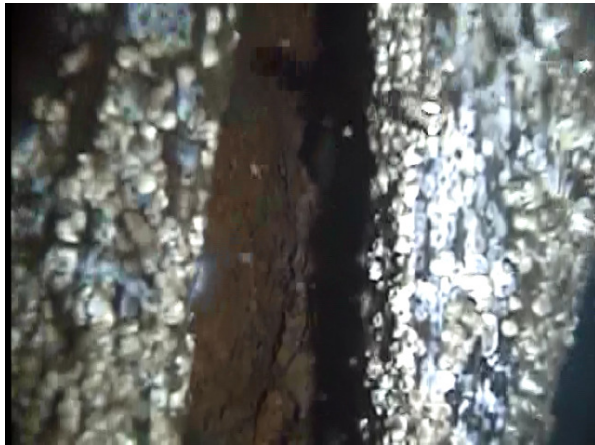
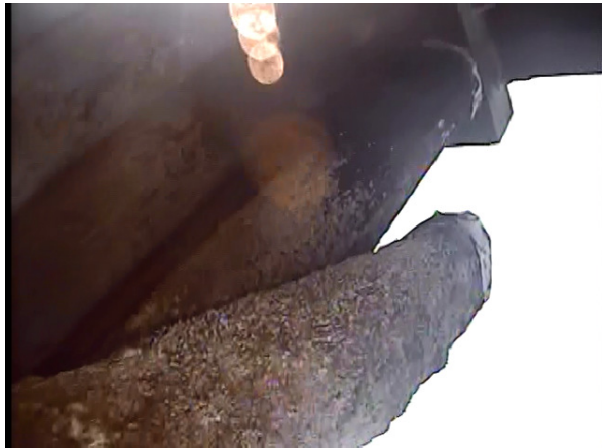
H) Row 40 Pile A, Vertical support pile, hollow section approx 2m up from mud line.
Approx 25% absent x 400mmH

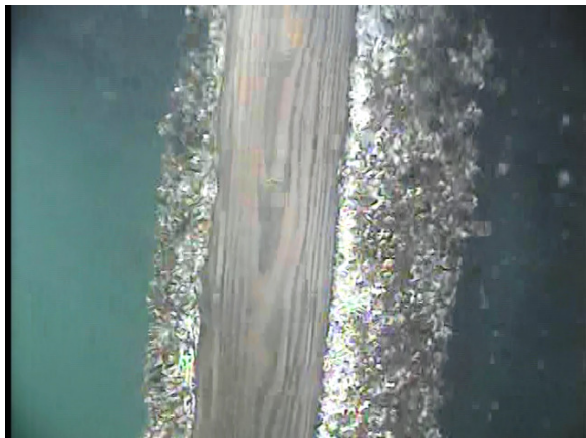
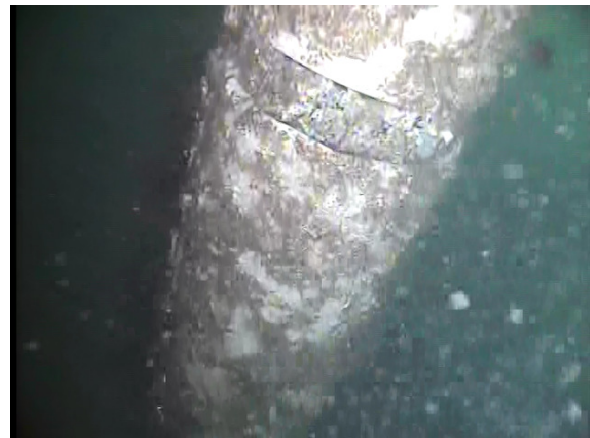
I) Rub marks on outer piles on row 40.

J) Majority of the pilings from Row D toward row H are fitted with pile wrap, no significant defects were sighted.

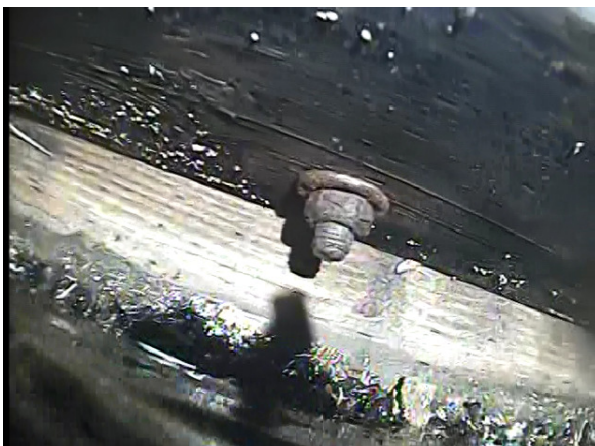
A) Float timber fasteners on fingers E and F approx 5-10% corroded.

B) Finger floats E and F have exposed foam billets with deterioration to 10-15%

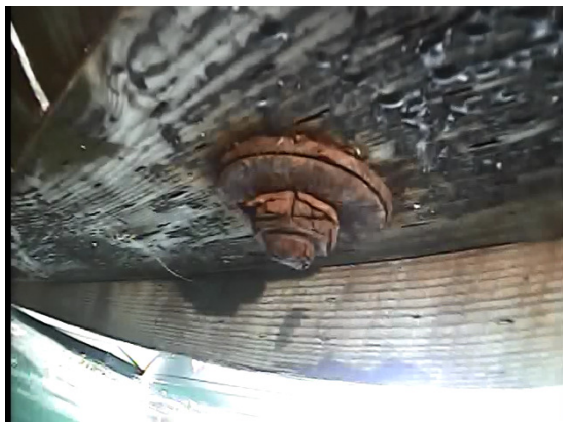
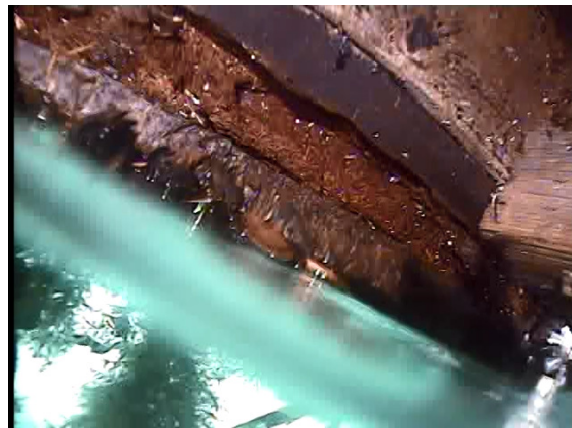
D) Float A North section, timber fasteners exhibiting corrosion.

E) Section of float horizontal timber, located at north end of float A on west side in way of the 3 piles at corner. Rotted section from outside running inward about half way.

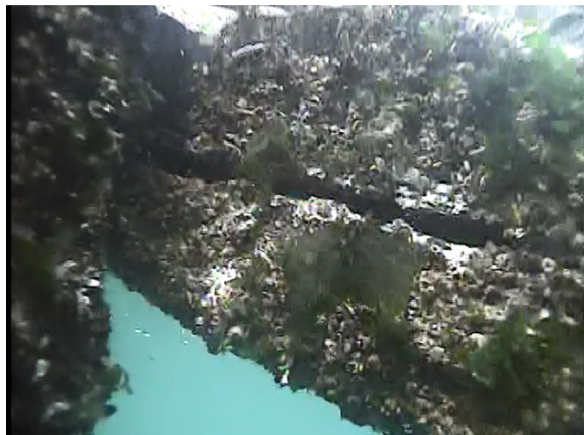
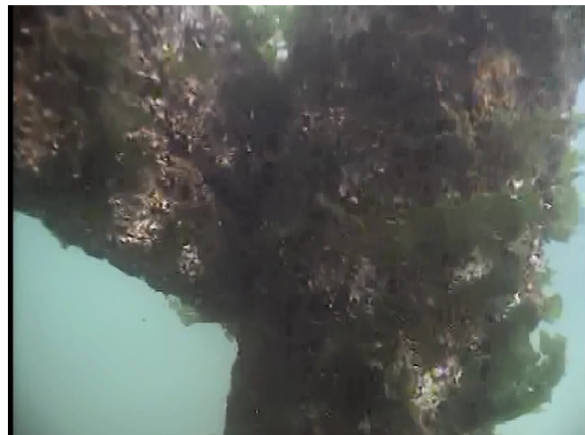
F) Row 6 pile diagonal cross member on main approach has a crack from propagating from both ends in way of the vertical pile fastening bolt. Each runs for approx 1 meter.

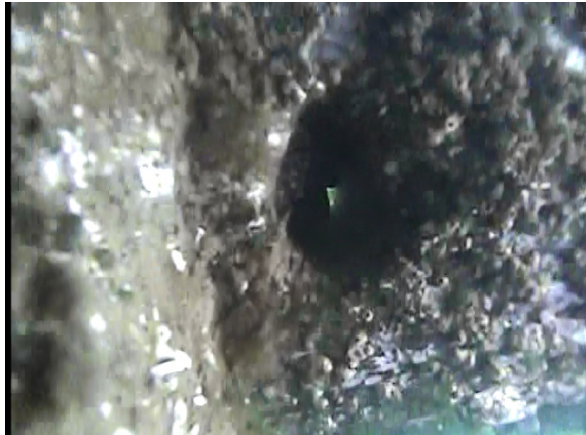
G) Pile row 2, first row where piles are set in concrete, a hole found in the east and west piles near the concrete setting. The holes run completely through and are bored out in the inside approx 75mm diameter.

41:55 East pile

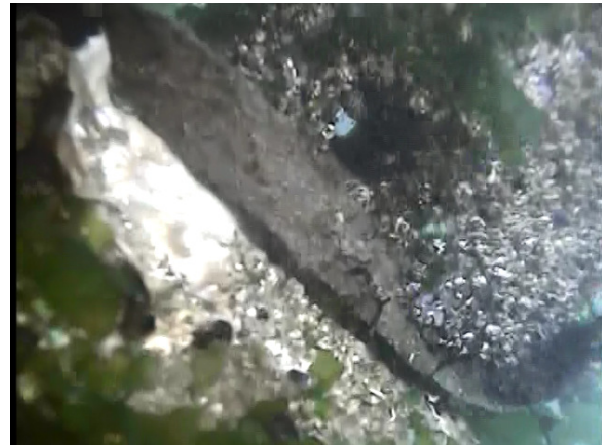
44:37 West Pile
