MINERS BAY DOCK FACILITY

CONDITION ASSESSMENT REPORT

Capital Regional District

M&N Project No. 8985 VC15

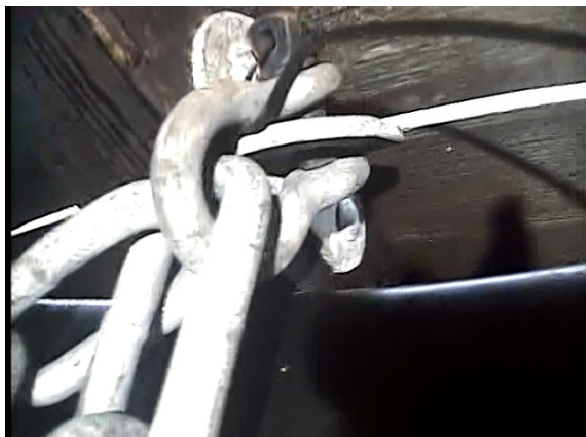
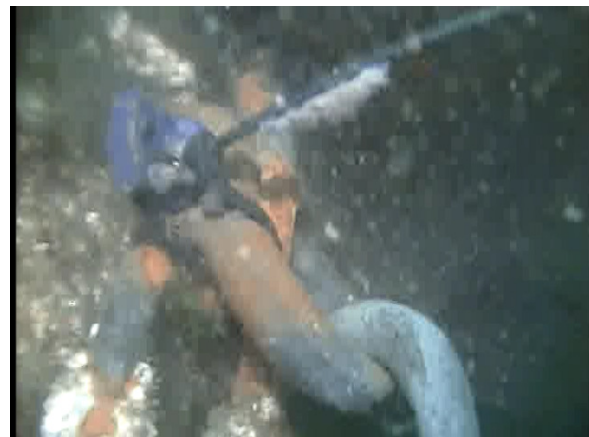
A) All Anchor chain connections and chains are in good condition.

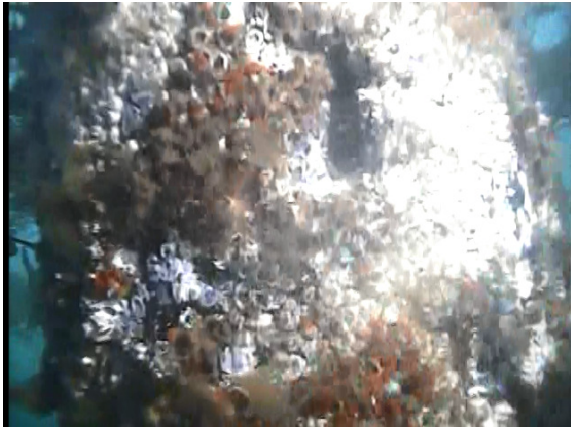
B) Row 12 Pile B, two cavities sighted approx 50mm depths.

24:57 Pile B cavity

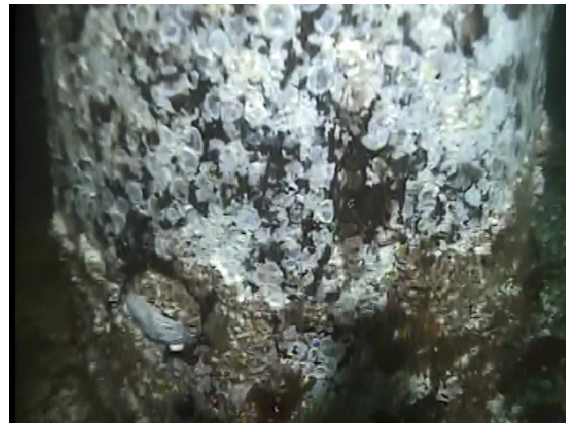
C) Row F Pile D, Pile was scraped in 3 locations, mud line section; small cavity sighted, less than 20mm depth.

40:43 Scraped pile D

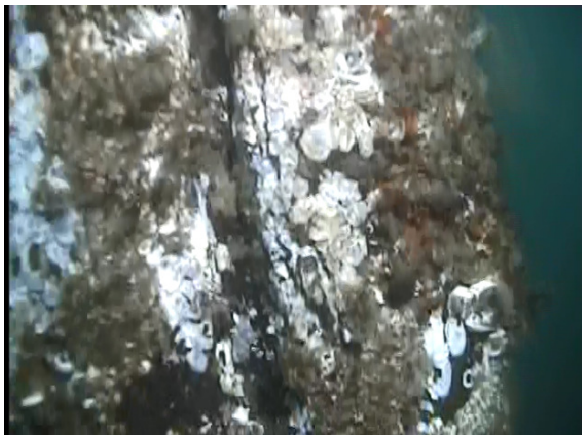
D) Row 11 Pile D, opening in the wood approx 300mm H x 20mmW

46:24 Pile D

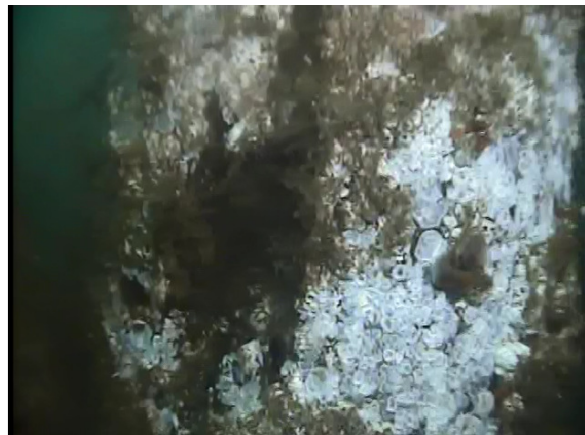
E) Batter pile running from Row 8 Line A toward Row 10. Near mud line a hollow area approx 75mmDiameter x 80mm deep.

59:02 Batter pile

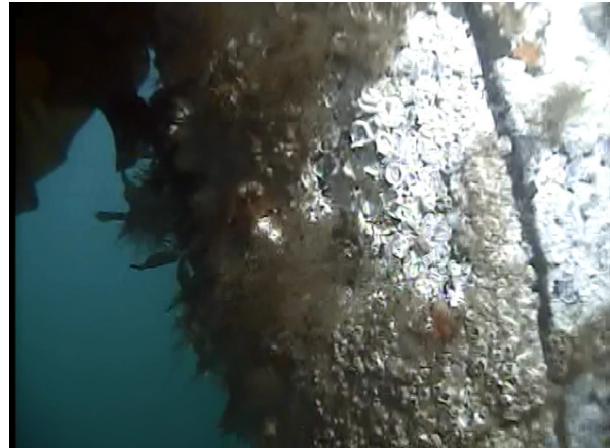
G) Row 9 Pile F, split in pile 1.5m from water line down and continues up and out of the water for approx 2m.

Ch 2; 01:04 Split pile

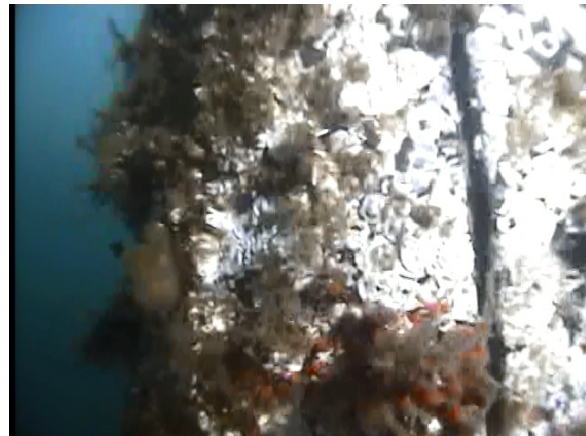
H) Row 8 pile D, split in the pile approx 300mmL x 50mm deep.

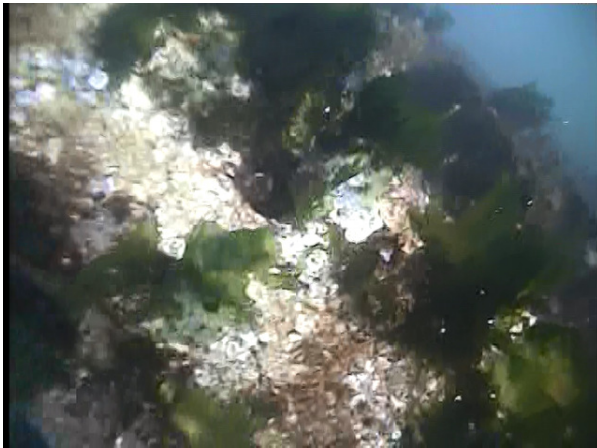
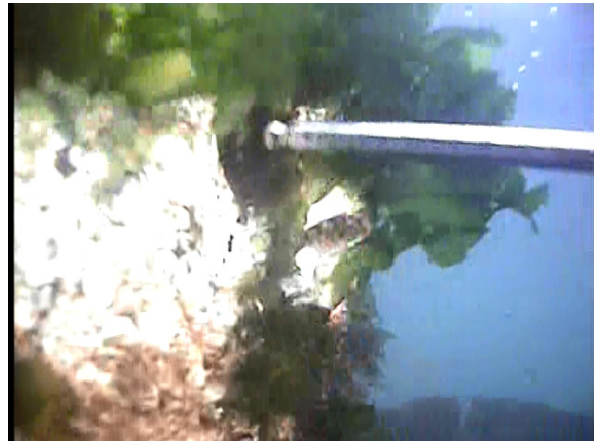
I) Row 6 pile D (adjacent to second pile). Two cavities approx 80mm deep

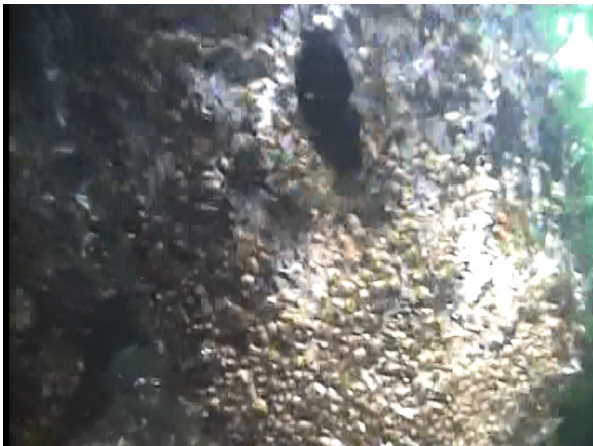
Ch2: 31:26

J) Row 4 West pile, cavity just above concrete, 80mm depth x 30mm wide.

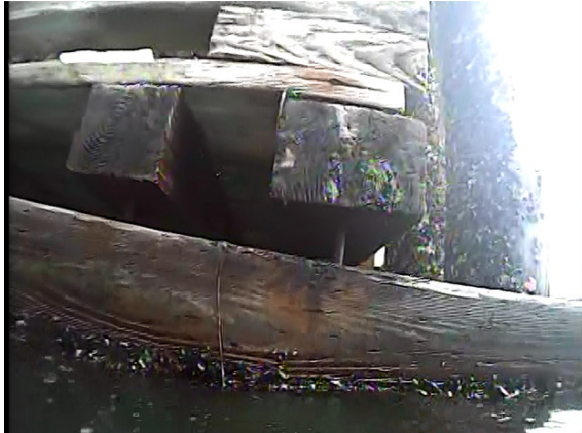
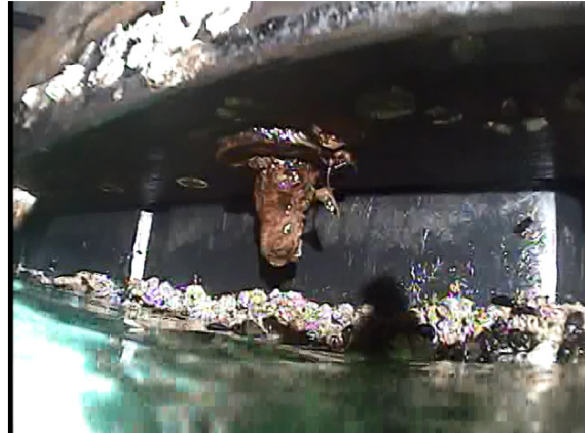
K) Float B under gangway at west end has dropped due to the washer and bolts wasted away.

L) General condition of timber fasteners on float B and C

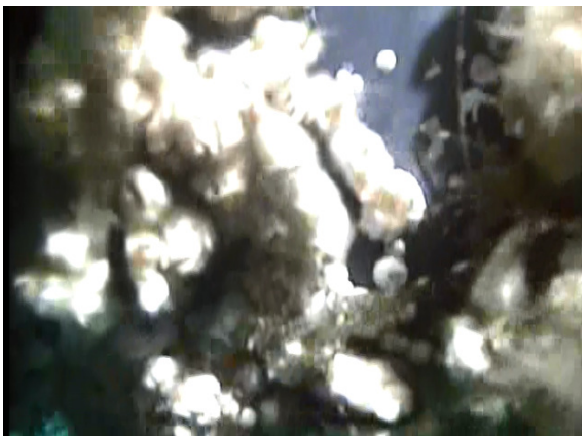
M) Billets on floats B and C encapsulated and in good condition.

Ch2: 40:40 Billets

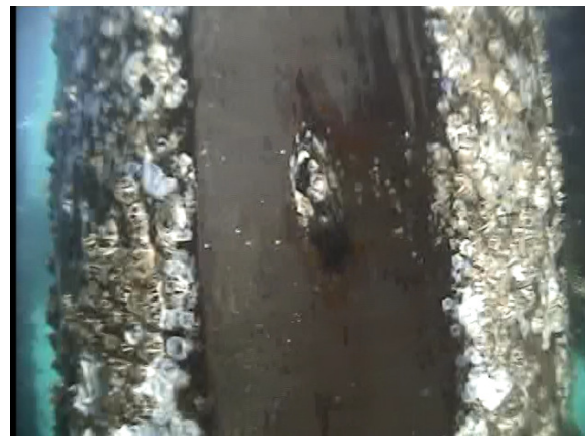
Ch2: 44:38

N) Pile cluster eastern set on float B, outboard center in rubbing area. Cavity approx 50mm deep.
